# SAFETY RECALL

Volvo Trucks North America

Release Date	Number	Release	Page
11.2024	RVXX2409	03	1(9)

**Bendix ABS ECU  
VAH, VHD, VN, VNRE**

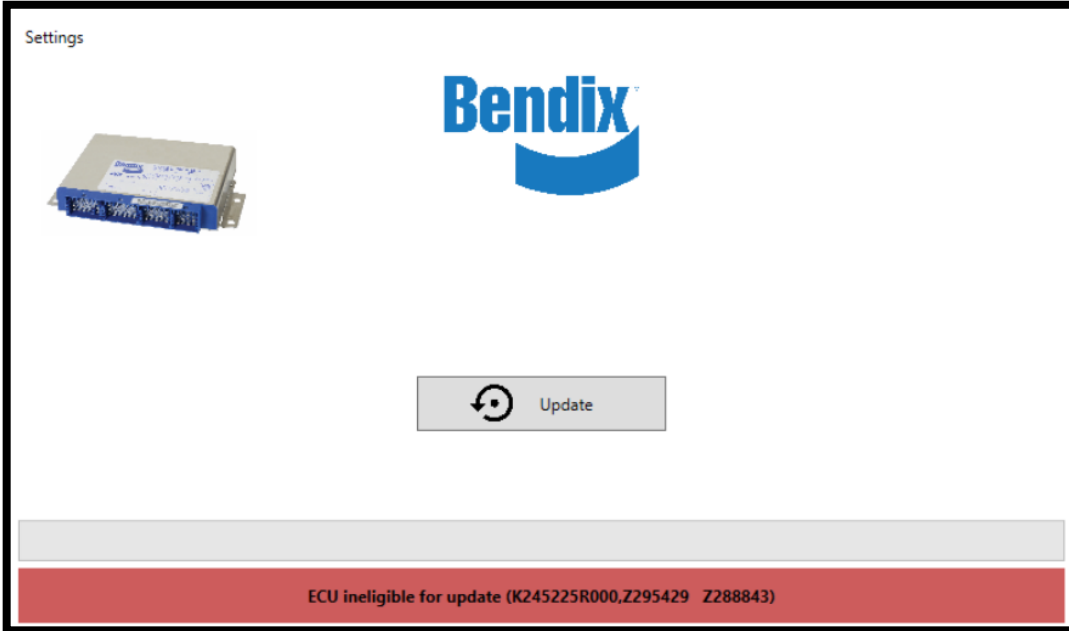
1. If the detected ECU is not eligible for an update, truck can be released for service.

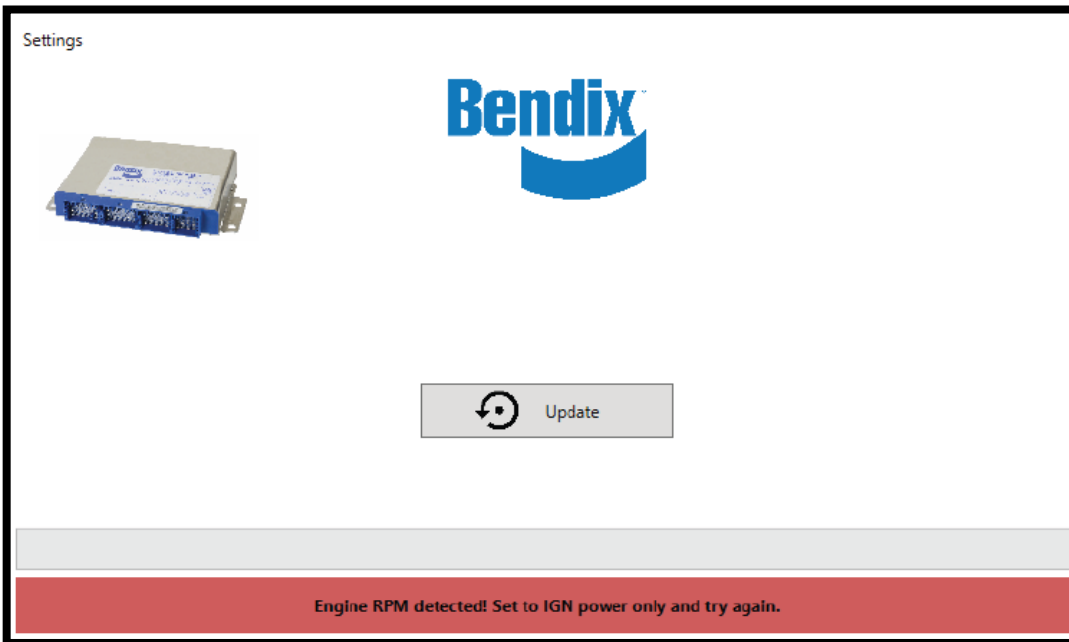
2. If engine RPM is detected during the procedure, power cycle to ignition only and restart the update procedure from Step 11.
