# SAFETY RECALL

Date	Number	Release	Page
11.2024	<b>SC0472</b>	<b>01</b>	<b>1(9)</b>

**Bendix ABS ECU**  
**AN, GR, PI, TE**

## RECALL INFORMATION

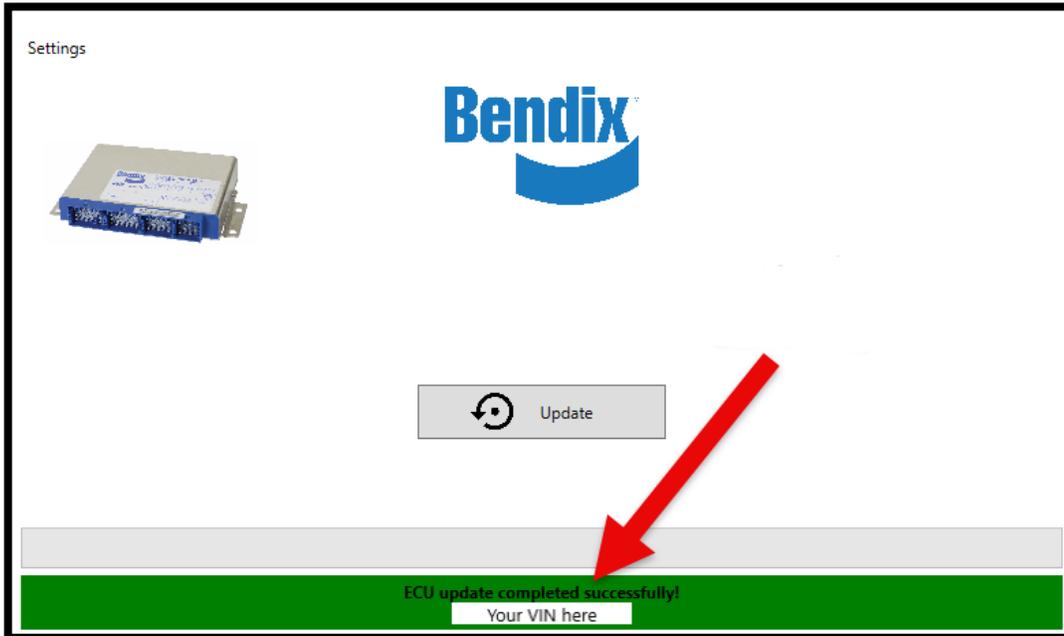
1. If the update is **successful**, the screen will show that the software has been updated and the procedure is complete.

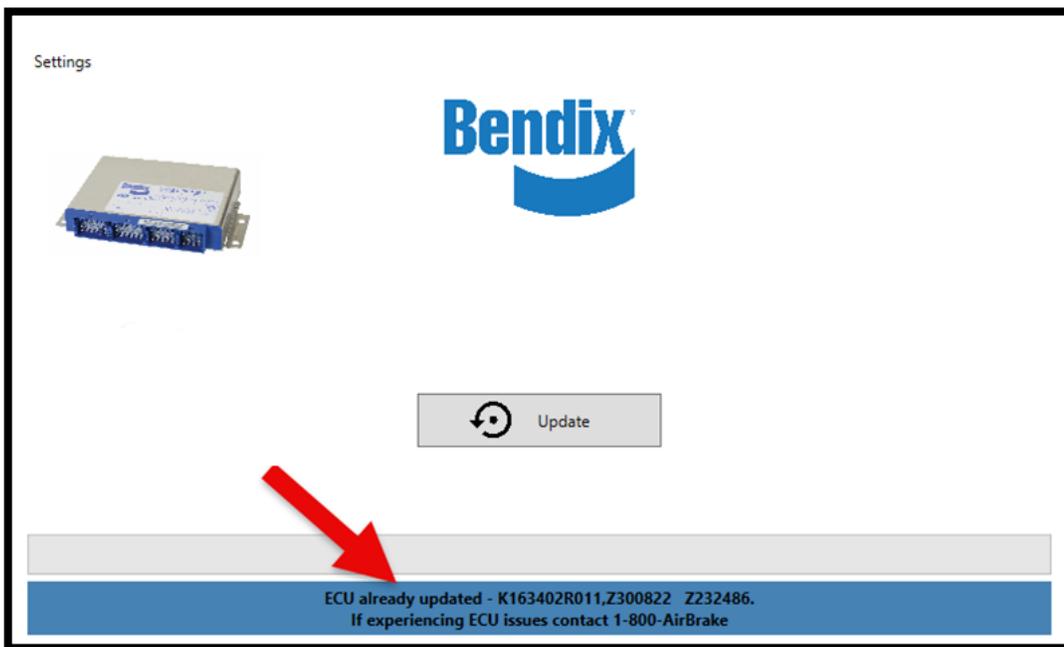
14. If the update has already been performed, no further action is required.

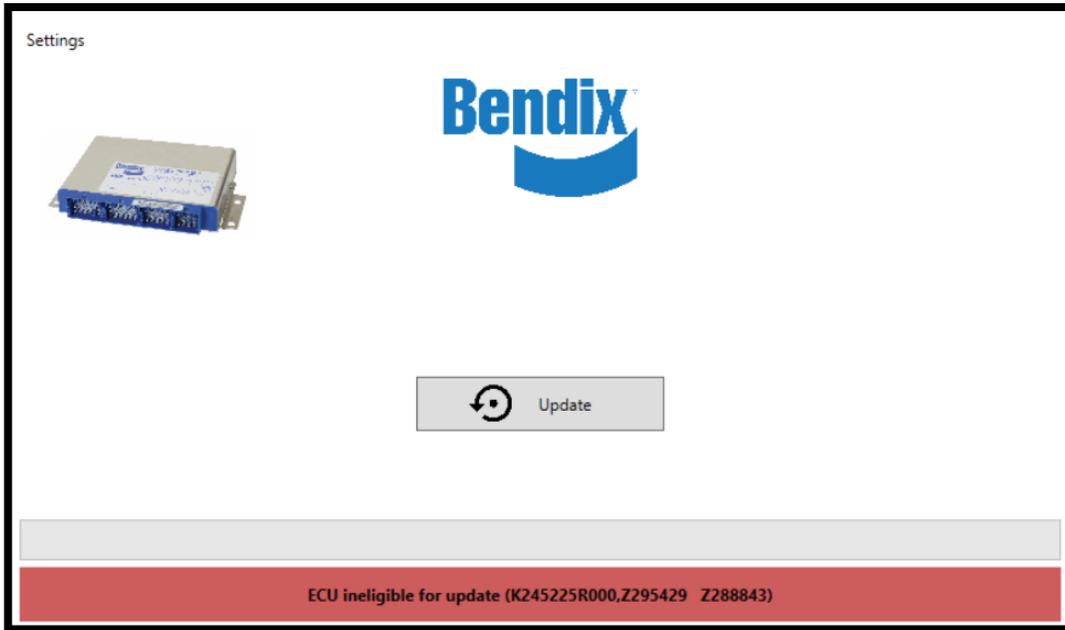
1. If the detected ECU is not eligible for an update, no further action is required.

15. If the update **fails or errors or ends in an errored state (examples of errors below)**, the screen will show the software was not able to update. Power cycle the vehicle and restart the update procedure from Step 11.

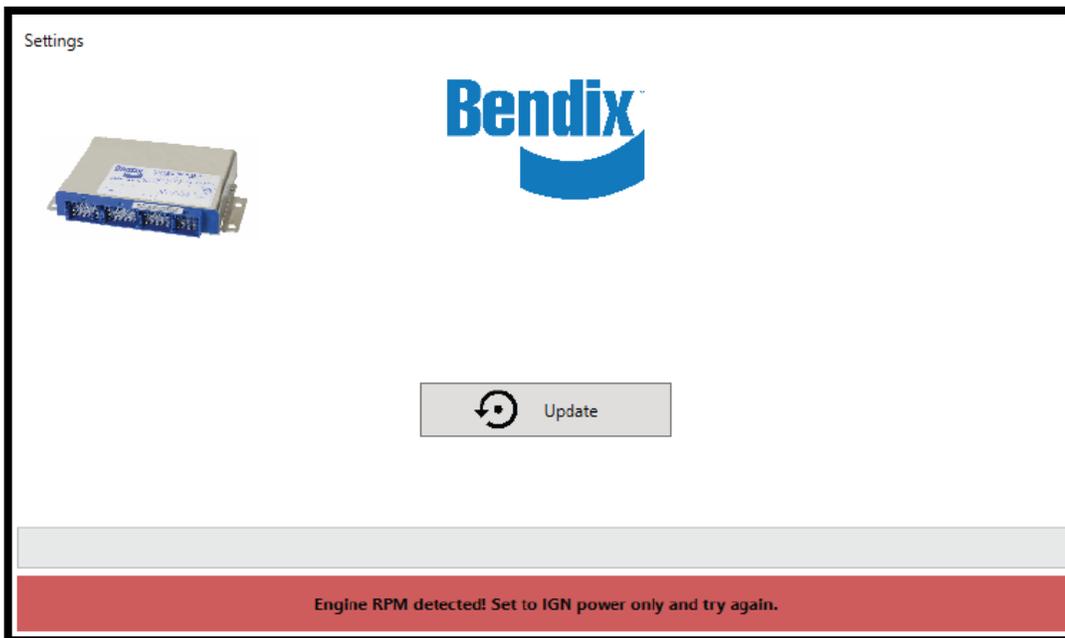
2. If engine RPM is detected during the procedure, power cycle to ignition only and restart the update procedure from Step 11.

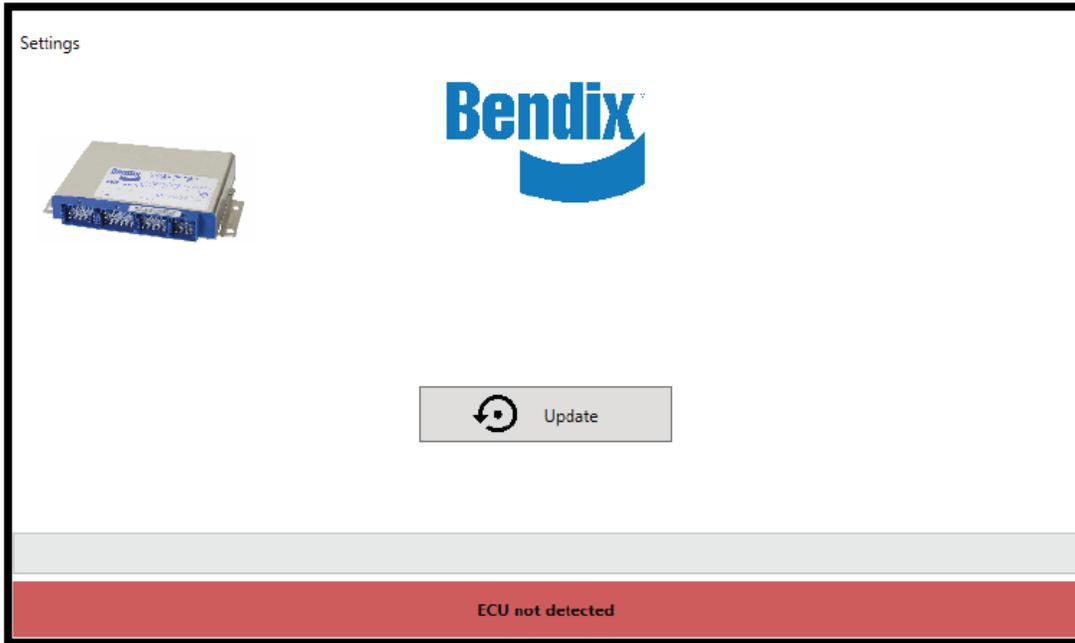
3. If the ECU is not detected, verify the ignition power is ON and/or ensure the correct channel is selected. Verify user is connected to the proper diagnostic connector. Then, restart the update procedure from step 11.
