# SAFETY RECALL

## Front Wheel Bearing Encoder Ring

Reference: 97B / NHTSA 24V-794

2025 (DT) RAM 1500 Pickup – Unsold Vehicles

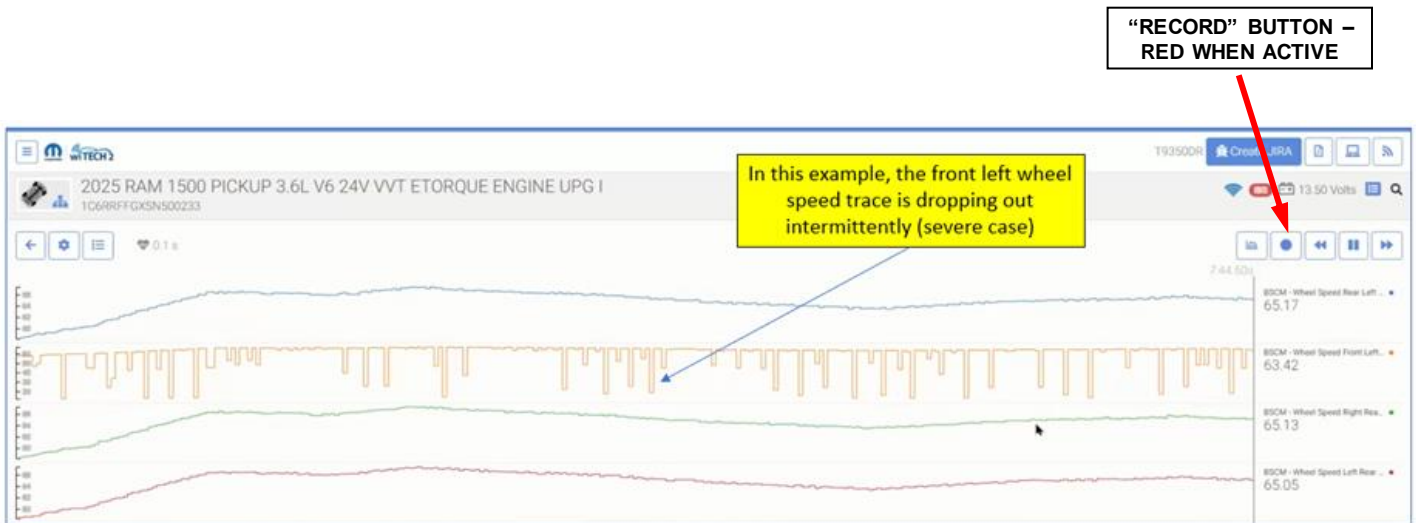
**Figure 1 – Wheel Speed Sensor Graph**

10. After the test drive, review the graph for signs of a wheel speed signal that is dropping out. See Figure 1.

11. If you notice any front wheel speed trace exhibiting an erratic signal or one that drops intermittently at any time, that specific front wheel hub and bearing must be replaced. Hold the vehicle until a remedy is available.
12. Check for DTCs **C0504 Left Front Wheel Speed Sensor A Intermittent/Erratic** or **C050A Right Front Wheel Speed Sensor A Intermittent/Erratic**.
  - No DTCs set: Vehicle has passed inspection.
  - One DTC set: Replace the wheel bearing for which the DTC is set. Hold the vehicle until a remedy is available.
  - Both DTCs set: Replace both front hub and bearing assemblies. Hold the vehicle until a remedy is available.
13. If all wheel speed sensors are operating and visually smooth, no further action is required.
14. Clear DTCs. Place the ignition in the **“OFF”** position and then remove the wiTECH MDP device from the vehicle.
