# SAFETY RECALL

## Front Wheel Bearing Encoder Ring

Reference: 97B / NHTSA 24V-794

FCA US LLC

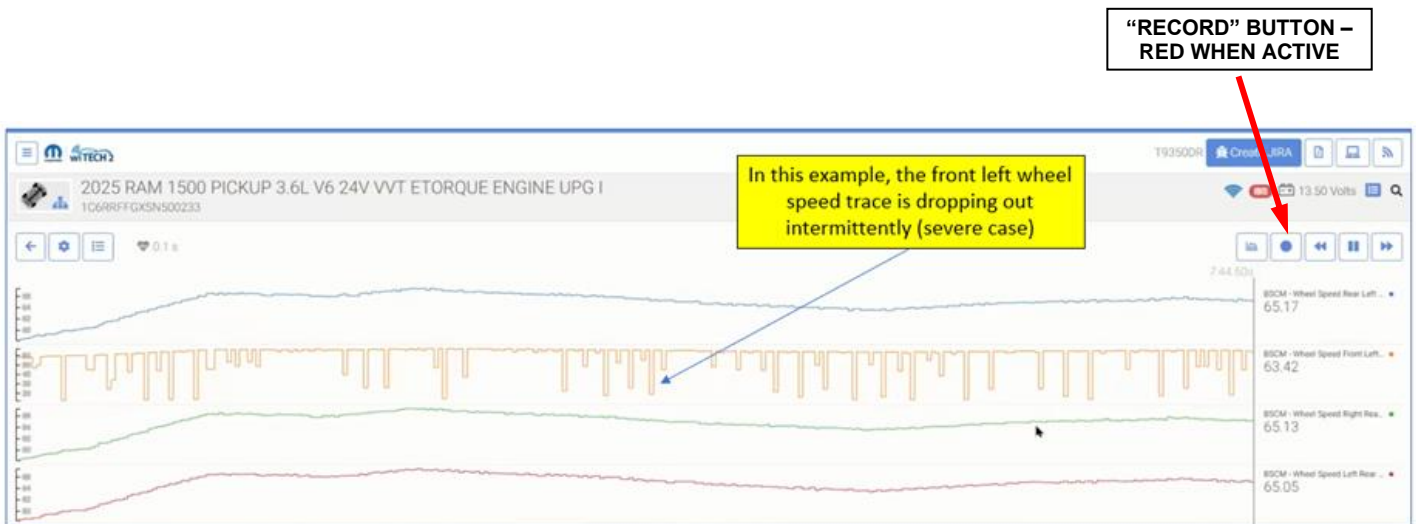
**Figure 1 – Wheel Speed Sensor Graph**

9. Perform a short test drive with speeds up to and including highway speeds. Record data at three different speeds including one at highway speeds, up to 70mph if possible.
10. After the test drive, review the graph for signs of a wheel speed signal that is dropping out. See Figure 1.

11. If you notice any front wheel speed trace exhibiting an erratic signal or one that drops intermittently at any time, that specific front wheel hub and bearing must be replaced. Hold the vehicle until a remedy is available.
12. Check for DTCs **C0504 Left Front Wheel Speed Sensor A Intermittent/Erratic** or **C050A Right Front Wheel Speed Sensor A Intermittent/Erratic**.
  - No DTCs set: Vehicle has passed inspection.
  - One DTC set: Replace the wheel bearing for which the DTC is set. Hold the vehicle until a remedy is available.
  - Both DTCs set: Replace both front hub and bearing assemblies. Hold the vehicle until a remedy is available.
13. If all wheel speed sensors are operating and visually smooth, no further action is required.
14. Clear DTCs. Place the ignition in the “**OFF**” position and then remove the wiTECH MDP device from the vehicle.
