# Safety Recall

## N242454440 Momentary Rear Wheel Lock-Up

**Release Date:** March 2025

**Revision:** 02

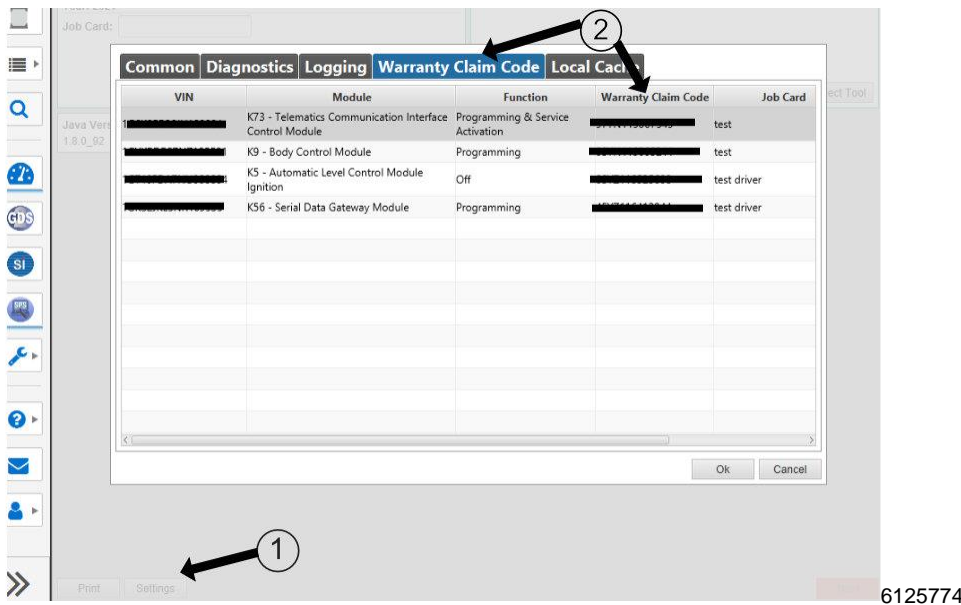
If the Warranty Claim Code was not recorded on the Job Card, the code can be retrieved in the SPS2 system as follows:

1. Open TLC on the computer used to program the vehicle.
2. Select and start SPS2.
3. Select Settings (1).
4. Select the Warranty Claim Code tab (2).

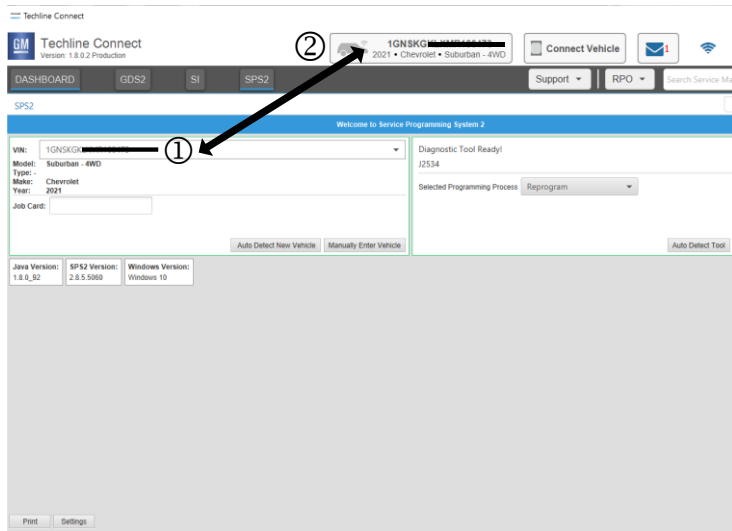
5743643

**Caution:** Be sure the VIN selected in the drop down menu (1) is the same as the vehicle connected (2) before beginning programming.

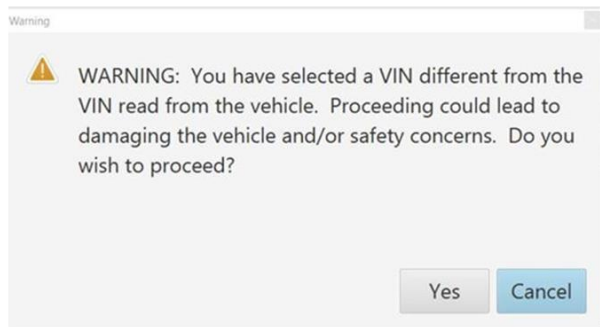
5877000

**Important:** If the vehicle VIN DOES NOT match, the message below will be shown.

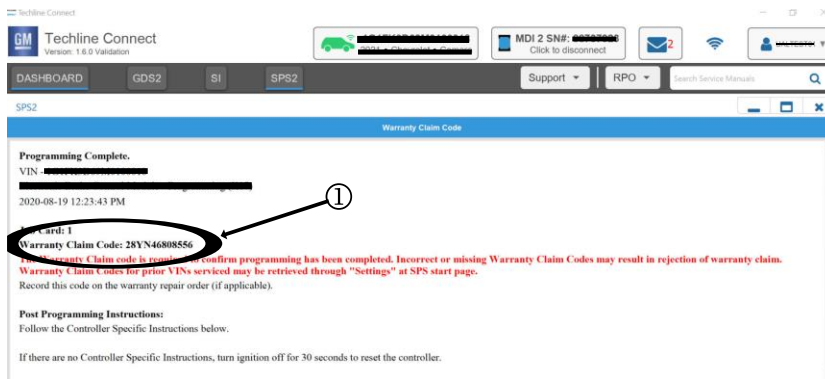
5644478

**Note:** The screenshot above is an example of module programming and may not be indicative of the specific module that is being programmed. Module selection and VIN information have been blacked out.

**Important:** To avoid warranty transaction rejections, you **MUST** record the warranty claim code provided on the Warranty Claim Code (WCC) screen shown above on the job card. Refer to callout 1 above for the location of the WCC on the screen.

- Record SPS Warranty Claim Code on job card for warranty transaction submission.
