VOLUNTARY RECALL CAMPAIGN

Classification: BT24-006	Reference: NTB24-047	Date: October 24, 2024
-----------------------------	-------------------------	---------------------------

VOLUNTARY SAFETY RECALL CAMPAIGN 2022-2024 Z; FRONT BUMPER FASCIA SUB-HARNESS

CAMPAIGN ID #: R24B6
APPLIED VEHICLES 2022-2024 Z (Z34)
APPLIED GRADES: Z and Z NISMO

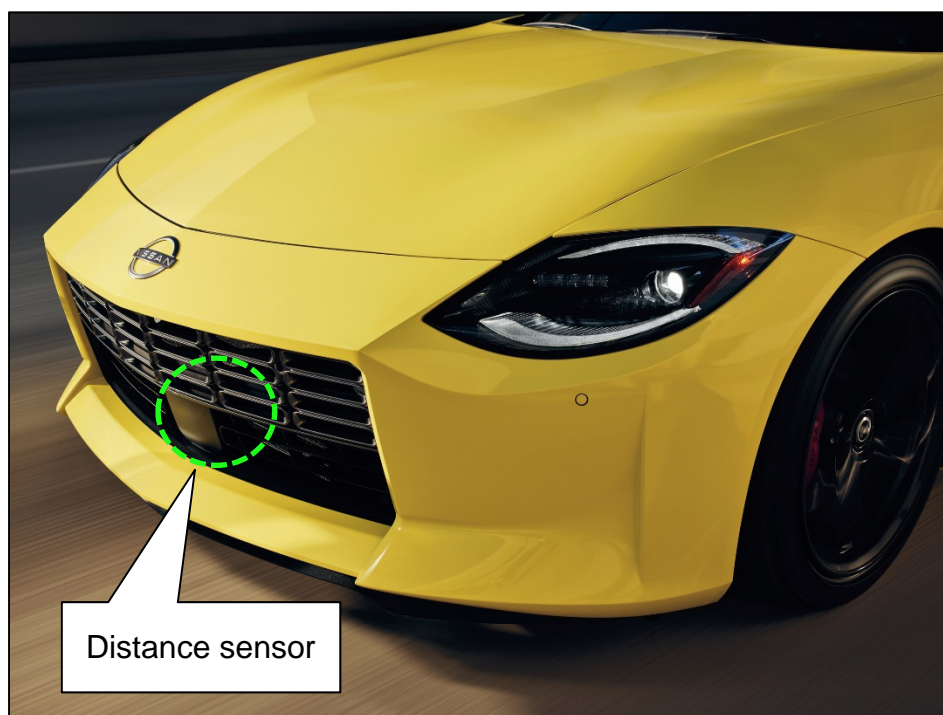
Figure 1

To avoid damage or the requirement of distance sensor realignment, move the front bumper fascia straight outward during removal to avoid any contact with the distance sensor.
