Recall Campaign Bulletin

Campaign No. 2024110003, November 2024

SUBJECT: **Model GLC (254 platform)**
Model Year 2023

Check the Driver and Front Passenger Seat Rail Bolts

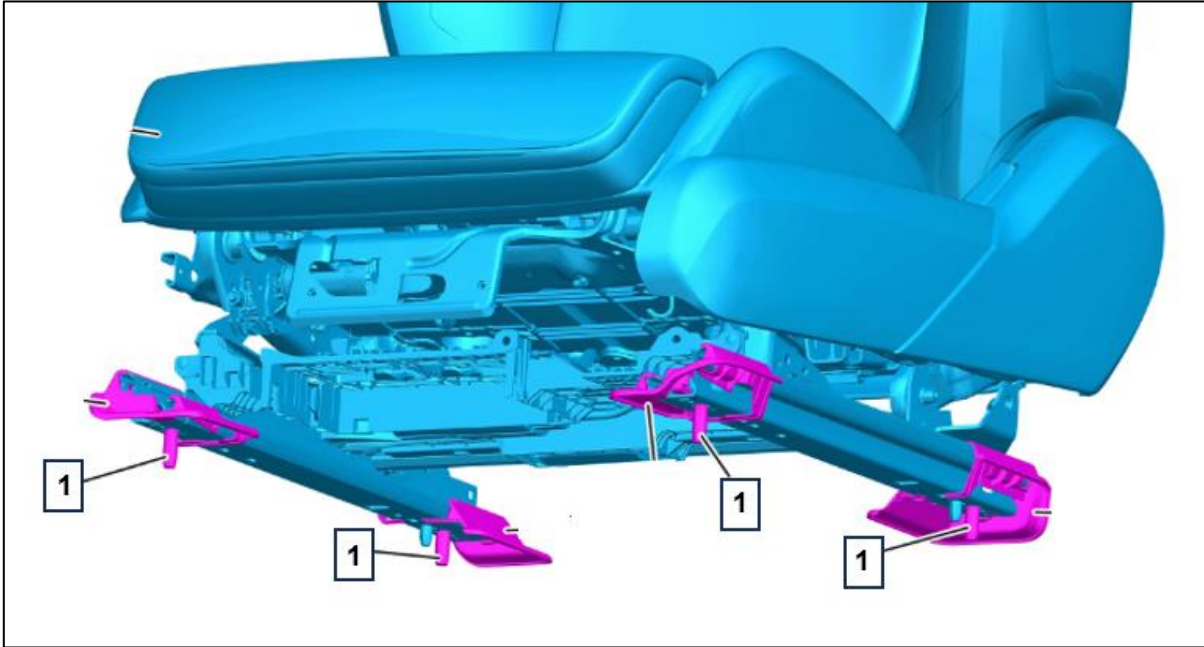
Figure 1

Mercedes-Benz AG, the manufacturer of Mercedes-Benz vehicles, has determined that on certain MY 2023 GLC (254 platform) vehicles, the rear bolt connections of the driver and/or front passenger seat rails to the vehicle body might not meet current production specifications. In the case of an incorrectly bolted seat rail, the anchoring of the driver and/or front passenger seat cannot be ensured in the event of a crash. As a result, the driver and/or front passenger seat could move more than expected, which could increase the risk of injury for the driver and/or front passenger. An authorized Mercedes-Benz dealer will check and rework the bolt connections between the driver and front passenger seat rails and the vehicle body, if necessary.

1. Check to see if mounting bolts (**Figure 1, 1**) are present on the front passenger and driver seat rails.

- a. If **all bolts are present** on both front seats:
Loosen and retorque bolts (Figure 1, 1) on both front seats to specified tightening torque (50 Nm).
i For basic information, see AR91.10-P-1000WT and BA91.10-P-1001-01T.
- b. If **bolts are not all present** on both front seats:
Retrofit bolts on front seats that are missing and retorque all bolts to specified tightening torque (50 Nm).
i For basic information, see AR91.10-P-1000WT and BA91.10-P-1001-01T.
