MOUNTAIN TOUGH FOUR SEASONS CAMPING

Service Advisory 24-1118

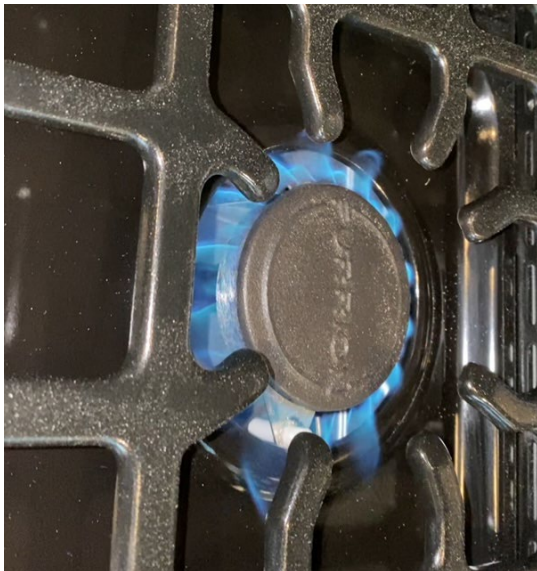
Outdoors RV is conducting a voluntary RECALL notification campaign in accordance with the National Highway Transportation and Safety Act. It has been decided that the vehicles in the recall population have a Furrion interior range cooktop that the burner flame may be affected during furnace operation. Under certain conditions, during furnace operation, the interior range cooktop burner flame can invert leading to an increased risk of personal injury, and/or fire.

**EXAMPLE OF AN
INVERTED FLAME**

Step 4 Remove the Furrion Range to access the inside of the cabinet using industry standards

Step 5 Install the bottom panel first and side panel or panels second using 1 ¼" screws

Step 6 Use Foil Tape to seal the panels at the joints and around the propane line and wiring to the stove, re-install the Furrion Range using industry standards. Perform a propane drop pressure test for propane gas leak detection and then repeat the test outlined in Step 3 to assure condition has been corrected.
