**NHTSA Safety Recall 24V-826**

**Transport Canada 2024-667**

**SUBJECT: Campaign # 192 – Hood Mounting Bracket(s)**

## E & F Series Hood Bracket

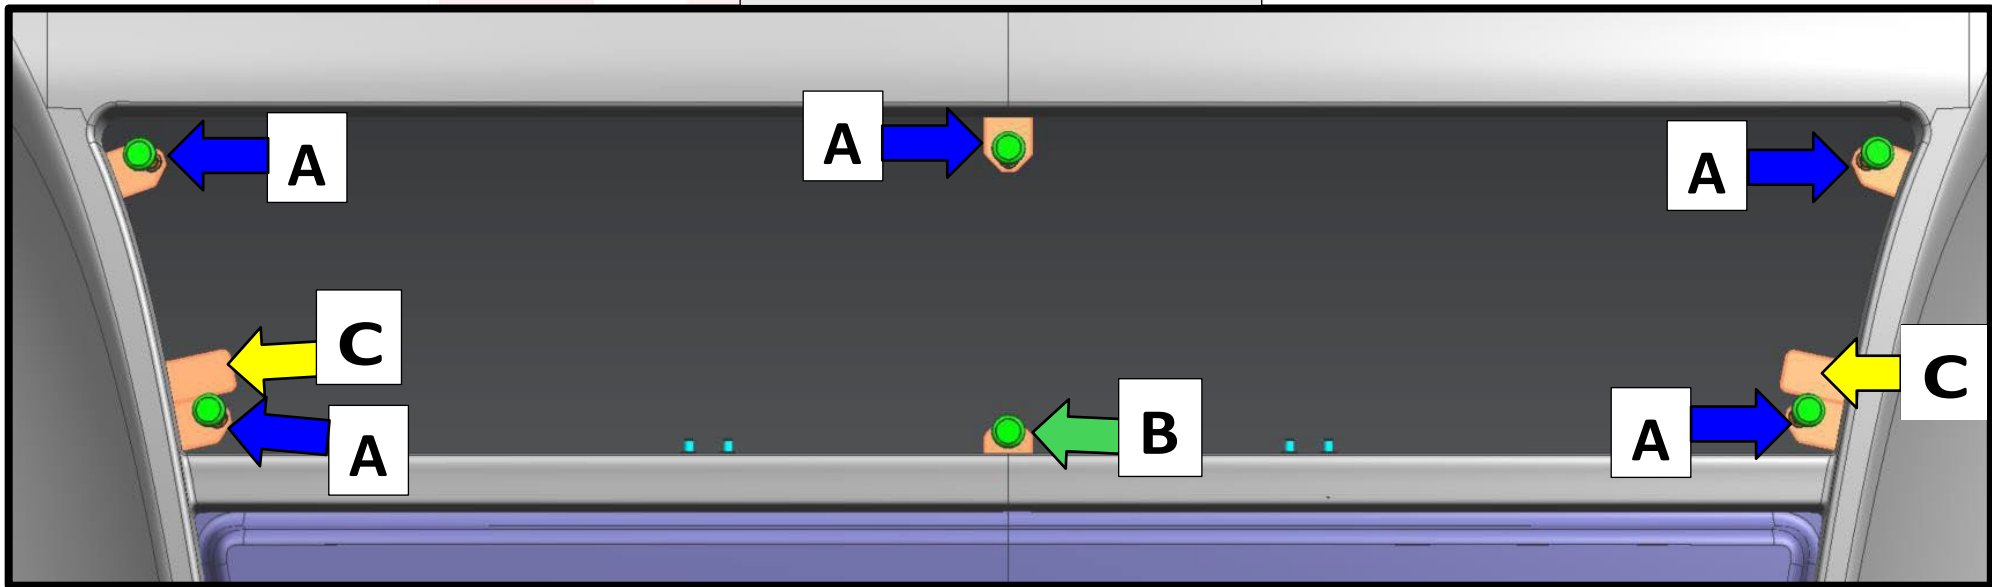
Figure 9 – Front Hood Opening

There are 8 critical brackets on the edges of the front cap.

- Total of 5 long hood stop brackets, 2 on either side and 1 on the center on the top. (See Figure 9 - Blue Arrows "A")
- Total of 1 short hood stop bracket, in the center on the bottom. (See Figure 9 - Green Arrow "B")
- Total of 2 hood latch brackets, 1 on either side. (See Figure 9 - Yellow Arrow "C")

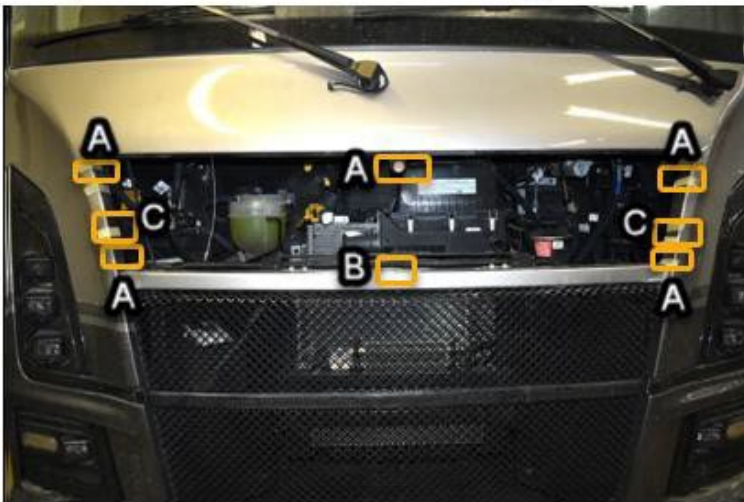
Example Photo of All 8 Brackets Missing:

**Note: If you have any MISSING or LOOSE Bracket/s, remove the Brackets, and send a photo of the front end of the unit for Winnebago's Documentation.**

**Note: Photos must be taken a few feet away from the Hood for Winnebago's visual inspection of the failed Bracket/s location/s.**
