# Safety Recall

## Code: 69E6

#### Driver Frontal Airbag Inflator

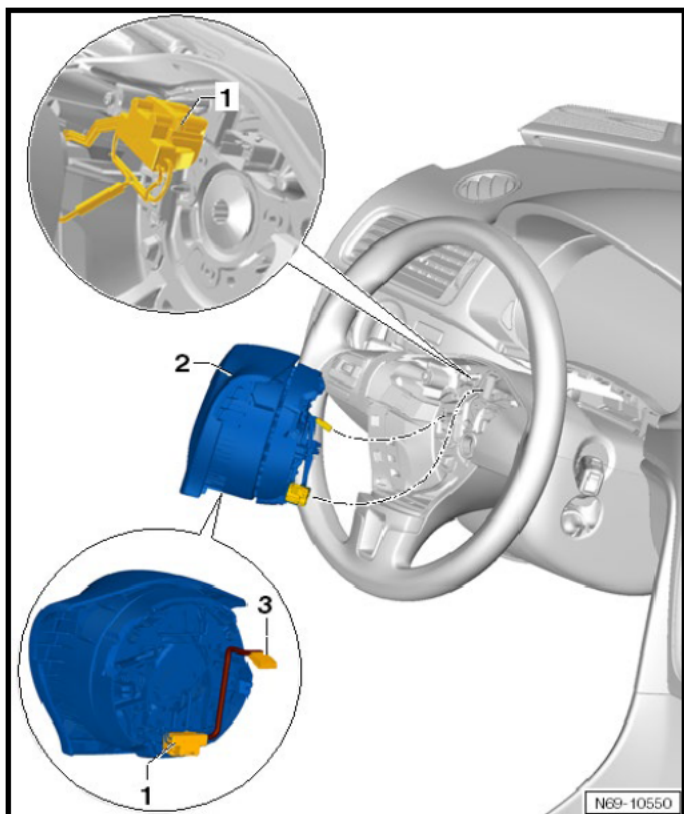
The driver's side frontal airbag inflator may explode due to propellant degradation occurring after long-term exposure to high absolute humidity, high temperatures, and high temperature cycling. An inflator explosion may result in sharp metal fragments striking the driver or other occupants resulting in serious injury or death.

- Replace driver airbag.
