Safety Recall

N242471620 Momentary Rear Wheel Lock-Up or Low-Speed Change in Intended Direction

Release Date: December 2024

Revision: 01

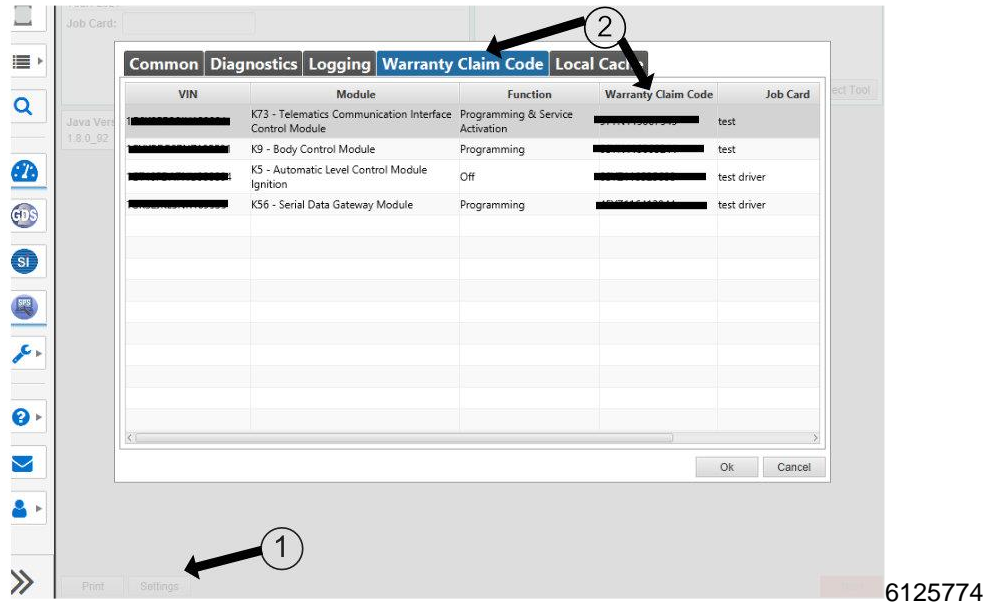
If the Warranty Claim Code was not recorded on the Job Card, the code can be retrieved in the SPS2 system as follows:

- Open TLC on the computer used to program the vehicle.
- Select and start SPS2.
- Select Settings (1).
- Select the Warranty Claim Code tab (2).

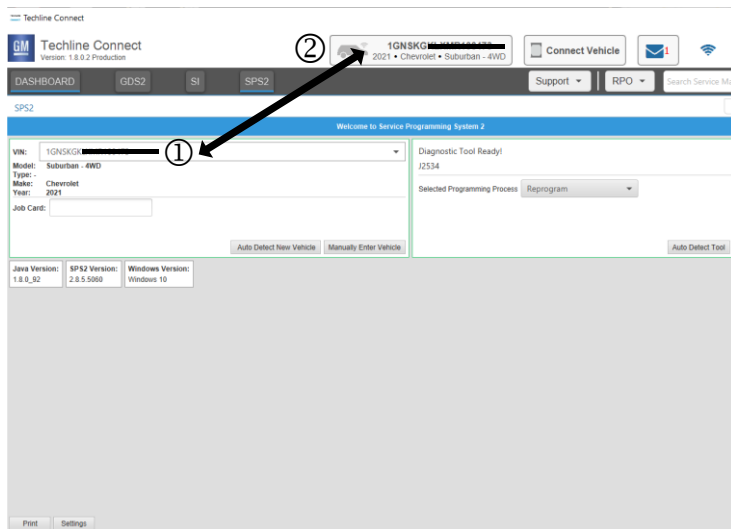
5743643

Caution: Be sure the VIN selected in the drop down menu (1) is the same as the vehicle connected (2) before beginning programming.

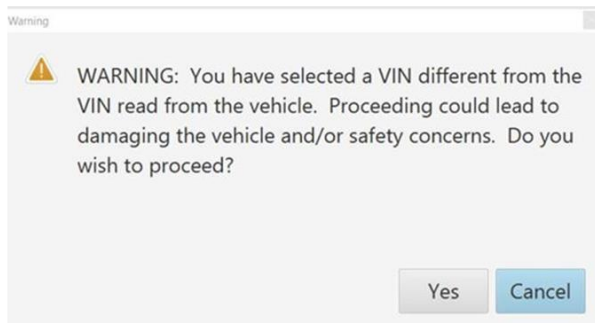
5877000

Important: If the vehicle VIN DOES NOT match, the message below will be shown.

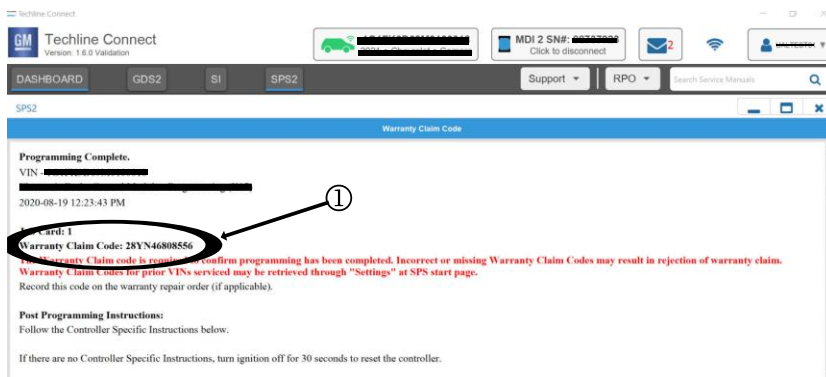
5644478

Important: To avoid warranty transaction rejections, you **MUST** record the warranty claim code provided on the Warranty Claim Code (WCC) screen shown above on the job card. Refer to callout 1 above for the location of the WCC on the screen.

1. Reprogram the Transmission Control Module. Refer to *K71 Transmission Control Module: Programming and Setup* in SI.

2. Record SPS Warranty Claim Code on job card for warranty transaction submission.
