SIB 65 32 24

SAFETY RECALL 24V-856: HEAD AIR BAG

E-Series	Model Description	Production Date
G45	X3 Sports Activity Vehicle	October 18, 2024

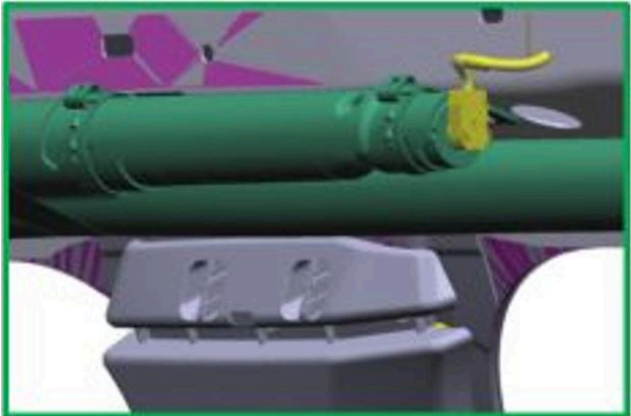
<p>The head air bag right gas generator electrical connector (shown here in yellow) is oriented towards the roof of the vehicle.</p> <p>This is the correct position.</p>
---	---

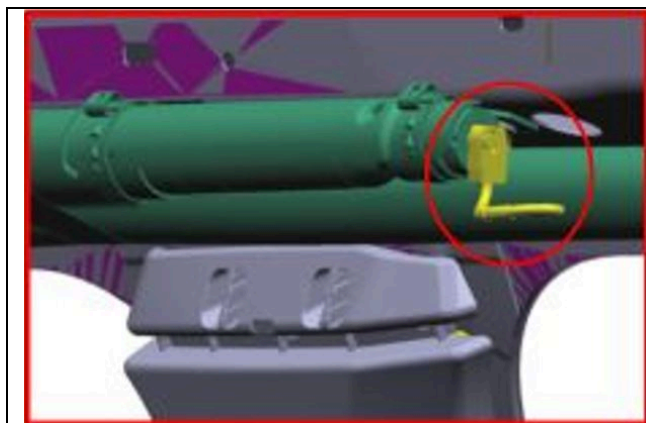
The supplier may have installed the gas generator in the RIGHT-side head airbag rotated 180°. This does not affect the left side.

The head air bag right gas generator electrical connector (shown here in yellow) is oriented towards the floor of the vehicle.

This is the incorrect position, and the head air bag assembly must be replaced.

NOTE: When replacing the RIGHT-side head air bag assembly make sure that the printed colored line that runs the length of the component points in the direction of the vehicle interior to ensure it will function correctly.
