November 15, 2024

Version 1

Safety Recall: 2024 Integra Driver's Seat Lift Link Bolt Loose

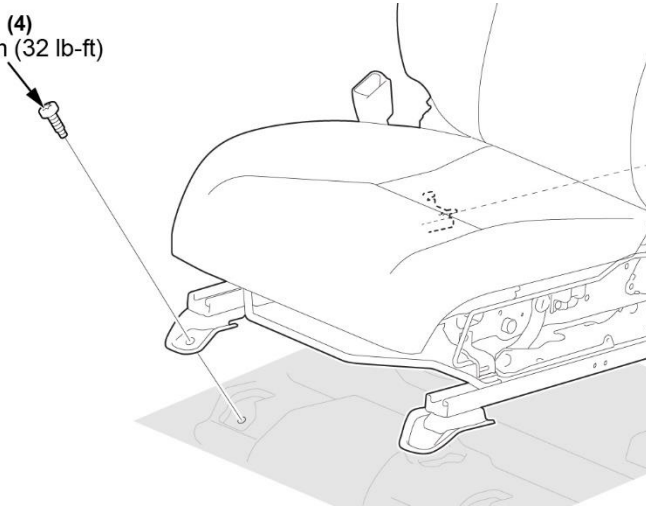
BOLTS (4)
43 N·m (32 lb-ft)

1. Remove the seat bolts using a 50 IP TORX Plus socket.
