HYUNDAI
Technical Service Bulletin

GROUP RECALL	NUMBER 24-01-086H-1
DATE DECEMBER 2024	MODEL(S) SEE BELOW

SUBJECT: DTC P1A9096 CHECK FOR ICCU & FUSE REPLACEMENT & ICCU SOFTWARE UPDATE (RECALL 272)

This TSB supersedes TSB 24-01-086H to update all sections with information for IONIQ 5 ROBOTAXI (NER) models.

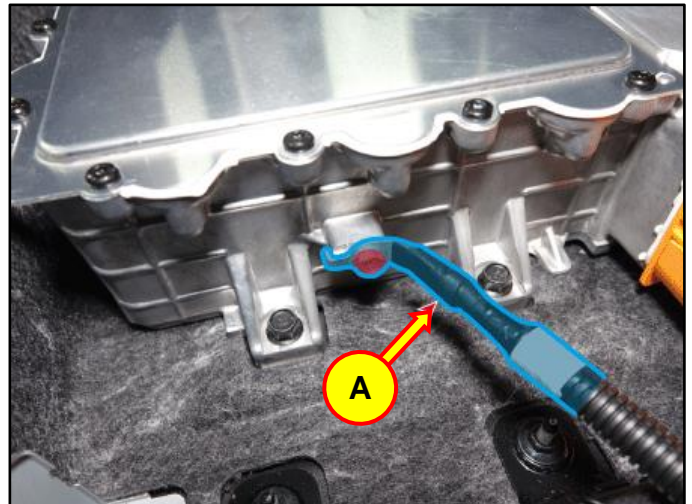
C5. Remove the ground (A) after removing the mounting bolt.

Tightening Torque:

lb-ft	7
lb-in	84
N.m	9

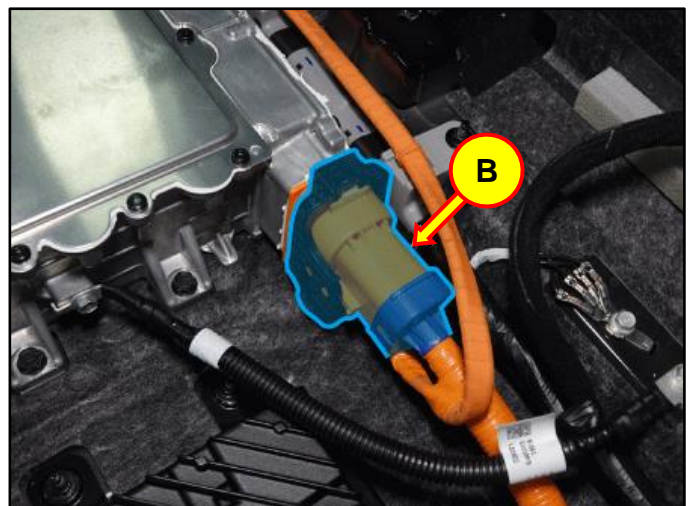
C6. Disconnect the ICCU AC connector (B).

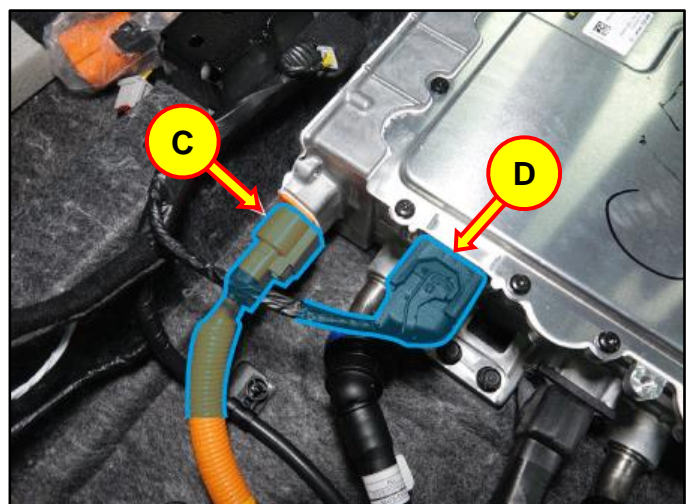
C7. Disconnect the ICCU DC connector (C) and ICCU signal connector (D).

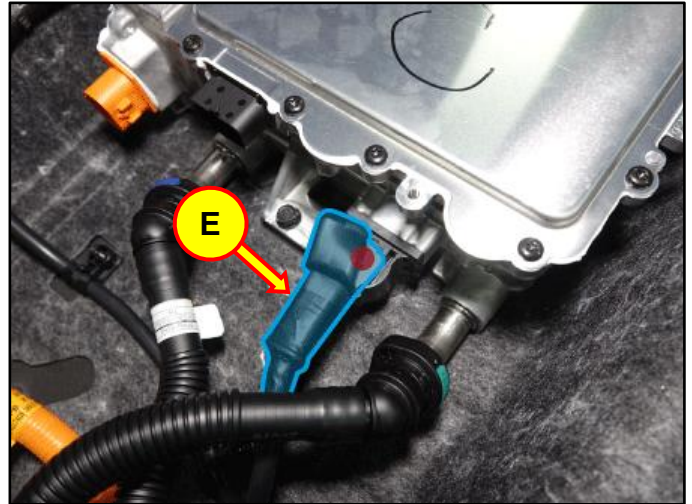
C8. After loosening the mounting bolts, remove the LDC plus (E).

Tightening Torque:

lb-ft	7
lb-in	84
N.m	9

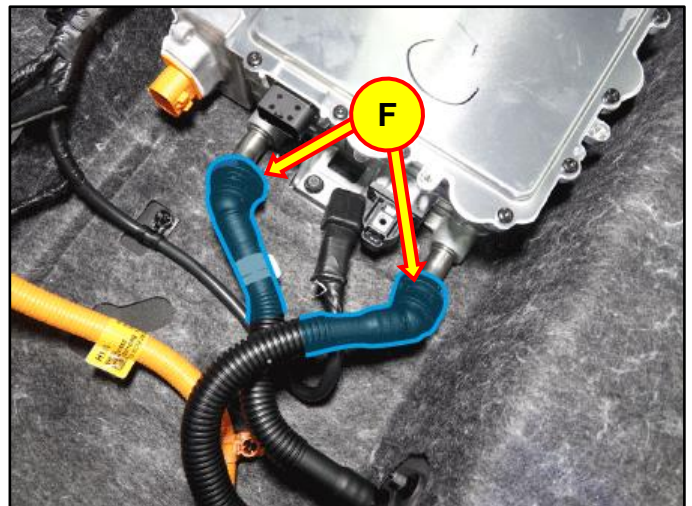
C9. Place an absorbent mat under the coolant tube quick connectors (U) then disconnect the coolant tube connectors (U).

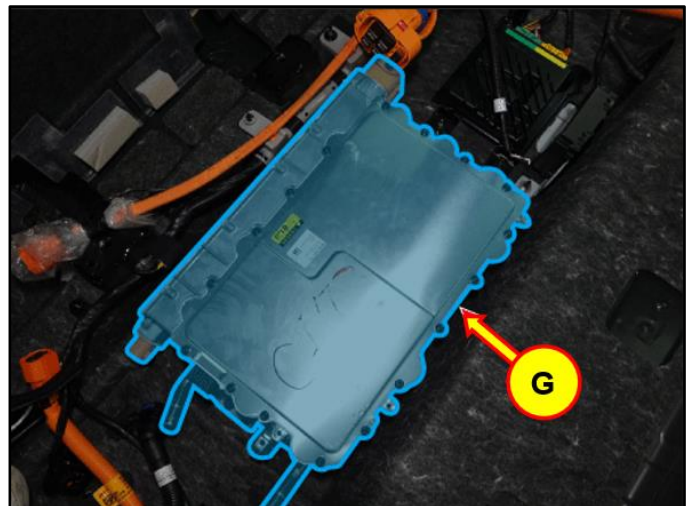
C10. After removing the mounting bolts, remove the ICCU (G).

Tightening Torque:

lb-ft	19
N.m	25

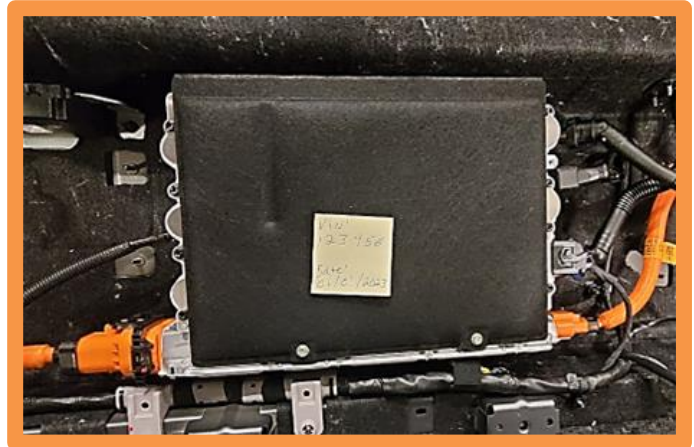
C11. Install the replacement part and take a STUI photo for uploading.

Using STUI, take a photo of the new ICCU with the last 6 digits of the VIN and the date of repair on a piece of paper. Upload the photo to STUI.

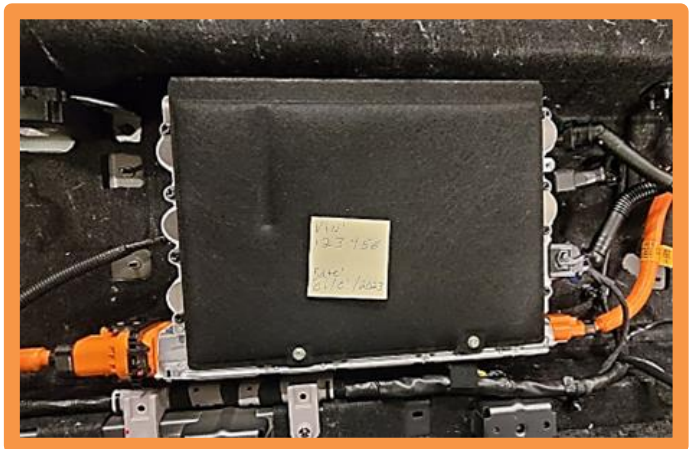
D13. Install the replacement part and take a STUI photo for uploading.

Using STUI, take a photo of the new ICCU with the last 6 digits of the VIN and the date of repair on a piece of paper. Upload the photo to STUI.

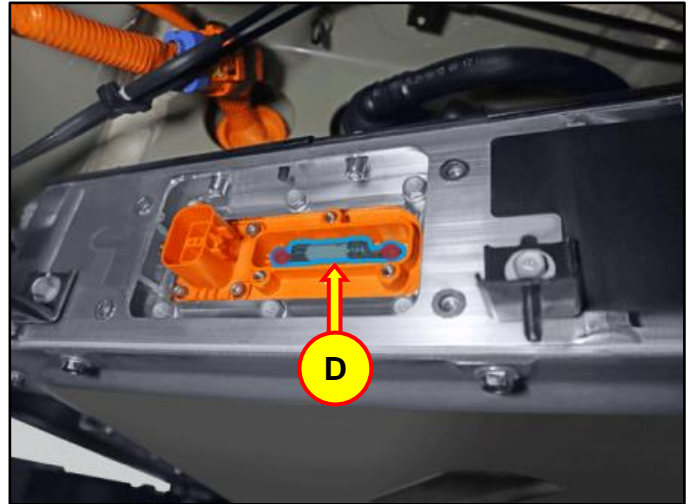
- E6. Remove the ICCU fuse (D).

Removing the fuse may be difficult since the nuts holding the fuse holder may fall into the battery.

Avoid using a power driver to remove and install the bolts. **ONLY** use hand tools.

If this occurs, see below for **SPECIAL INSTRUCTIONS**.

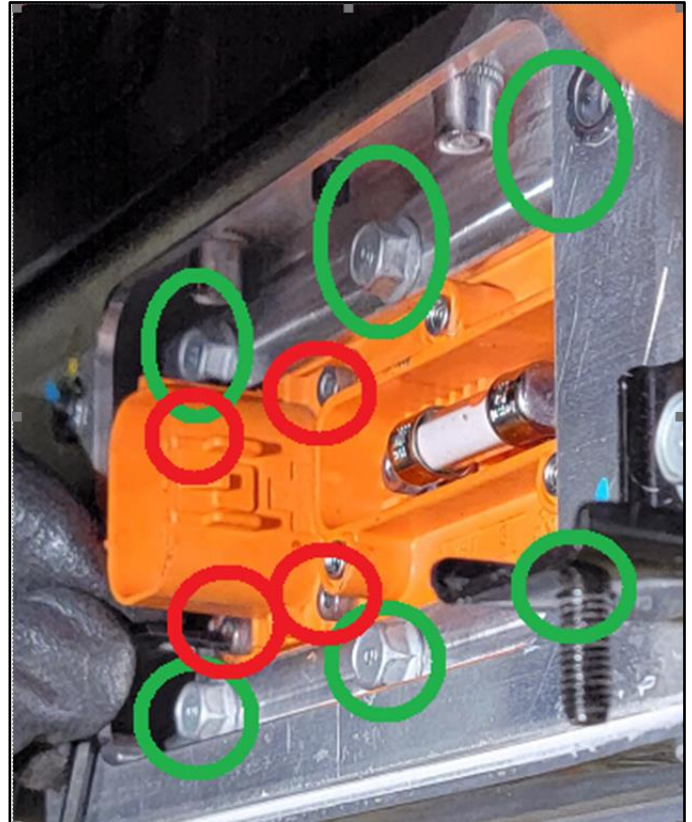
F. SPECIAL INSTRUCTIONS (perform only if ICCU fuse rear nut(s) falls into the battery)

- F1. Remove the following parts:
- 6 qty. 10mm bolts (green)
 - 4 qty. bolts by Allen wrench (red)
- F2. Push in bottom area. Pull out top area.
- F3. Reach in to grab the nut behind the plate on the bottom surface.
- F4. Hold the nut at the back side.
- F5. Install the fuse bolt at the location where the nut had fallen.
- F6. Reinstall all the other bolts in reverse order of removal.
- F7. Install the rest of the fuse bolts.

Contact Techline if the above procedure did not resolve a dropped nut problem.
