**HYUNDAI**
Technical Service Bulletin

GROUP	NUMBER
RECALL	24-01-086H
DATE	MODEL(S)
NOVEMBER 2024	IONIQ 5 (NE EV) IONIQ 6 (CE EV)

SUBJECT: DTC P1A9096 CHECK FOR ICCU & FUSE REPLACEMENT
& ICCU SOFTWARE UPDATE (RECALL 272)

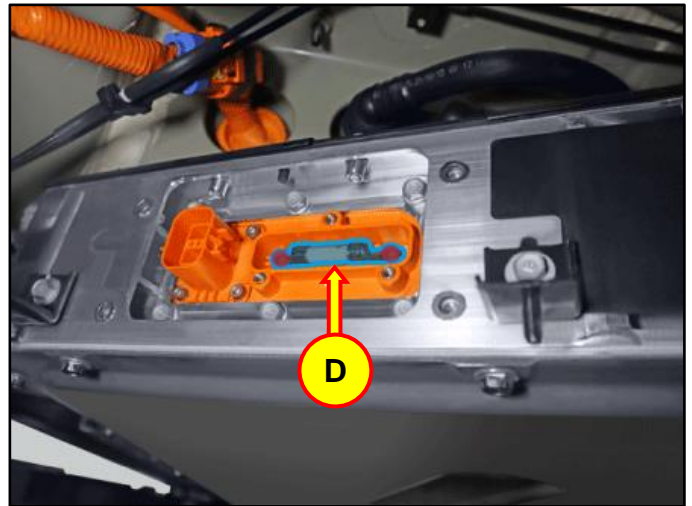
- E6. Remove the ICCU fuse (D).

Removing the fuse may be difficult since the nuts holding the fuse holder may fall into the battery.

- E7. Install the supplied replacement part for the ICCU fuse.
- E8. Reinstall all parts in the reverse order of removal.
