# Technical Service Bulletin

<b>GROUP</b>	<b>NUMBER</b>
<b>RECALL</b>	<b>24-01-087G</b>
<b>DATE</b>	<b>MODEL(S)</b>
<b>NOVEMBER 2024</b>	<b>SEE BELOW</b>

**SUBJECT:** DTC P1A9096 CHECK FOR ICCU & FUSE REPLACEMENT & ICCU SOFTWARE UPDATE (RECALL 025G)

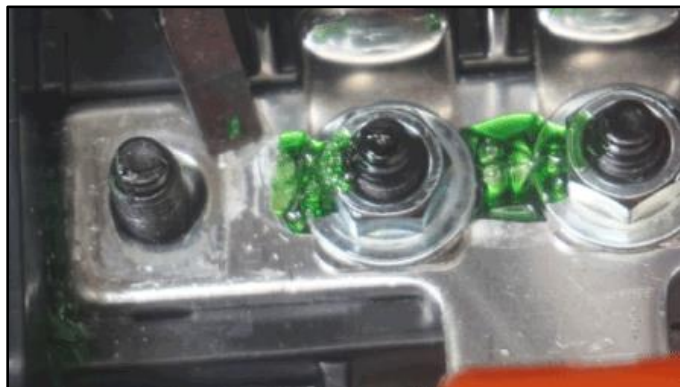
Any foreign substance in this area may cause poor contact between terminals.

- D4. After removing the fuse, carefully clean the fuse mating surface prior to installation.
