Technical Service Bulletin

GROUP RECALL	NUMBER 26-01-025H
DATE MARCH 2026	MODEL(S) SEE BELOW

SUBJECT: DTC P1A9096 CHECK FOR ICCU & FUSE REPLACEMENT & ICCU SOFTWARE UPDATE (RECALL 272)

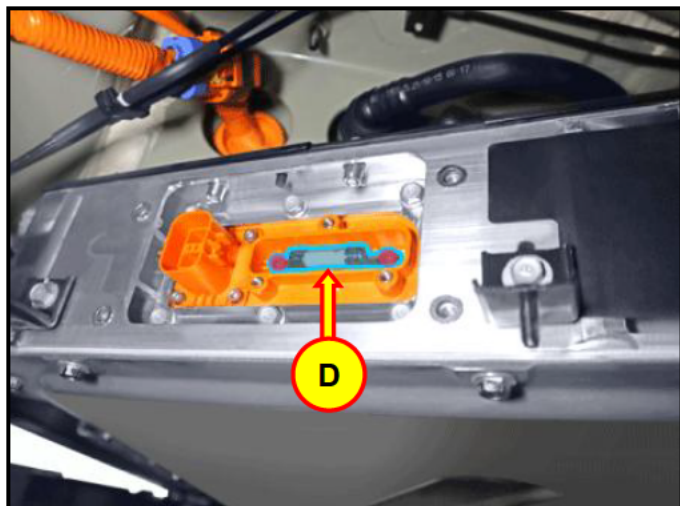
6. Remove the ICCU fuse (D).

Removing the fuse may be difficult since the nuts holding the fuse holder may fall into the battery.

Avoid using a power driver to remove and install the bolts. **ONLY** use hand tools.

If this occurs, see below for **SPECIAL INSTRUCTIONS**.

7. Install the supplied replacement part for the ICCU fuse.
8. Reinstall all parts in the reverse order of the removal process.
9. The service procedure is now complete.
