TECHNICAL INSTRUCTIONS
FOR
SAFETY RECALL 24TA13
POTENTIAL LOSS OF STEERING
CERTAIN 2023-2024 MODEL YEAR Corolla and Corolla HV

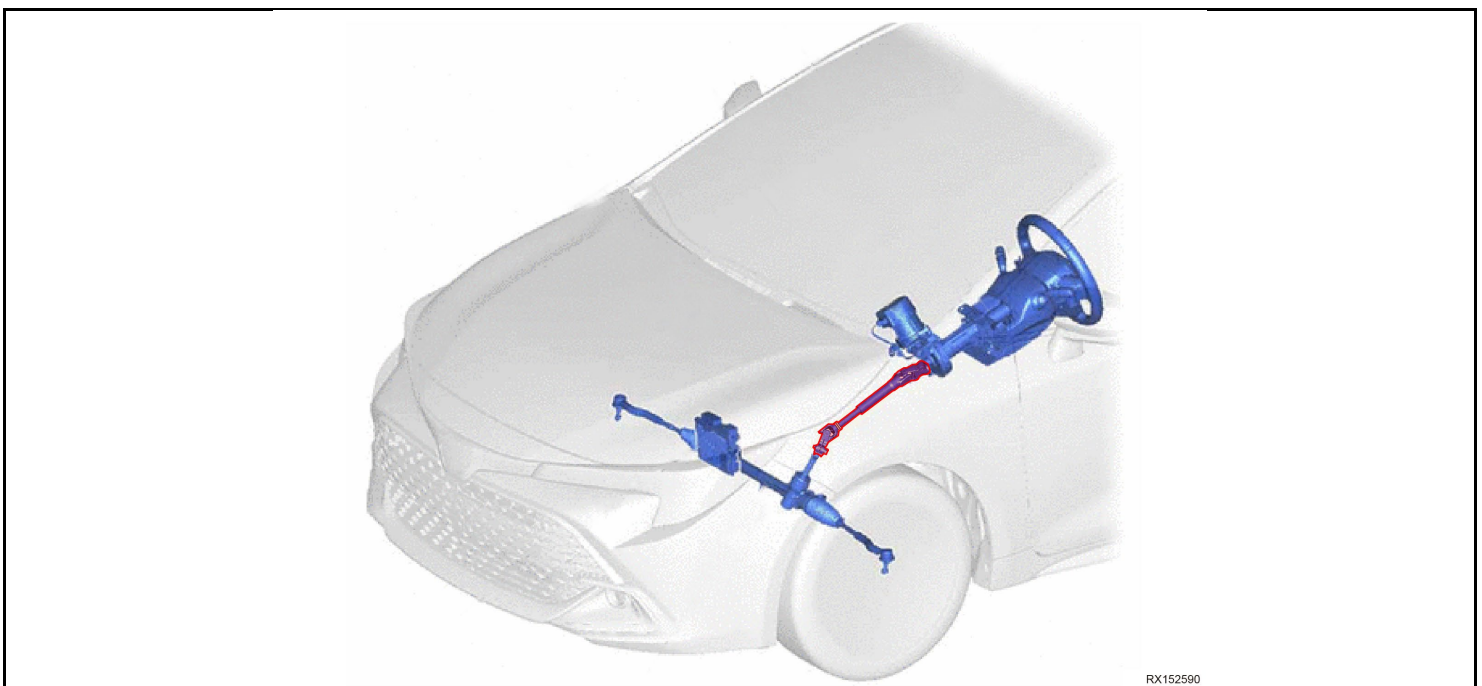
RX152590

A part of the steering shaft, which allows the steering wheel to control the direction of the front wheels, may have been manufactured with cracks. If the cracks grow over time, this part of the steering shaft can separate and can lead to a loss of steering, increasing the risk of a crash.

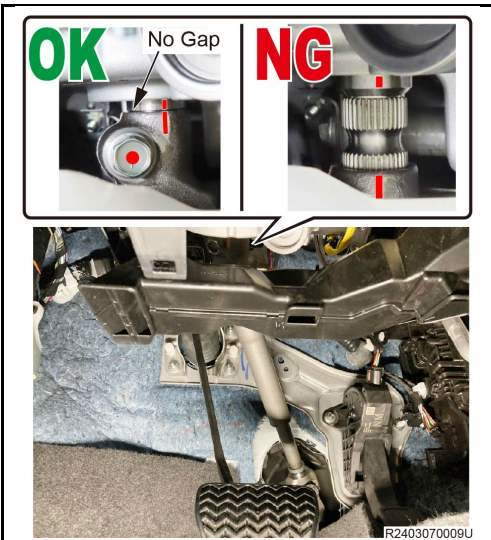
- a) INSERTION CHECK (UPPER)

- (1) Check that the steering intermediate shaft is fully inserted without any gap at the matchmark as shown in the picture, and move the intermediate shaft up and down with your hand to make sure it cannot be removed.

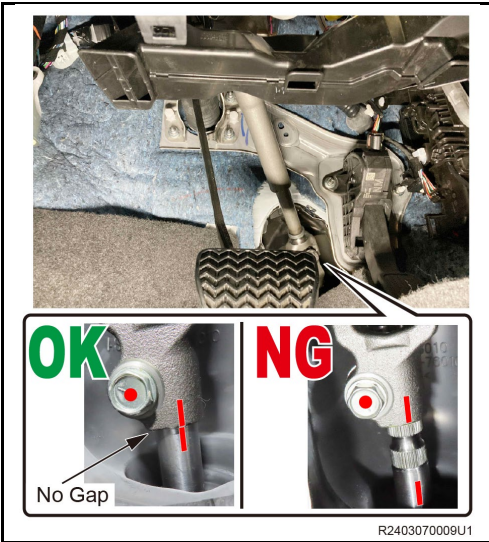
b) INSERTION CHECK (LOWER)

- (1) Check that the steering intermediate shaft is fully inserted without any gap at the matchmark as shown in the picture and move the intermediate shaft up and down with your hand to make sure it cannot be removed.

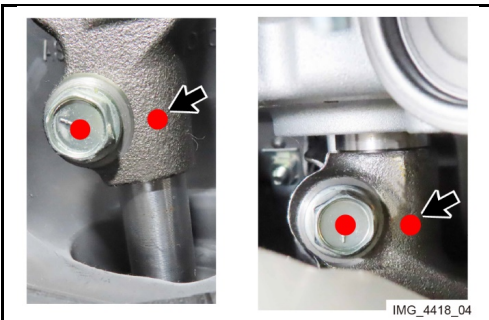
c) TORQUE CHECK (UPPER/LOWER)

- (1) Check that the mark is on the bolt head and apply mark to indicate it is checked.
- (2) iii. Re-check that the bolts are tightened at the specified torque.

64 N*m (653 kgf*cm, 47 ft.*lbf)

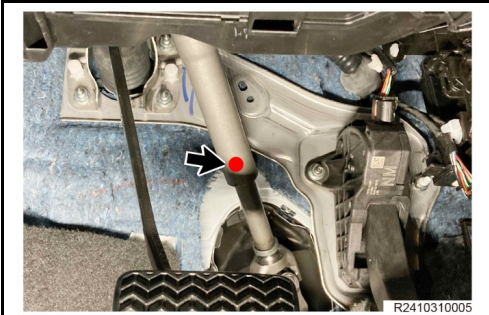
d) CHECK THE NEW PART IDENTIFICATION MARK

- (1) Check there is the identification mark applied after opening the package which means it is the new part.

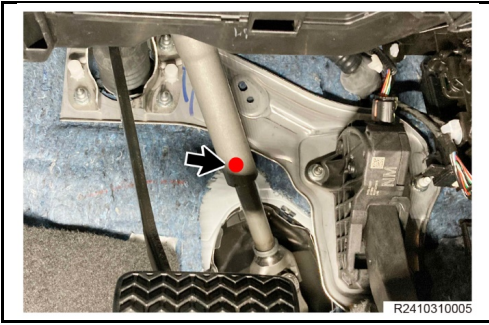
- a) WORK COMPLETION CHECK
- (1) Check the identification mark applied on the intermediate shaft to confirm the correct part is installed.
