**HYUNDAI**
Technical Service Bulletin

GROUP RECALL	NUMBER 25-01-002H
DATE JANUARY 2025	MODEL(S) SEE BELOW

SUBJECT: REAR BACKUP CAMERA INSPECTION/REPLACEMENT
(RECALL 271)

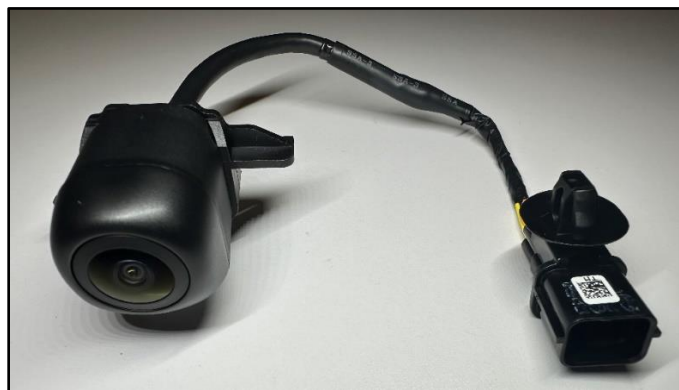
Description: Certain 2021-2022 Santa Fe, Santa Fe Hybrid, Santa Fe Plug-in Hybrid, Elantra, Elantra Hybrid, and Elantra N vehicles may have been produced with insufficient solder joints on the camera’s printed circuit board (“PCB”), which may worsen over time increasing the risk of camera failure during operation. As such, the affected vehicles fail to comply with the requirements set forth in Federal Motor Vehicle Safety Standard No. 111, “Rear Visibility.” Obstruction of the rear-view image during operation reduces rearward visibility and increases the risk of a crash or injury to bystanders. This bulletin provides instructions to inspect and replace the rear backup camera when applicable.

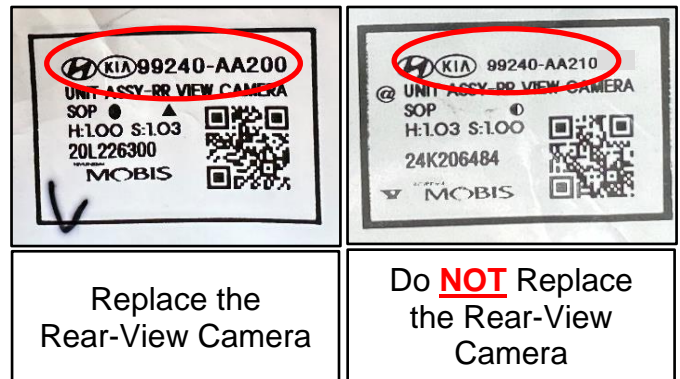
2. Locate the rear-view camera and inspect the rear-view camera part number tag:

Replace the rear-view camera if the part number is:

- 99240-AA200
- 99240-AA000

Do NOT replace the rear-view camera if the part number is:

- 99240-AA210

Proceed to rear-view camera replacement section on page 5.

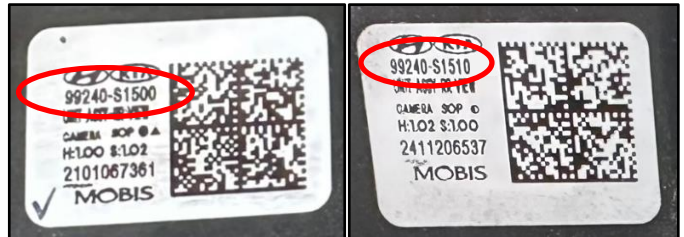
9. Locate the rear-view camera and inspect the rear-view camera part number label:

Replace the rear-view camera if the part number is:

- 99240-S1500

Do NOT replace the rear-view camera if the part number is:

- 99240- S1510

Proceed to rear-view camera replacement section on page 12.
