## RECALL 24V895 REMEDY INSTRUCTIONS

<b>FOREST RIVER</b>	Make(s): MANY, SEE BELOW Model(s): MANY, SEE BELOW Model Year(s): 2025	Repair Code: RC-058-01-00-004650 Allotted Time: .50 HRS. Inspection Code: N/A Allotted Time: N/A
	Concern: The triple square taillamp may experience excessive heat, which may lead to premature taillamp failure.	Photo(s) Required: NO Prior Authorization Required: YES Part(s) Kit Number: F100121680 Part(s) Return: NO, FIELD DESTROY

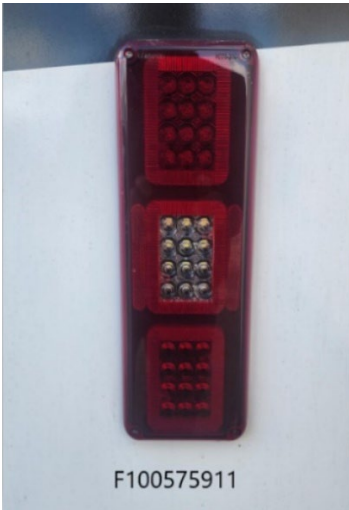
STEP 1: LOCATE THE REAR TAIL LAMPS ON THE REAR WALL;

- REMOVE AND DISCARD;
