## SAFETY ADVISORY # 24-459

### Helux Pin Box Torque

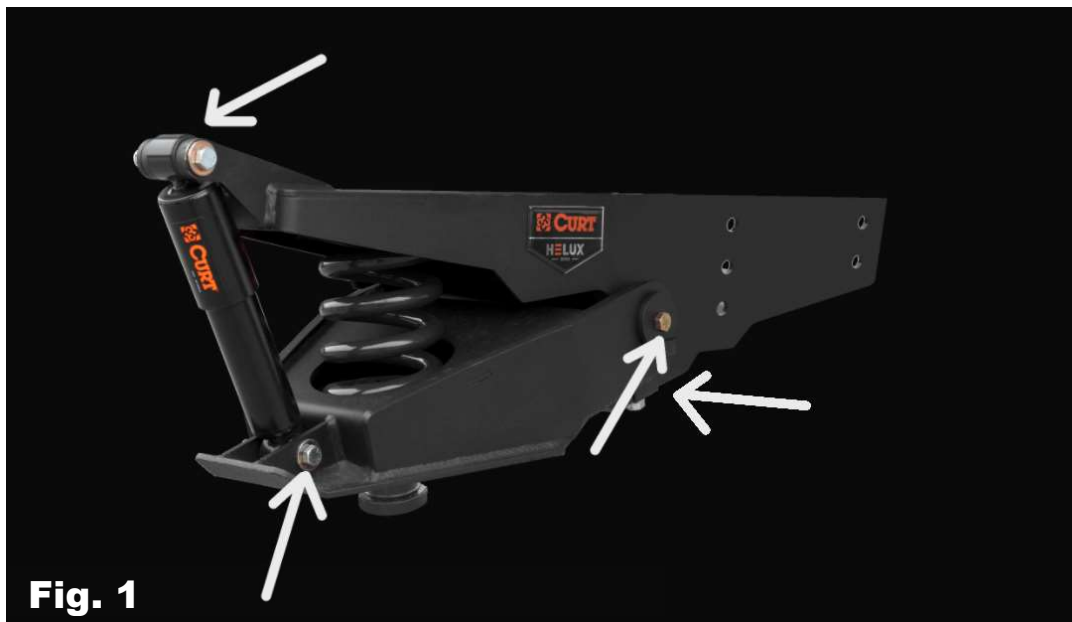
**Fig. 1**

Keystone is conducting a voluntary RECALL notification campaign in accordance with the National Highway Transportation and Safety Act. It has been decided that the vehicles in the recall population are assembled with fasteners that may have been improperly torqued on some Helux pin boxes. Under certain conditions during travel, if the fasteners are not properly torqued and become loose or fall out, the pin box may detach from the tow vehicle leading to an increased risk of personal injury or vehicle crash.

The remedy is to properly torque the fasteners on the CURT Helux Pin Box, see Figure 1.

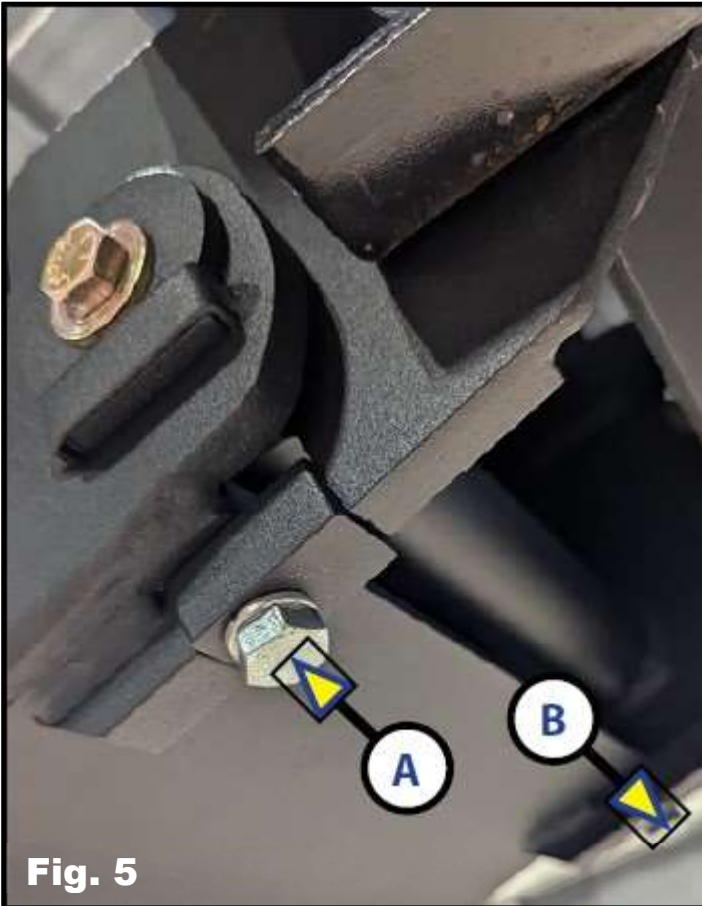
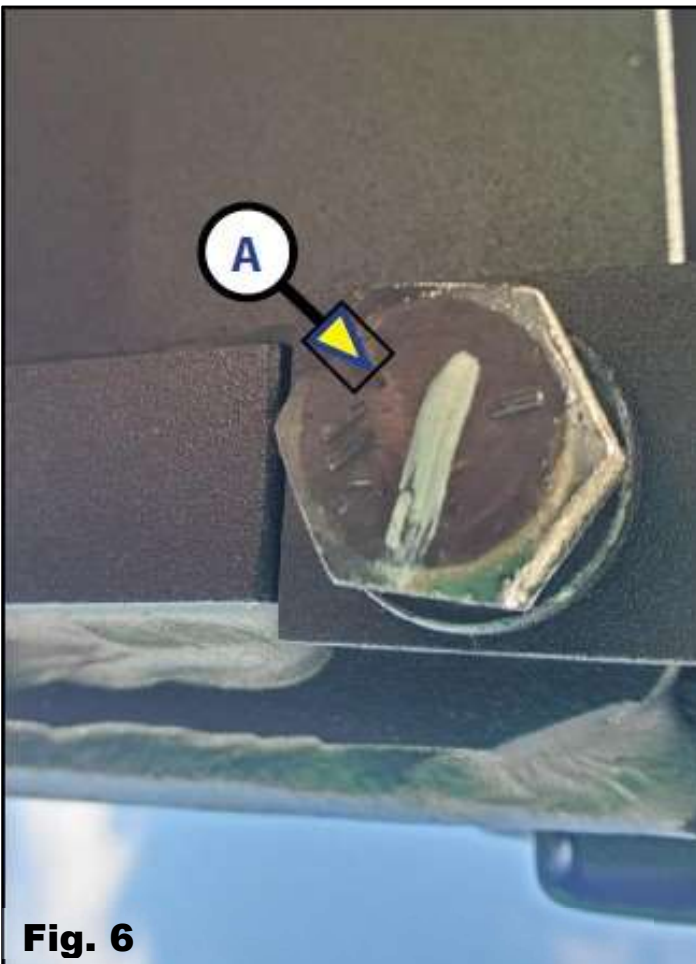
**NOTE:** Stop Bolt locations are found on the underside of the pin box (Figures 5 & 6 bolts A & B).

Tighten the Roadside Stop Bolt (Figure 5) to 75 ft-lb.

Repeat for the Curbside Stop Bolt A & B.
