SIB 41 09 24

RECALL 24V-910: ROOF FRAME

This Service Information Bulletin (Revision 2) replaces SI B41 09 24 **dated December 2024.**

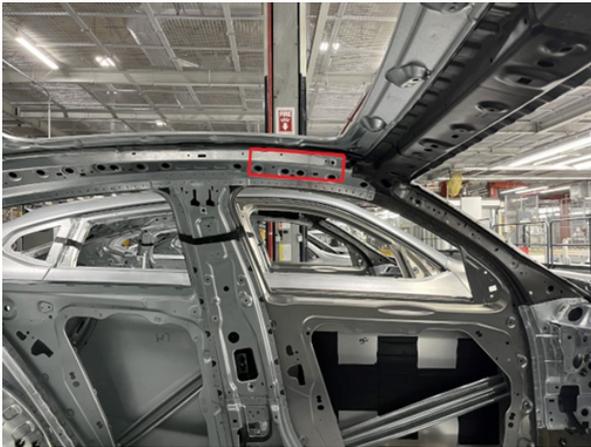
On the top left of inside the vehicle, the roof frame may not have been produced by the supplier in accordance to specification. The crack has no effect on crash performance and structural integrity. However, it cannot be ruled out that the head airbag might be damaged by the crack during the airbag deployment.

Inspect the top left side of the vehicle’s roof frame and rework if necessary.

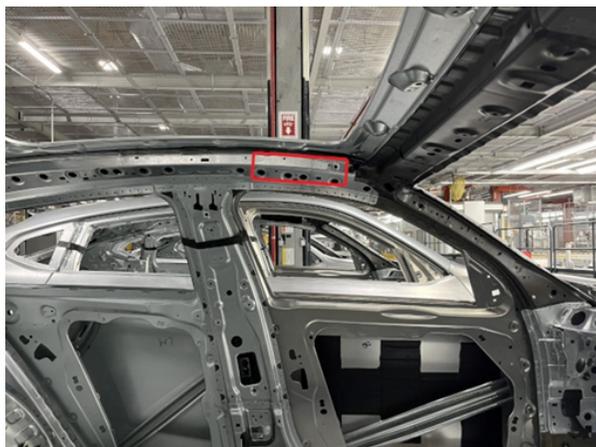
The red rectangular box shows the location of where the crack/constriction has/could occur.

2. Using a suitable light, inspect the top left side of the vehicles roof frame for a crack or thinned metal.

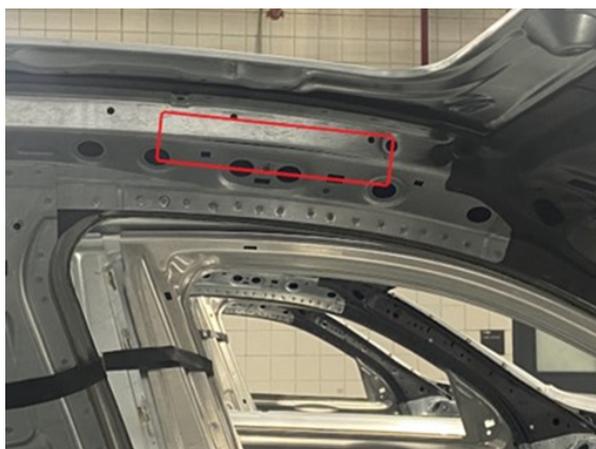
The red rectangular box is showing a crack on the top left side of the roof frame.

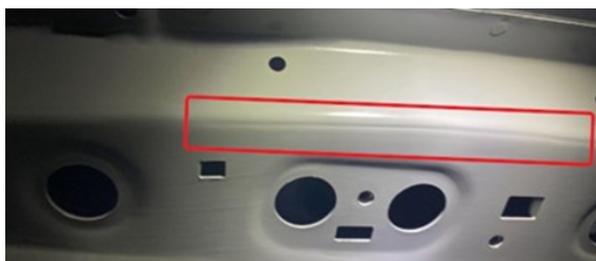
The red rectangular box is showing thinned metal on the top left side of the roof frame.

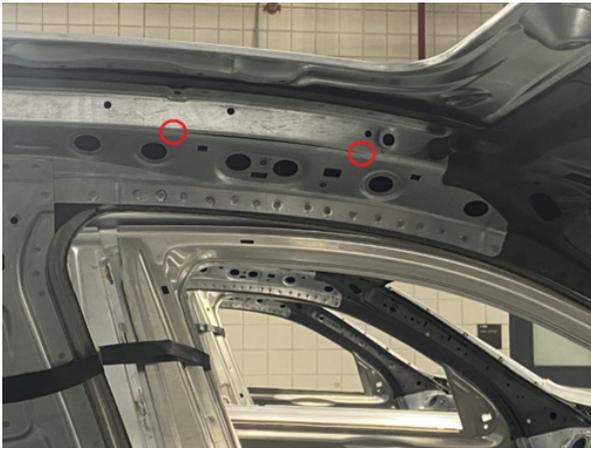
The red circles in the photo show where the holes would be drilled.

5. Using a 4 mm drill bit, drill a stress relief hole on both sides of the crack/constriction.
