This Service Information Bulletin (Revision 03) replaces SI 41 09 24 **dated December 2024**.

RE: Recall 24V-910: Roof Frame – B41 09 24

**Safety Recall
24V-910
Roof Frame
Model Year 2025
BMW X4 SAC
Issue Date: 12/02/2024**

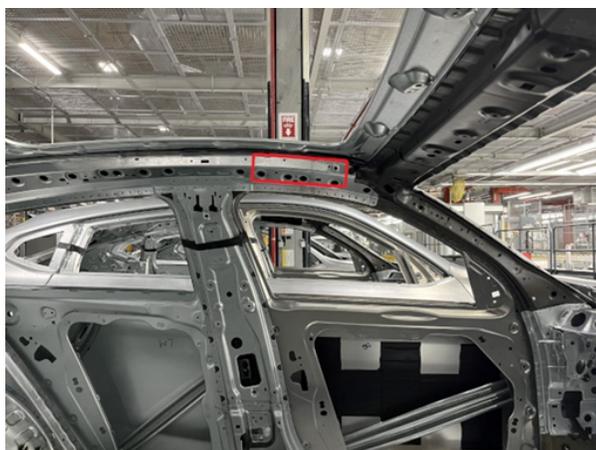
On the top left of inside the vehicle, the roof frame may not have been produced by the supplier in accordance to specification. The crack has no effect on crash performance and structural integrity. However, it cannot be ruled out that the head airbag might be damaged by the crack during the airbag deployment.

Inspect the top left side of the vehicle's roof frame and rework if necessary.

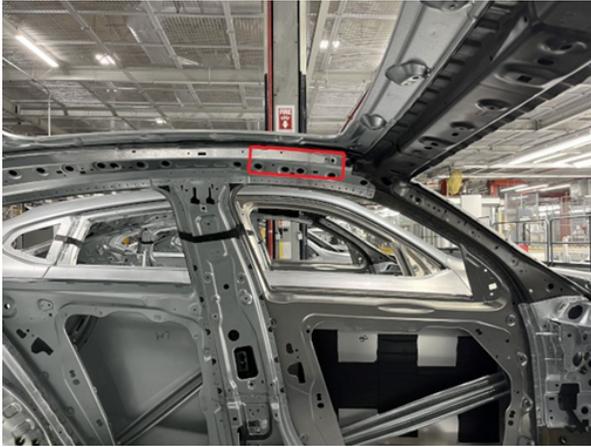
The red rectangular box in the photo shows the location of where the crack/thinned metal has/could occur.

2. Using a suitable light, inspect the top left side of the vehicles roof frame for a crack or thinned metal.

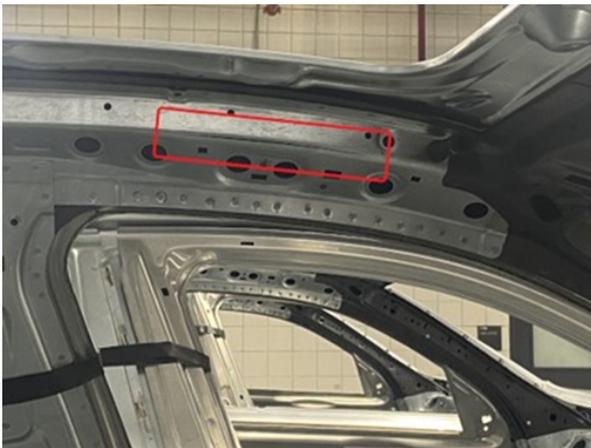
The red rectangular box is showing a crack on the top left side of the roof frame.

5. Using a 4 mm drill bit, drill a stress relief hole on both sides of the crack/thinned metal.

8. Weld the crack/thinned metal.

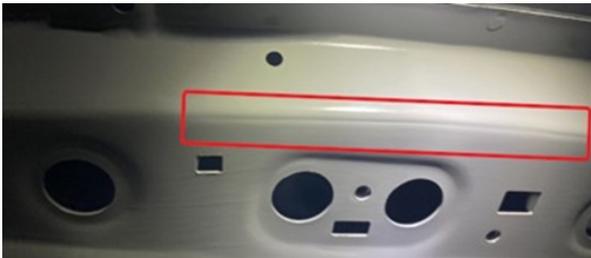
The red rectangular box is showing thinned metal on the top left side of the roof frame.
