<b>NGDVTSB027</b> Head Unit Replacement 1.5.0		<b>Revision</b>	-
<b>Release Date:</b>	December 2024	<b>Bulletin Type:</b>	Safety Recall
<b>Rework Time:</b>	0.5 Hrs/Vehicle (1 Person Hrs)	<b>PLRS Number:</b>	P108039.A0999
<b>Parts Returned:</b>	Old Head Unit	<b>Tread Component</b>	Electrical

**Description:** The Head Unit may become non-responsive with a blank screen and telltales for BLIS and FCW are illuminated on the IPC. The Head Unit requires replacement with new firmware for field correction. Additionally, the fuse for the Telematics Control Unit (TCU) will need to be reinstalled if it was removed during a previous service procedure (e.g. NGDVTSB024)

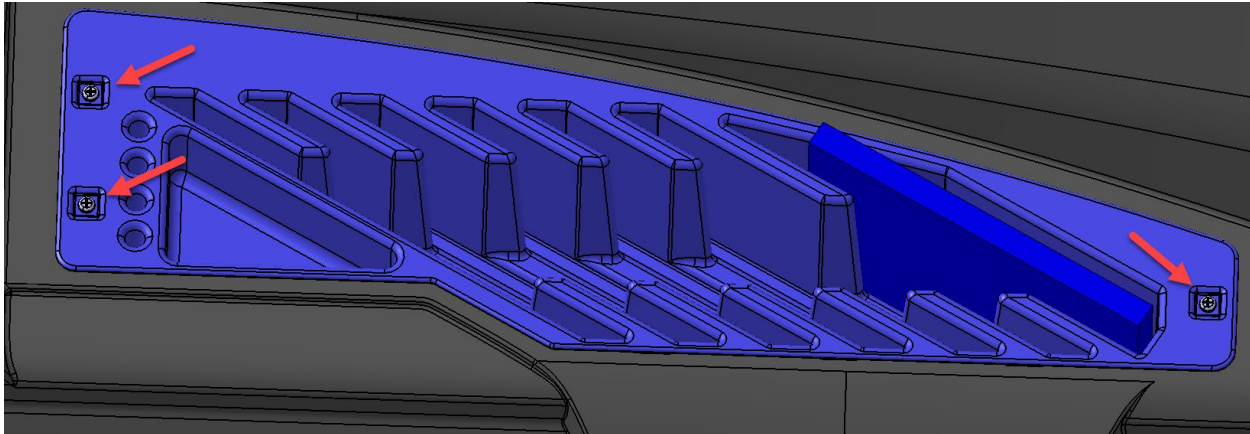
- 1) Ensure vehicle is parked on a flat, level, solid surface. Turn ignition off, remove the key, engage the parking brake and chock wheels.
- 2) Remove qty 3 screws from the form holder on top of the upper console. Set aside.
