SAFETY RECALL

Brake Pedal Actuator Rod

Reference: E0B / NHTSA 24V-943

2019 - 2020 (GA) Alfa Romeo® Giulia

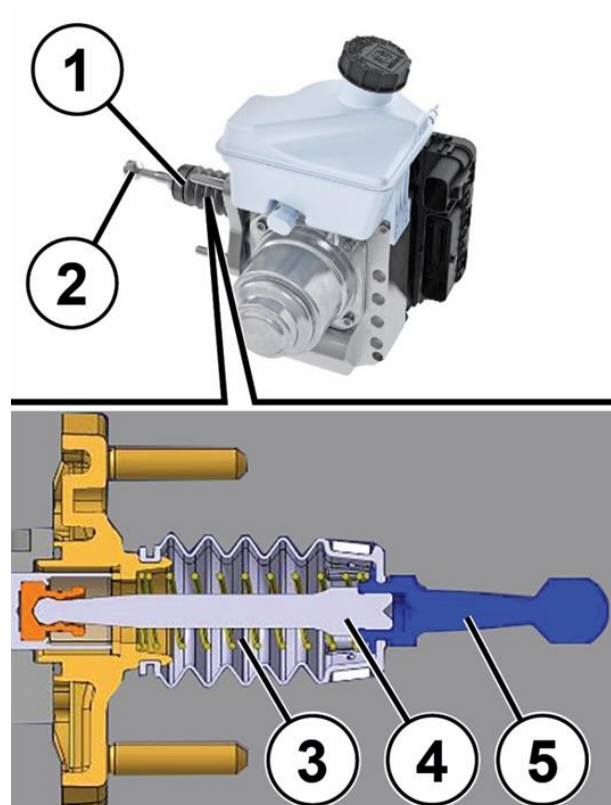
Figure 2 – IBS Control Unit

- (1) Dust boot with filter
- (2) Tip assembly (spherical head + push rod)
- (3) Spring
- (4) Push rod
- (5) Spherical head
