L74X-R.03.24

Rear oil cooler pipe tightening check

Revuelto

2024

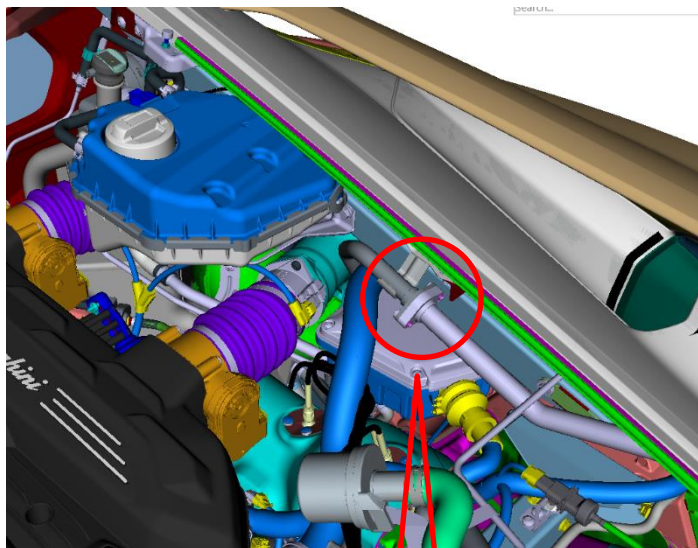
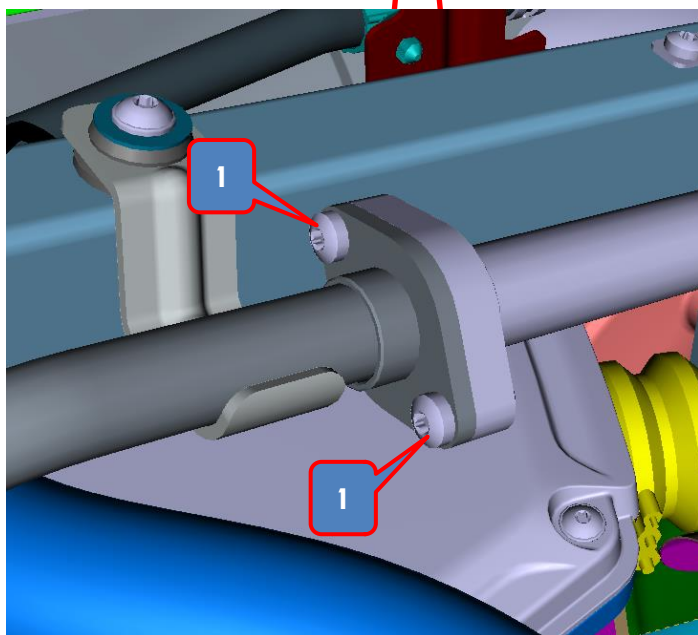
During ongoing product monitoring, Automobili Lamborghini S.p.A. identified a potential issue on some vehicles that have been reworked internally and has released a new mandatory update for the potentially affected cars for the verification of the correct tightening torque of the oil cooler pipe.

1. Open the engine hood.
2. Verify that the tightening torque of the two M6X20 screws (1) is 10.00 Nm \pm 5% (7.38 lbf ft).
