GROUP	MODEL
Safety Recall Campaign	2024-2025MY EV9 (MV)
NUMBER	DATE
SC329	December 2024

# SEAT MOUNTING BOLT INSPECTION/RETIGHTENING OR INSTALLATION (SC329)

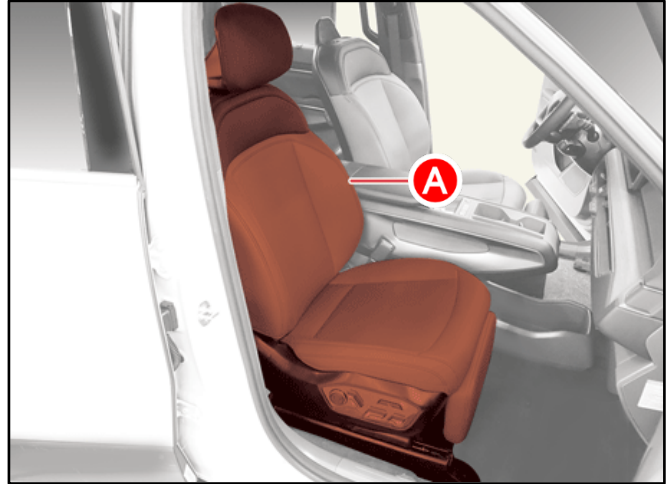
1. Locate the four (4) front (Left and Right) seat (A) retaining bolts (X).

**Note:** Removal of the bolt cover is required to access the bolts.

Refer to "Body (Interior / Exterior / Electrical)  
→ Front Seat → Front Seat Assembly →  
Removal and Installation" in the applicable  
Shop Manual on KGIS for instructions to  
access the seat bolts.

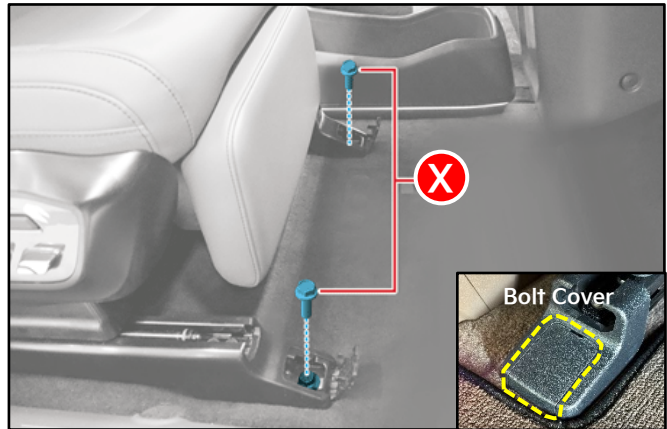
- 2a. Using a torque wrench, verify that the seat bolt(s) (X) are torqued to the specifications outlined below.

Tightening torque for seat bolts:  
32.5 - 43.4 lb.ft (44.1 - 58.8 N.m)

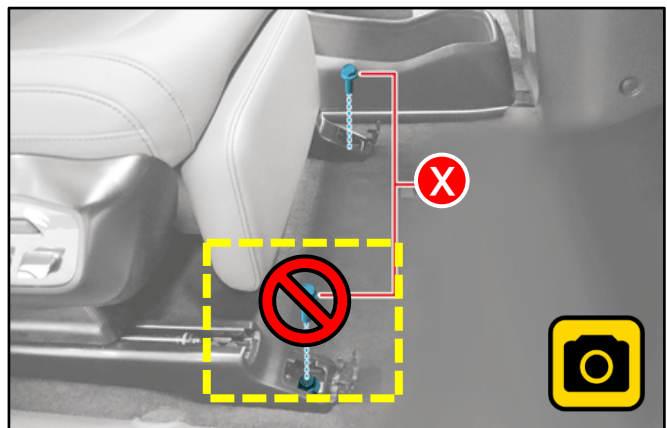
- 2b. **IMPORTANT:** If any seat bolts are missing (NG), attach a KDS Warranty Attachment photo of each missing bolt(s) with the claim.

- 2c. Install a new bolt(s) for the left and/or right-side (if applicable) and torque to the specification outlined above.

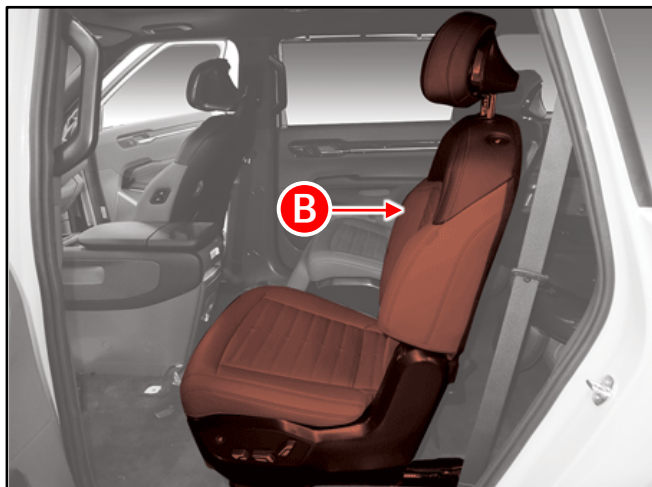
- 4a. Locate the four (4) (L or R) 2<sup>nd</sup> row seat (B) retaining bolts (X) - w/Captain Chairs - 8 total.
- 4b. Locate the nine (9) 2<sup>nd</sup> row seat (B) retaining bolts (X) - w/Bench Seat - 9 total.

Refer to "Body (Interior / Exterior / Electrical) → Rear Seat (2<sup>ND</sup>) → Rear Seat Assembly → Removal and Installation" in the applicable Shop Manual on KGIS for instructions to access the seat bolts.

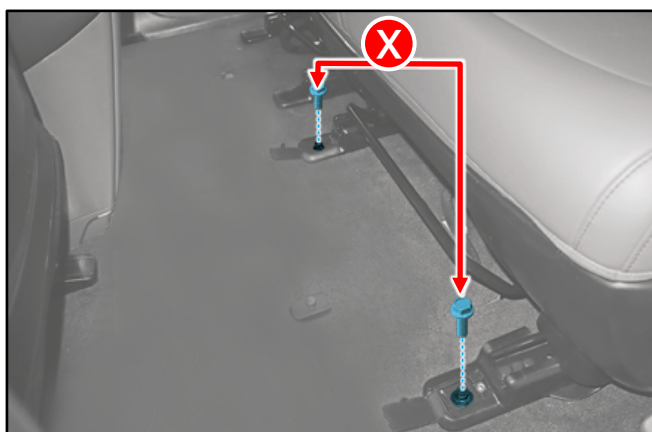
- 4c. Using a torque wrench, verify that the 2<sup>ND</sup> row seat bolt(s) (X) are torqued to the specifications outlined below.

Tightening torque for seat bolts:  
32.5 - 43.4 lb.ft (44.1 - 58.8 N.m)

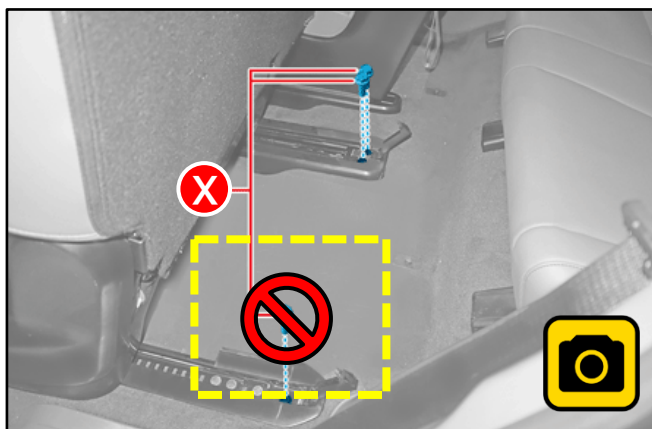
- 4d. **IMPORTANT:** If any seat bolts are missing (NG), attach a KDS Warranty Attachment photo of each missing bolt(s) with the claim.
- 4e. Install a new bolt(s) for the 2<sup>ND</sup> row seat(s) (if applicable) and torque to the specification outlined above.

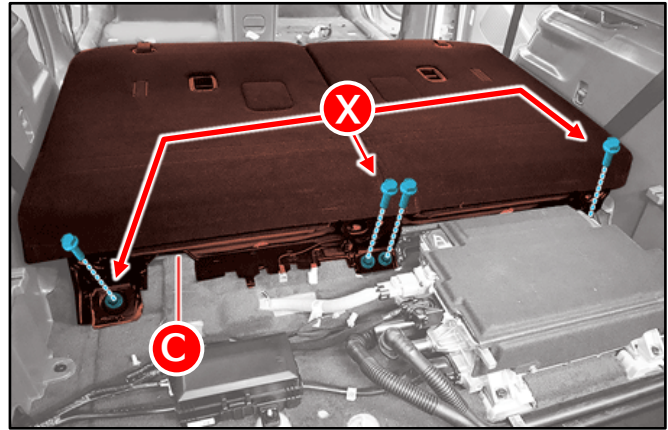
- 6a. Locate the seven (7) 3<sup>RD</sup> row seat (C) retaining bolts (X).

Refer to "Body (Interior / Exterior / Electrical) → Rear Seat (3<sup>RD</sup>) → Rear Seat Assembly → Removal and Installation" in the applicable Shop Manual on KGIS for instructions to access the seat bolts.

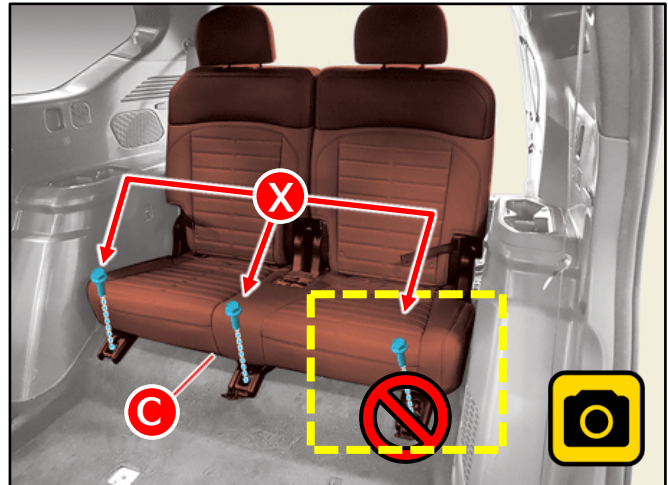
- 6c. **IMPORTANT:** If any seat bolts are missing (NG), attach a KDS Warranty Attachment photo of each missing bolt(s) with the claim.

- 6d. Install a new bolt(s) for the 3<sup>RD</sup> row seat (if applicable) and torque to the specification outlined above.
