SUBJECT: <h2 style="margin: 0;">SAFETY BULLETIN</h2> <h1 style="margin: 0;">Ball Joint Mount Fastener Torque</h1> <p style="margin: 0;">NHTSA Campaign Number: 24V-971</p>	R25-3-01R4
	Date: 1/16/2025
	Model: All (see VIN list)

Product Line: Taylor-Dunn GEM Tiger

Subject: R25-3-01 Ball Joint Mount Fastener Torque

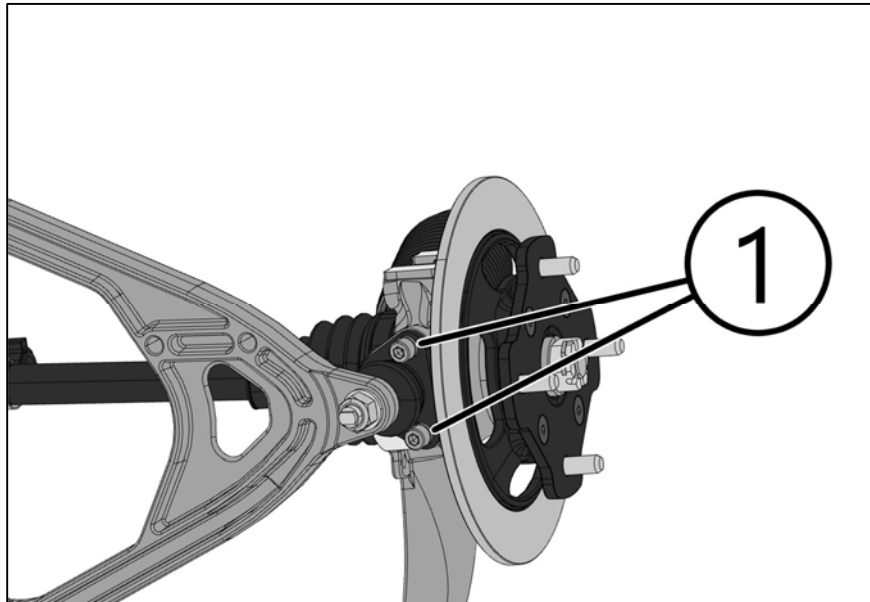
On some vehicles the ball joint retainer fasteners ① may not have been torqued to the correct specification. Incorrectly torqued fasteners could lead to ball joint separation from the wheel. Ball joint separation can cause a loss of steering control, increasing the risk of crash. The fasteners must be torqued to the correct specification.

- 1) Set parking brake and ensure vehicle cannot move.
- 2) Turn steering as needed to gain access to fasteners.
- 3) Set the torque wrench to 18-ft-lbs (24 Nm) and torque the two (2) fasteners that retain each ball joint..
- 4) Apply a red paint mark to each ball joint fastener after torquing to the correct specification
