## IMPORTANT SAFETY RECALL

**NHTSA Recall No. 24V-042**

<b>Terex Utilities</b>	
<b>SAFETY NOTICE</b>	<b>SN724A</b>

**SUBJECT:** Rotation Bearing Bolts

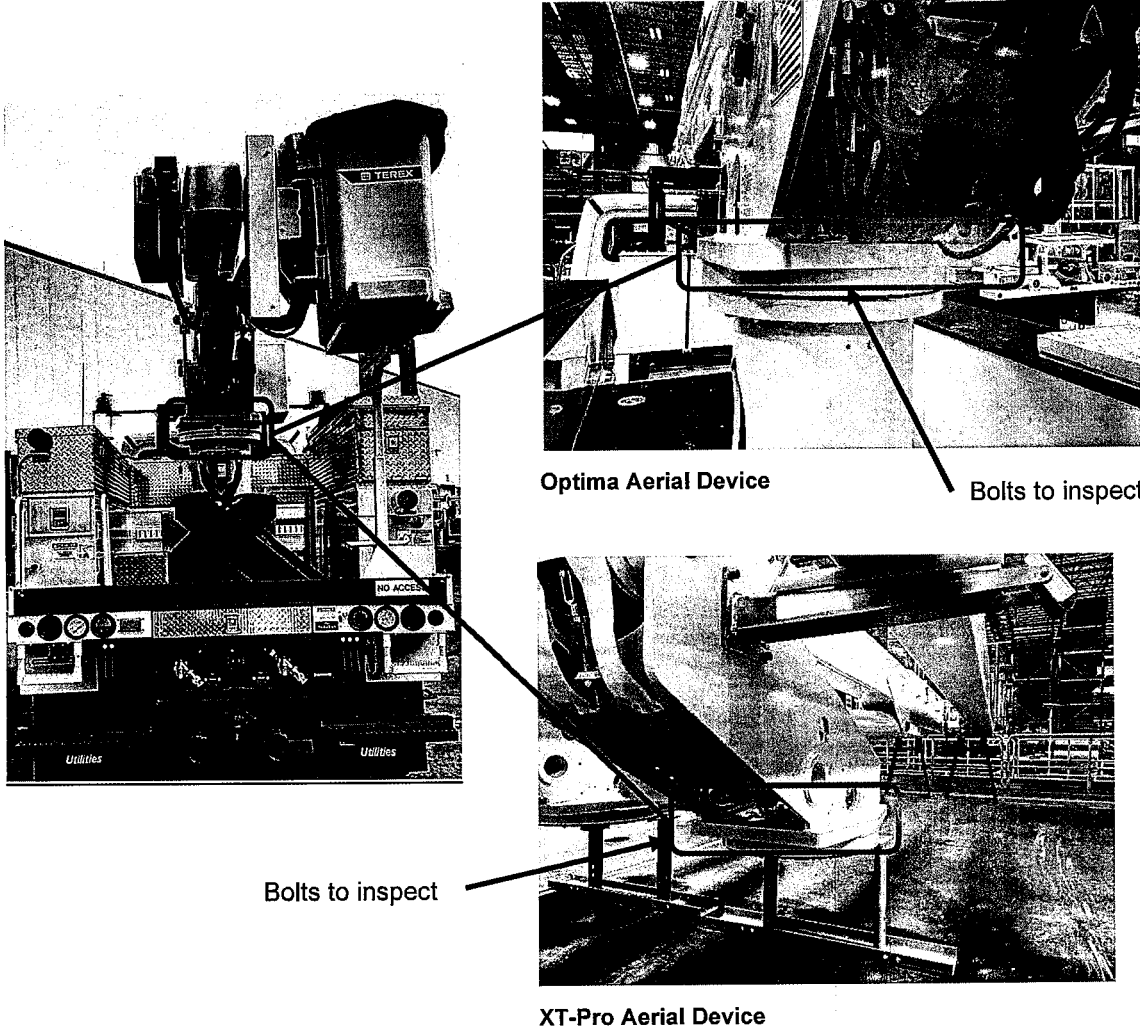
**Figure 1. Turntable to Rotation Bearing Bolts**

Terex single basket Optima-TC55, Optima-HRX50, and Optima-HRX55 model aerial devices, produced from August 28, 2023 through October 5, 2023, and Terex XT Pro model aerial devices, produced from May 2, 2023 through July 11, 2023 may have turntable to rotation bearing bolts that were not torqued properly. The improperly torqued bolts may loosen causing the bearing bolts to fail. **Failure of the rotation bearing bolts could cause the boom to fall, which could result in injury or death.**

3. Perform a torque check on the turntable to rotation bearing bolts, see Figure 1, following the procedure in the Maintenance Manual and PA1016. The torque for each unit is in the Quick Reference section of the Maintenance Manual and shown below:

- a. Optima – 180 ft-lbs
  - b. XT Pro – 180 ft-lbs
4. If bolts are broken or fail to reach the specified torque, do not use the machine until these bolts are replaced. Only the broken bolts or bolts that do not reach the specified torque need to be replaced. Contact Terex Utilities or your dealer to order replacement bolts and washers. Retain broken bolts for 30 days from the time the Completion Form is submitted. After 30 days, the bolts can be discarded.
