IMPORTANT SAFETY RECALL

NHTSA Recall No. 24V-042

Terex Utilities	
SAFETY NOTICE	SN724A

SUBJECT: Rotation Bearing Bolts

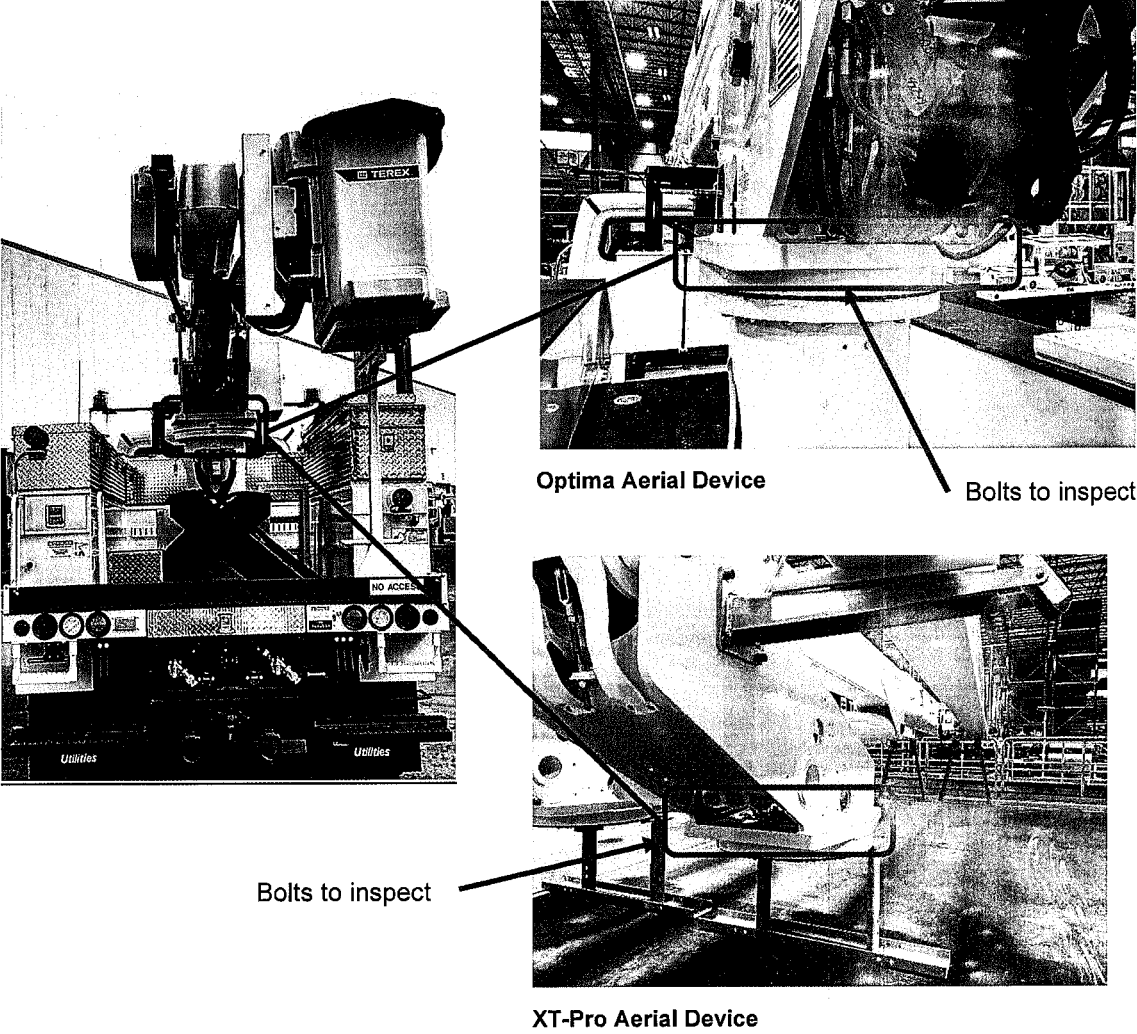
Figure 1. Turntable to Rotation Bearing Bolts

Terex single basket Optima-TC55, Optima-HRX50, and Optima-HRX55 model aerial devices, produced from August 28, 2023 through October 5, 2023, and Terex XT Pro model aerial devices, produced from May 2, 2023 through July 11, 2023 may have turntable to rotation bearing bolts that were not torqued properly. The improperly torqued bolts may loosen causing the bearing bolts to fail. **Failure of the rotation bearing bolts could cause the boom to fall, which could result in injury or death.**

3. Perform a torque check on the turntable to rotation bearing bolts, see Figure 1, following the procedure in the Maintenance Manual and PA1016. The torque for each unit is in the Quick Reference section of the Maintenance Manual and shown below:

- a. Optima – 180 ft-lbs
 - b. XT Pro – 180 ft-lbs
4. If bolts are broken or fail to reach the specified torque, do not use the machine until these bolts are replaced. Only the broken bolts or bolts that do not reach the specified torque need to be replaced. Contact Terex Utilities or your dealer to order replacement bolts and washers. Retain broken bolts for 30 days from the time the Completion Form is submitted. After 30 days, the bolts can be discarded.
