IMPORTANT SAFETY RECALL

NHTSA Recall No. 24V-740

SN732

SUBJECT: Jib Extension Cylinder Rod Weld

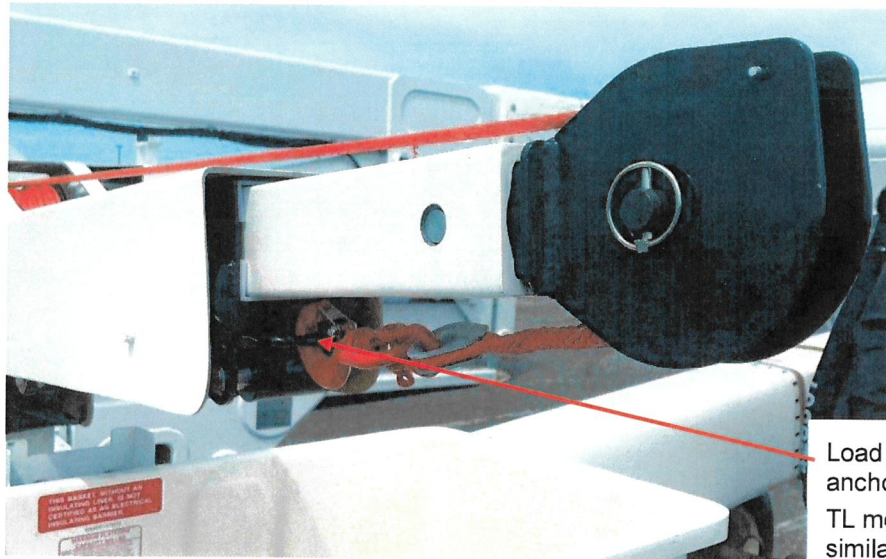
Figure 1. Load Line Hook Secured to Anchor on Main Jib Boom

1. Always follow the inspection and maintenance requirements as specified in the manuals.
2. Ensure the jib extend hydraulic cylinder is at or above horizontal when loaded.
3. Secure the load line hook when stowing the machine as shown in Figure 1 below.

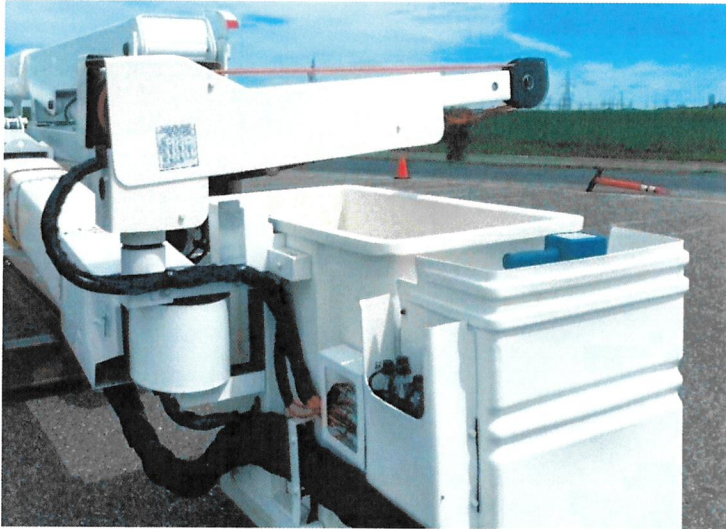
1. Deploy the outriggers and position the booms in the ground mount position clear of any obstacles. For the TM, position with the lower boom fully articulated and the upper boom articulated and extended so the basket is near the ground. For the TL80, TL80/112, and TL100, position with the lower boom raised to approximately 20 degrees, upper boom fully lowered and extended.
2. Visually inspect the jib assembly to determine if the jib assembly is affected using the Figures below as reference. Included are certain top mounted jibs, Figure 2.

Figure 2. Included – Certain Top Mount Jib Assemblies

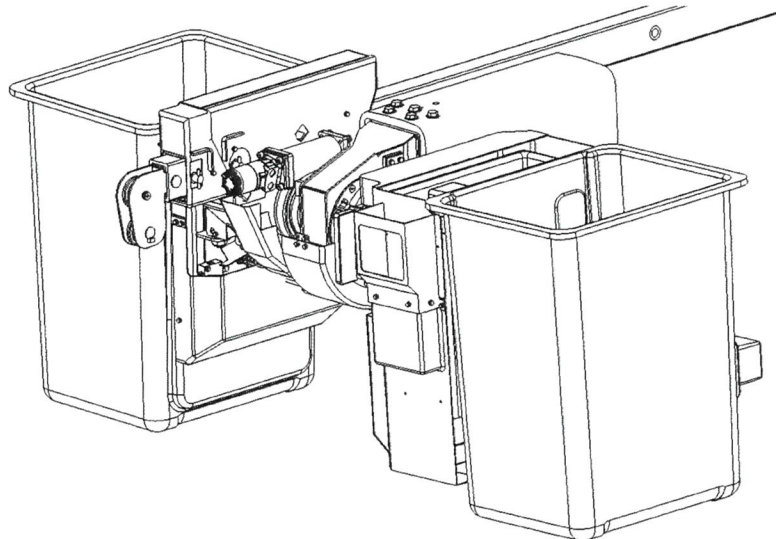
Excluded are dual basket machines where the jib is between the baskets, Figure 3, and single 2-man baskets with side mount jibs, Figure 4.

Figure 3. Excluded – Dual Basket with Side Mount Jib Assembly

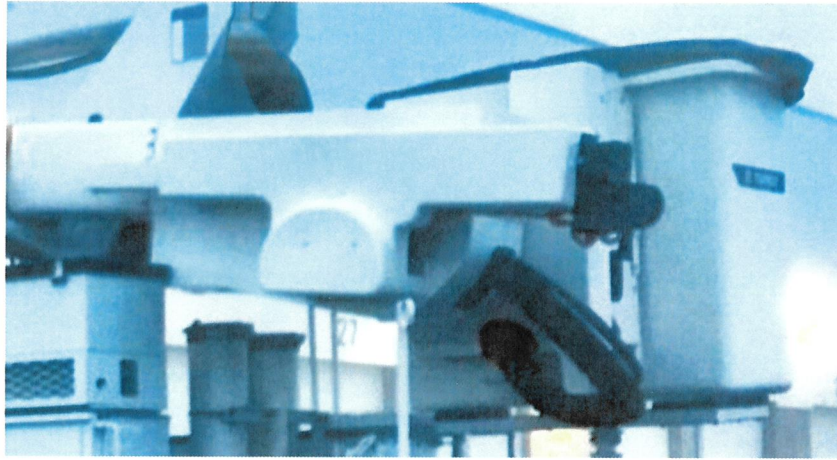
Figure 4. Excluded – Single 2-Man Basket with Side Mount Jib Assembly

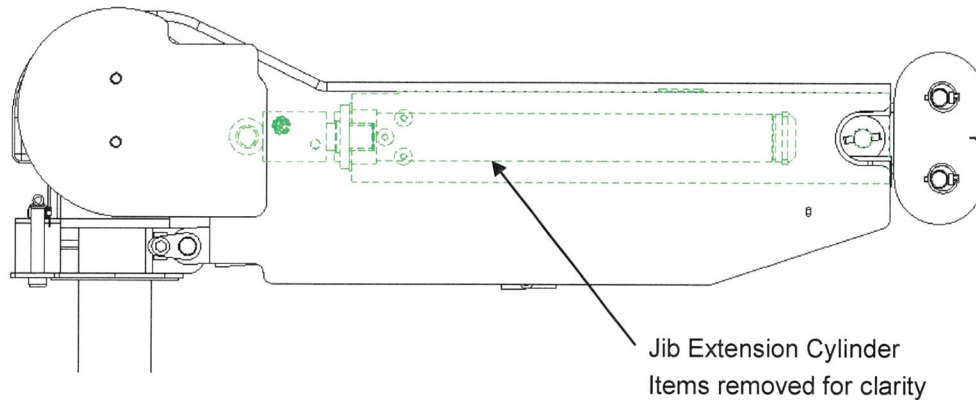
3. Locate the jib extension hydraulic cylinder, using Figure 5 below as reference.

Figure 5. Location of Jib Extension Cylinder

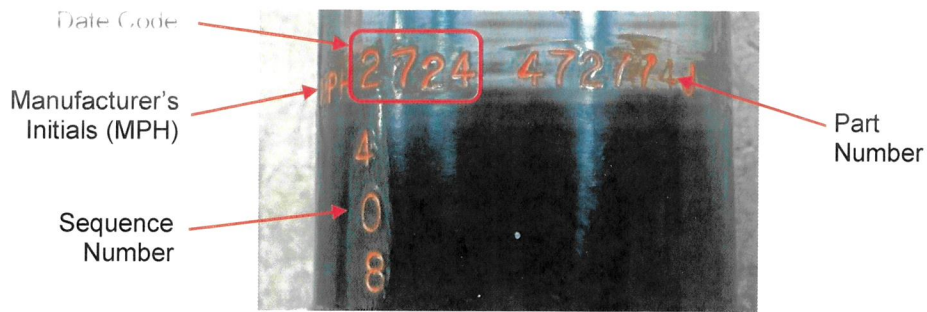
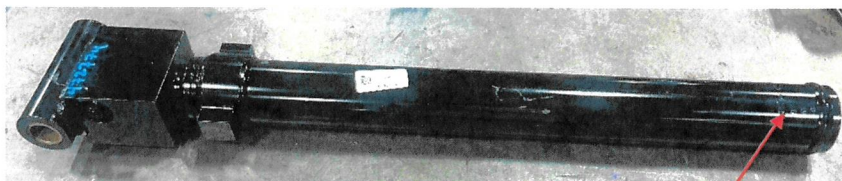
4. Remove covers as needed and remove the jib extend hydraulic cylinder following the instructions in the Maintenance Manual of your machine.
5. Using Figure 6, inspect the part number and date code on the hydraulic cylinder. The first two numbers in the date code are the week the cylinder was manufactured. The second two numbers are the year the cylinder was manufactured. The example below was manufactured week 27 in 2024. Sequence number 408 represents this was the 408th cylinder manufactured in week 27 in 2024.

Figure 6. Example Hydraulic Cylinder Date Code

6. Any MPH hydraulic cylinder with part number 472774 and date codes and sequence numbers shown in the table below stamped in the case is subject to the recall and will need the hydraulic cylinder replaced.
