WARRANTY BULLETIN SAFETY CAMPAIGN

Can-Am® On-Road Spyder™

Campaign no.: 2017-0013, 2018-0013, 2019-0025

Subject: **Engine Output Shaft Can Break and/or
Sprocket Wear - Potential Loss of Drive Power**

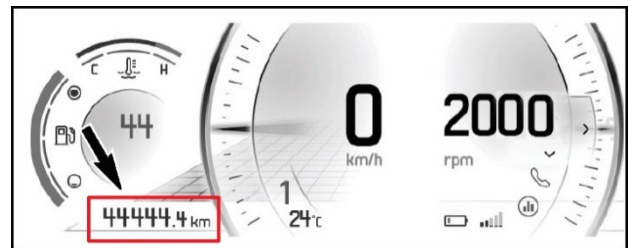
TYPICAL – RT MY18 SHOWN

If the mileage is equal or above the threshold, output shaft replacement is not required. Attach odometer picture to your claim. Proceed with **Sprocket Replacement**.

If the mileage is below the threshold, output shaft replacement is required. Proceed with **Output Shaft and Sprocket Replacement**. You will need to connect the vehicle to BUDS during the procedure. Take a vehicle BUDS reading and attach the BUDS file to your claim.
