<b>Terex Utilities</b>	
<b>SAFETY NOTICE</b>	<b>SN732</b>
<b>NHTSA Recall No.</b>	<b>24V-740</b>

**MODELS AFFECTED:** TM, TL80, TL80/112, & TL100 Aerial Devices

**SUBJECT:** Jib Extension Cylinder Rod Weld

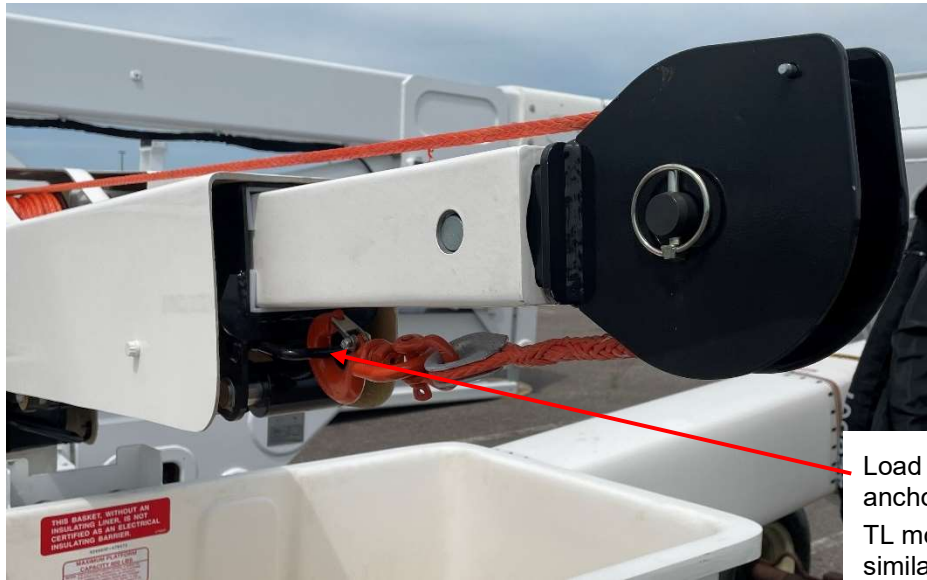
Figure 1. Load Line Hook Secured to Anchor on Main Jib Boom

Load line secured to anchor on jib.  
TL model shown, TM similar.

### Continued Use:
