Safety Recall – 2024 CX-90 Sudden increase in steering effort

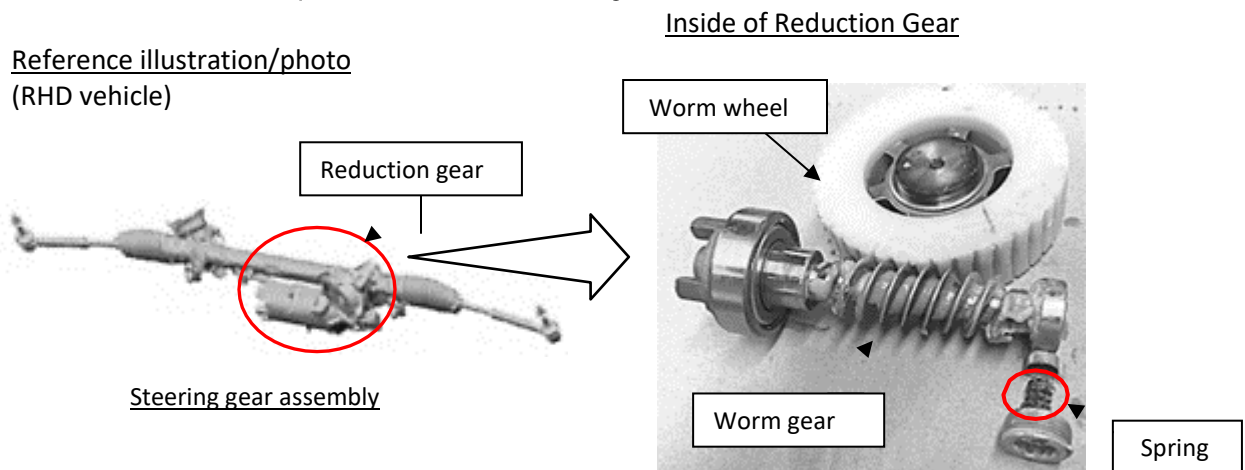
A worm gear is incorporated in the steering gear assembly, which transmits the power assist generated by the power steering motor. The worm gear friction force may be excessive which results in increased force required to turn the steering wheel.

- Reapply grease to the gear teeth. Replace the spring engaging the worm gear with an improved part. (The improved spring will reduce the spring force to the worm gear in the steering assembly.)

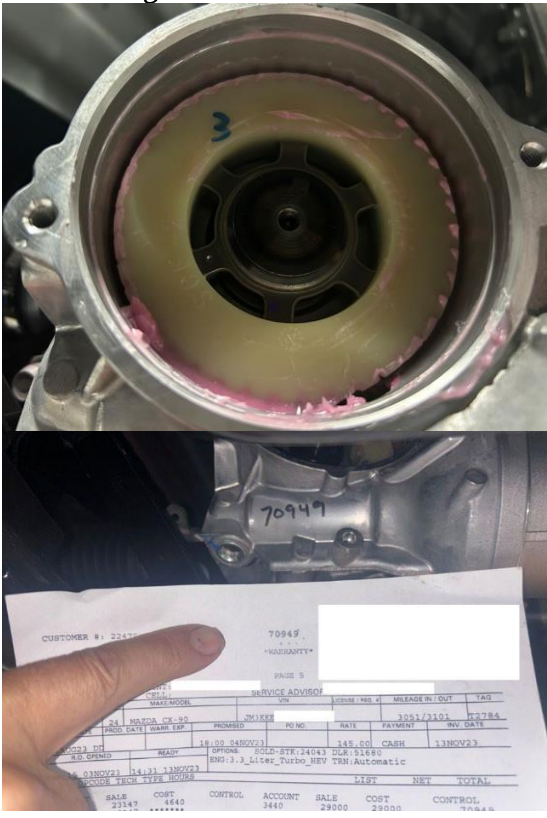
Photo #1 and #2 with the condition after pushing the grease into the gap. Steering Rack must have RO# written on it and in frame except photo #1 as it is too difficult to take one photo showing both requirements. Note paperless dealers or to save printing costs do not have to have the RO in frame just the written RO# on the steering rack.

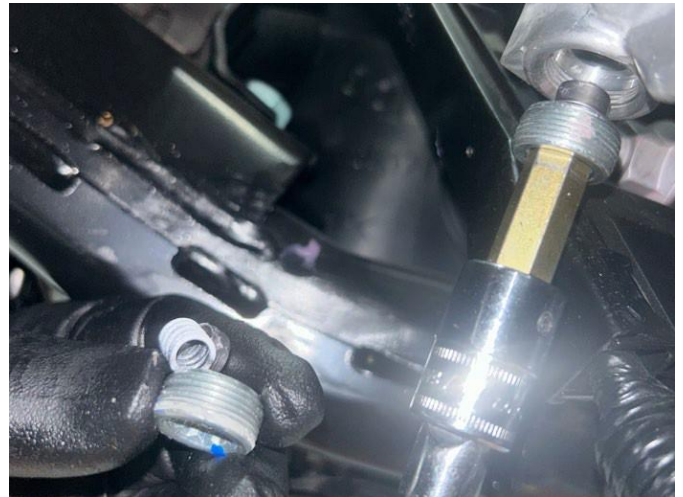
Photo #3 with the pre-assembled new parts and the removed old spring. **NOTE:** This photo was a bit low and is missing the written RO#. Make sure it is visible as in Photo #4.

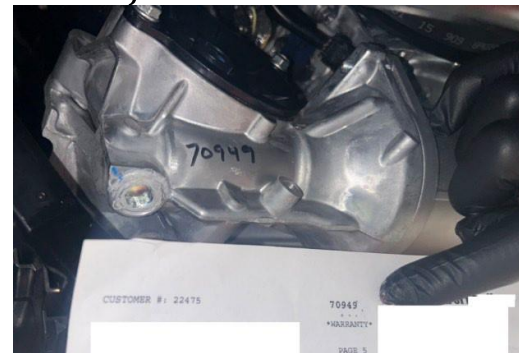
Photo #4 of completed steering gear housing with the black cover. Note the added silicone sealant is on the end cap nut. Note paperless dealers or to save printing costs do not have to have the RO in frame just the written RO# on the steering rack.
