## Safety Recall – 2024 CX-90 Sudden increase in steering effort

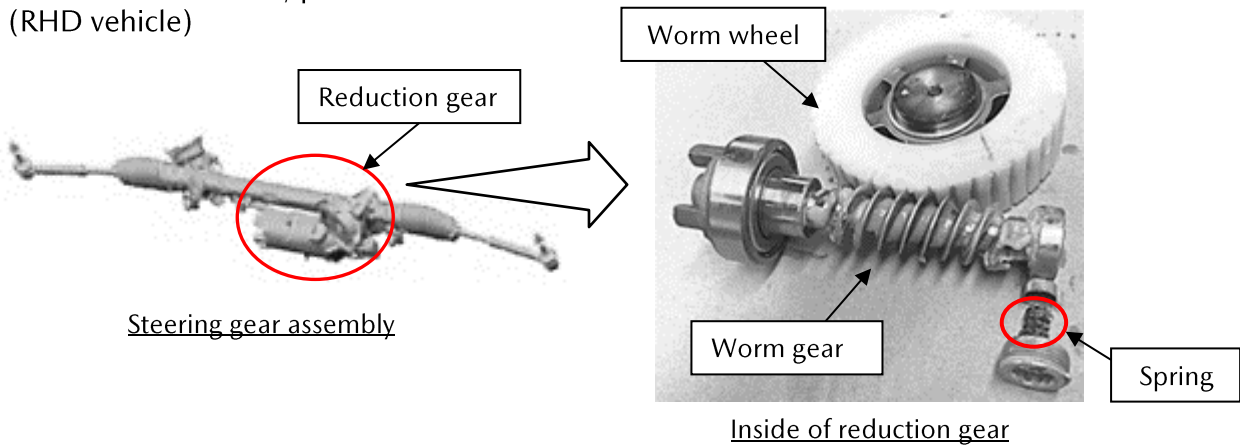
Reference illustration/photo  
(RHD vehicle)

On certain subject vehicles, while driving, the customer may feel a sudden increase of effort when steering the vehicle. Sudden and unexpected change of steering effort while driving may increase the risk of a crash.

A worm gear is incorporated in the steering gear assembly, which transmits the power assist generated by the power steering motor. The worm gear friction force may be excessive which results in increased force required to turn the steering wheel.

- Reapply grease to the gear teeth.
- Replace the spring engaging the worm gear with an improved part.  
(The improved spring will reduce the spring force to the worm gear in the steering assembly.)
