## RECALL H514 - HIGH VOLTAGE BATTERY PACK THERMAL OVERLOAD – USA ONLY

## SAFETY RECALL H514 – HIGH VOLTAGE BATTERY PACK ASSY THERMAL OVERLOAD - USA

| AFFECTED MODELS | 19MY I-PACE |

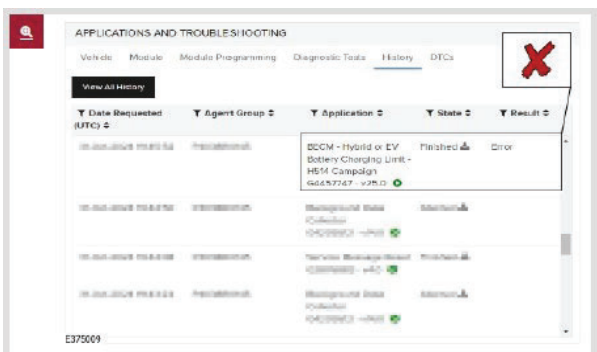
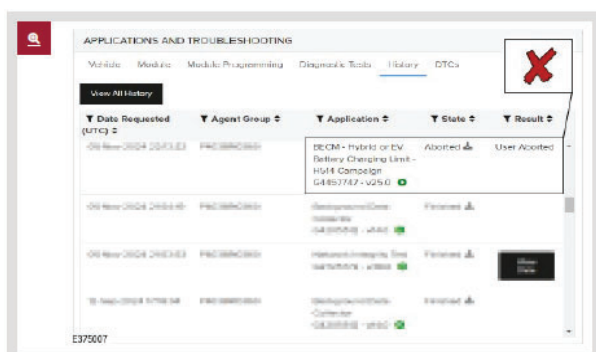
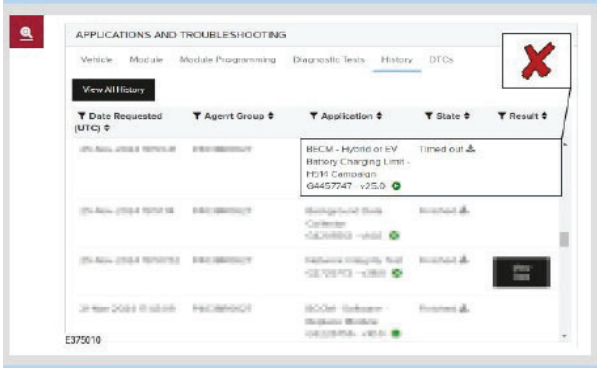
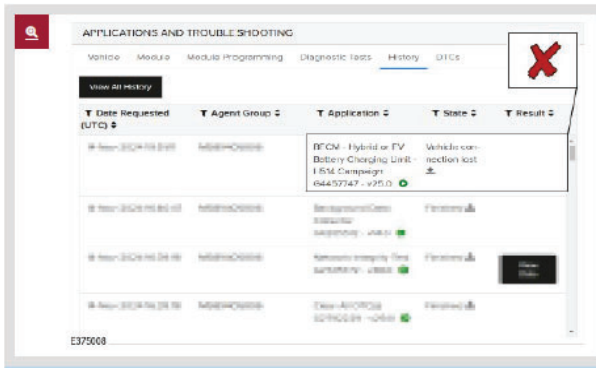
H514 Recall Bulletin was republished as v4 Dec 9<sup>th</sup> 2024 with additional Diagnostic Information showing some of the incomplete repairs performed. Bulletin extracts below.

| NOTES | <b>IMPORTANT!</b> The only valid repair procedure is to run the special application hyperlink in the bulletin procedure. To date, 34 vehicles closed in this recall have not had the interim repair applied correctly. These will need to be brought back under a new Safety Recall to have the correct repair performed.<br><br>Until the interim recall remedy has been completed, retailers and clients should park vehicles away from structures and where possible vehicles should be charged outside to a maximum of 80%. |

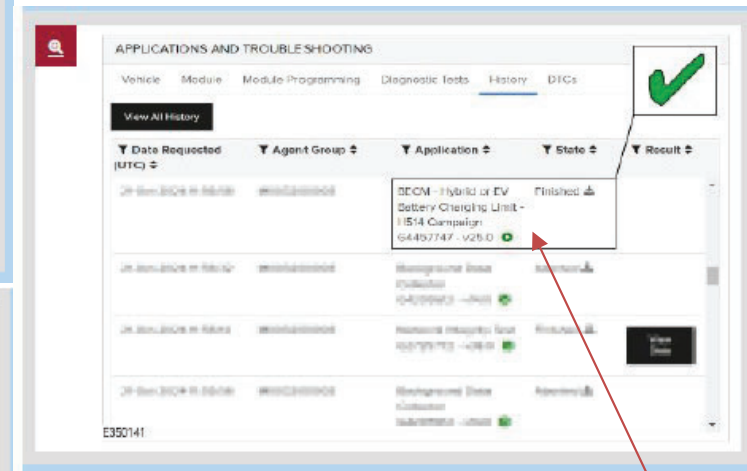
Repair Completed correctly
