# SAFETY RECALL

Mack Trucks Inc.  
Greensboro, NC USA

Date 12.2024 Number SC0472 Release 01 Page 1(9)

## Bendix ABS ECU Updated Software AN, GR, PI, TE

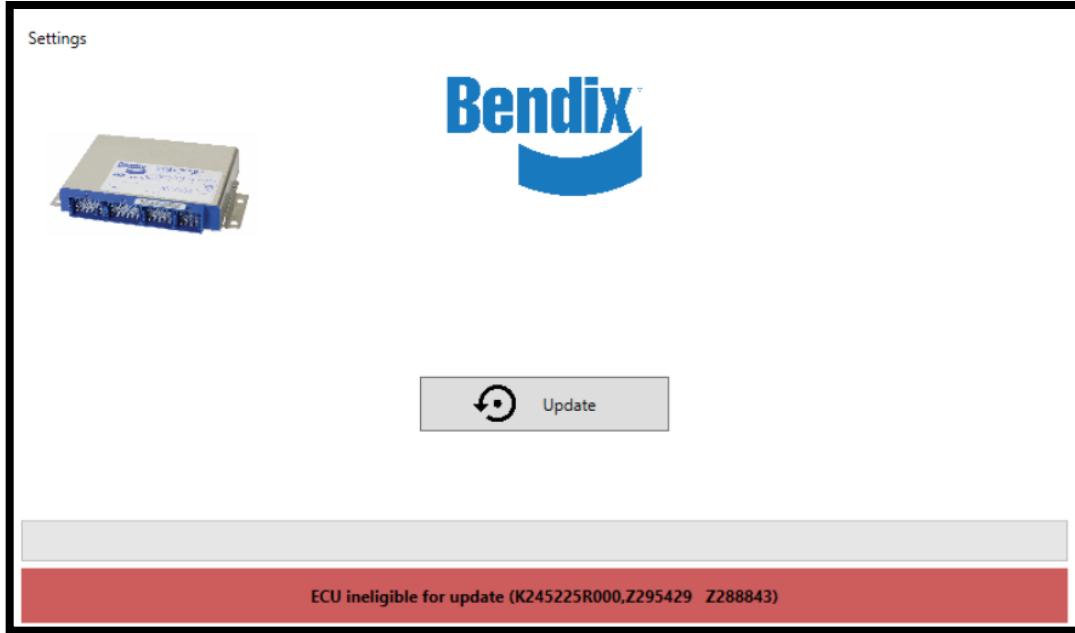
1. If the detected ECU is not eligible for an update, truck can be released for service.

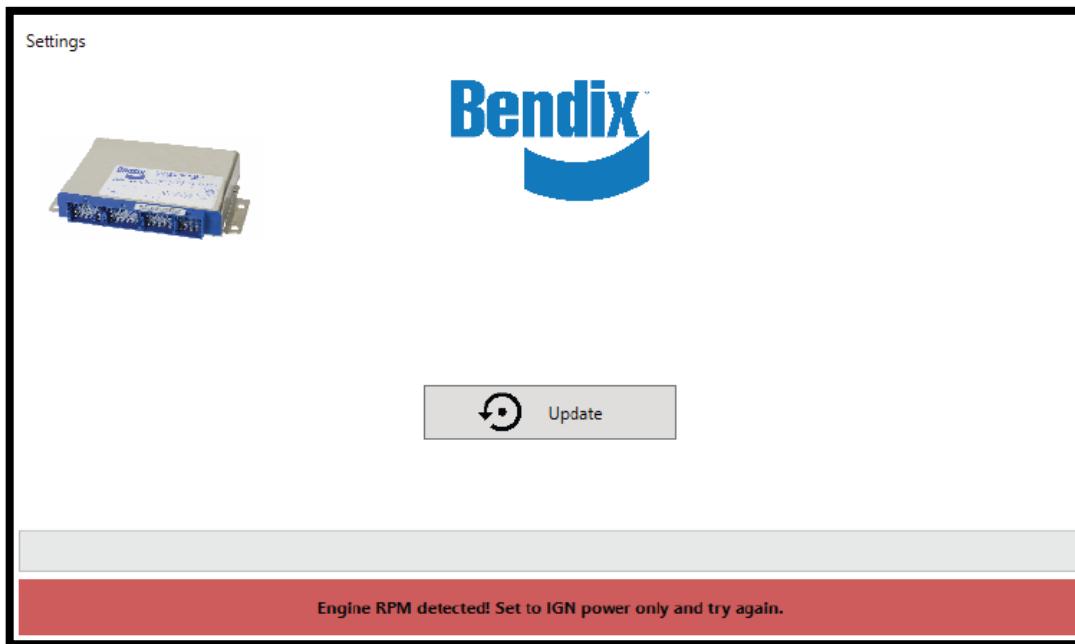
2. If engine RPM is detected during the procedure, power cycle to ignition only and restart the update procedure from Step 11.

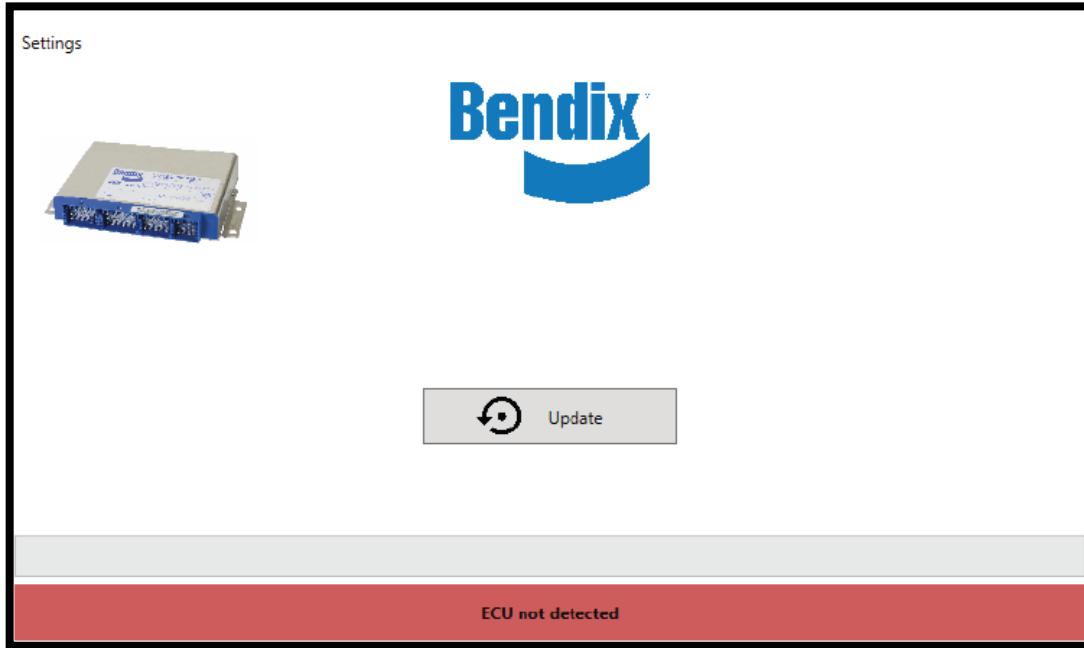
3. If the ECU is not detected, verify the ignition power is ON and/or ensure the correct channel is selected. Verify user is connected to the proper diagnostic connector. Then, restart the update procedure from step 11.
