F1017 A

Creation Date:	05/16/2025
NHTSA #	25V-046
Transport Canada #	2025-040

Subject: Electric Vehicle Power Distribution Module

Inspection and Repair of the Electric Vehicle Distribution Module (EVDM) Connector Plate

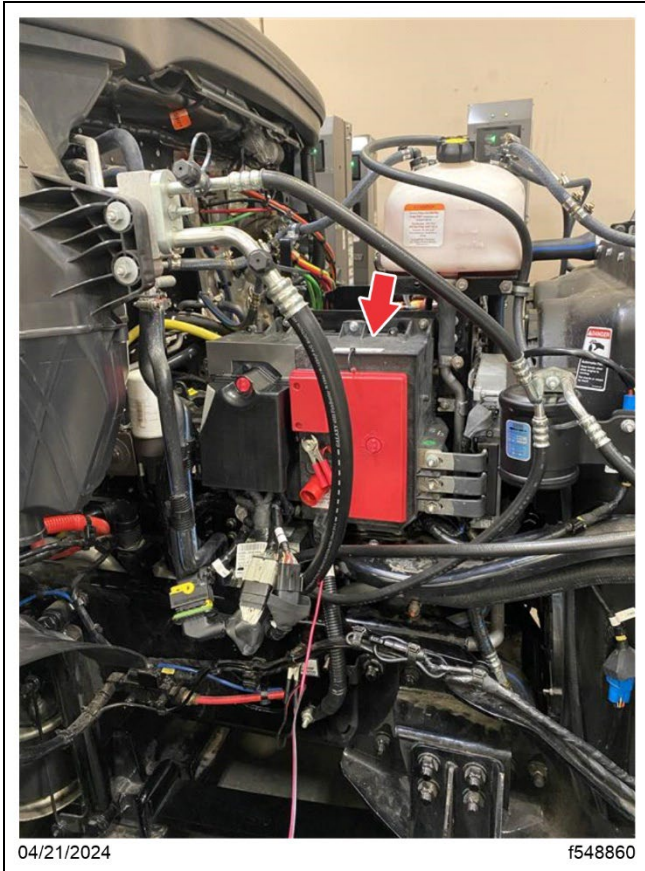
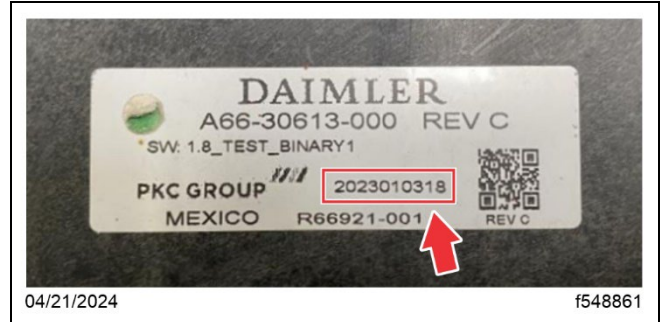
Fig. 1, EVDM on the Vehicle

4. Locate the sticker on top of the EVDM and check the serial number. Inspect if the clean date on the EVDM is on or after 10/07/2024 (20241007XX). See [Fig. 1](#) and [Fig. 2](#).

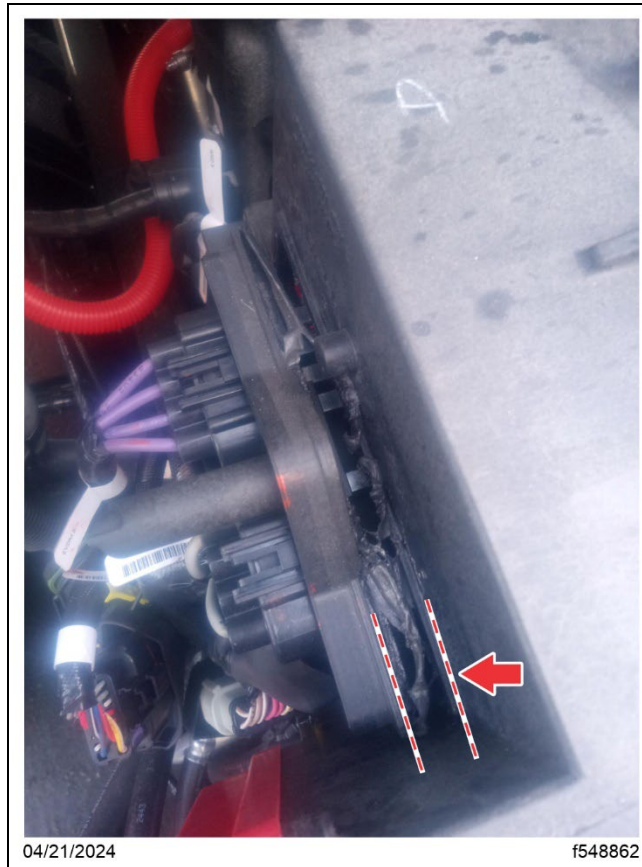
Fig. 3, Connector Plate Pulling Away from the EVDM

5. Use DiagnosticLink® to check for fault codes related to the EVDM. To clear the codes, follow the standard process.
6. Shut off the low-voltage battery smart switch on the left-hand side B-pillar.
7. Inspect the EVDM for separation between the connector plate and the EVDM. See Fig. 3.
Is a separation found between the connector plate and the EVDM?
YES → Capture a photo and send to DTNA and PKC at DTNA-WAR-Campaigns@daimlertruck.com and flavio.serina@motherson.com respectively for approval.
Replace the EVDM. For instructions, see **Group 54** of the applicable workshop manual.
Go to step 17. (Page 13)
NO → Continue with step 8. (Page 10)
