F1017 A

Creation Date: 05/16/2025
Revised Date: 06/06/2025
NHTSA # 25V-046
Transport Canada # 2025-040

Subject: Electric Vehicle Power Distribution Module

Inspection and Repair of the Electric Vehicle Distribution Module (EVDM) Connector Plate

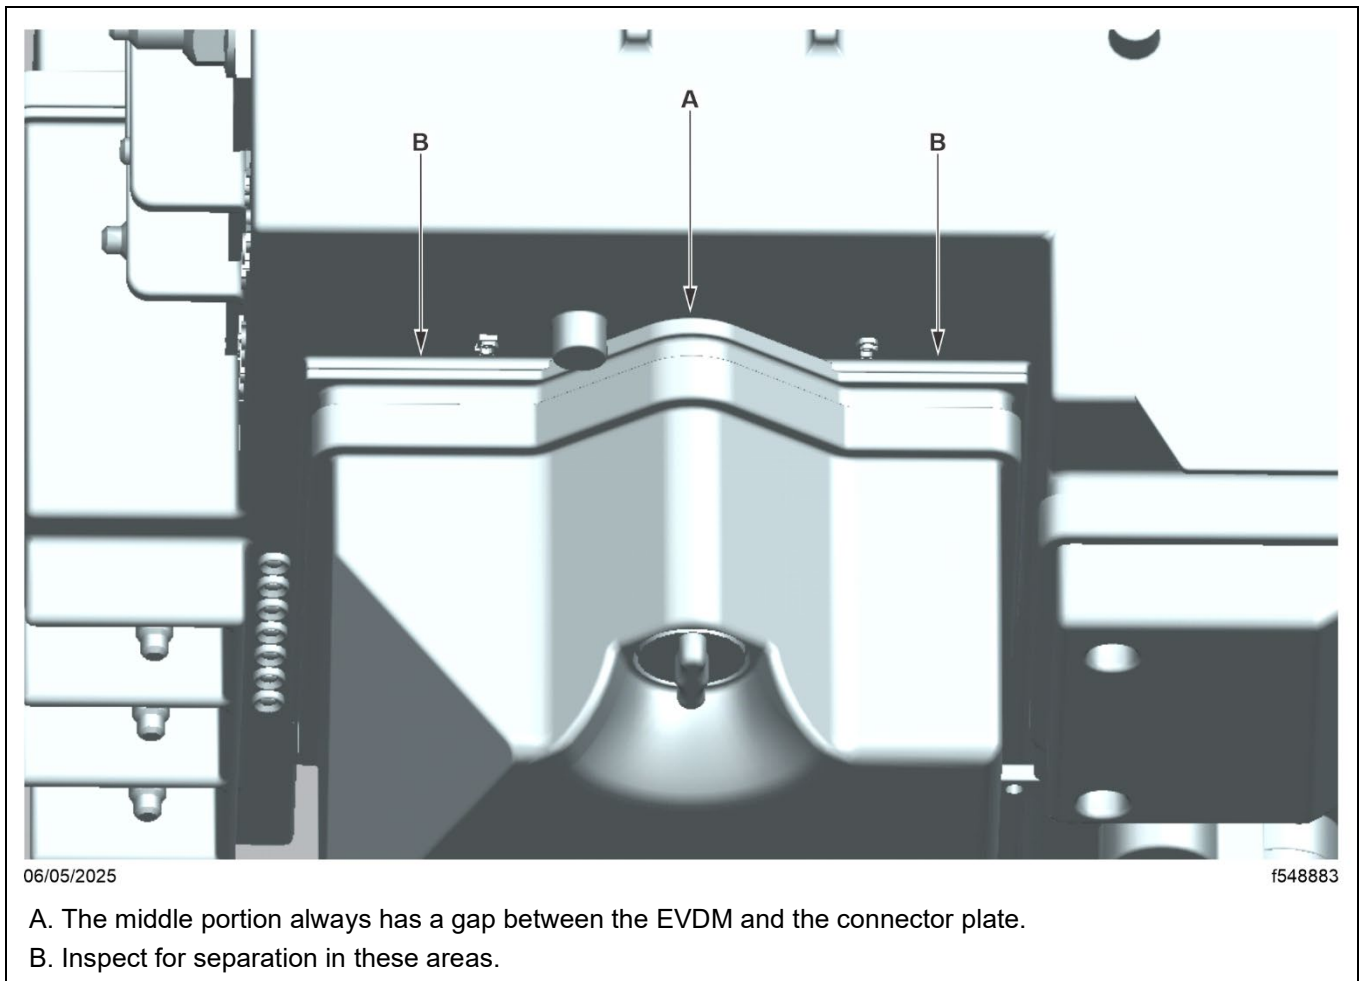
Fig. 3, EVDM Connector Plate Inspection Locations

7. Inspect the EVDM for separation between the connector plate and the EVDM. See **Fig. 3** and **Fig. 4**.

Is a separation found between the connector plate and the EVDM?

YES → Capture a photo and send to DTNA and PKC at DTNA-WAR-Campaigns@daimlertruck.com and flavio.serina@motherson.com respectively for approval.

Replace the EVDM. For instructions, see **Group 54** of the applicable workshop manual.

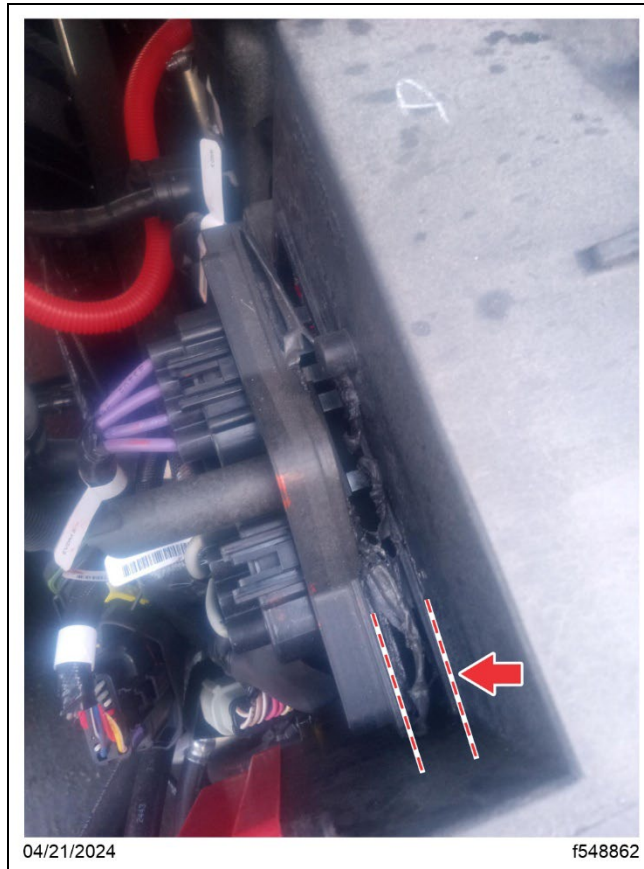
Fig. 4, Connector Plate Pulling Away from the EVDM

PROBLEM: In affected vehicles, the Electric Vehicle Power Distribution Module (EVDM) connector plate assembly may detach from the housing, causing pin disconnection in one or more circuits. The impact depends on the affected circuits, but in the worst case, it could lead to a sudden loss of motive power without warning, increasing the risk of a crash.
