Safety Recall Launch Notification

Campaign #	NHTSA ID	Description	Check Bolting of the Ground Connections
2025040007	25V240	25P5491321

Recall Campaign Bulletin

CAMPAIGN NO.	2025040007
CAMPAIGN DESC.	25P5491321
NHTSA ID	25V240
SUBJECT	Check Bolting of the Ground Connections
MODEL(S)	E-Class (214 platform)
MODEL YEAR(S)	2024
CAMPAIGN POPULATION	14

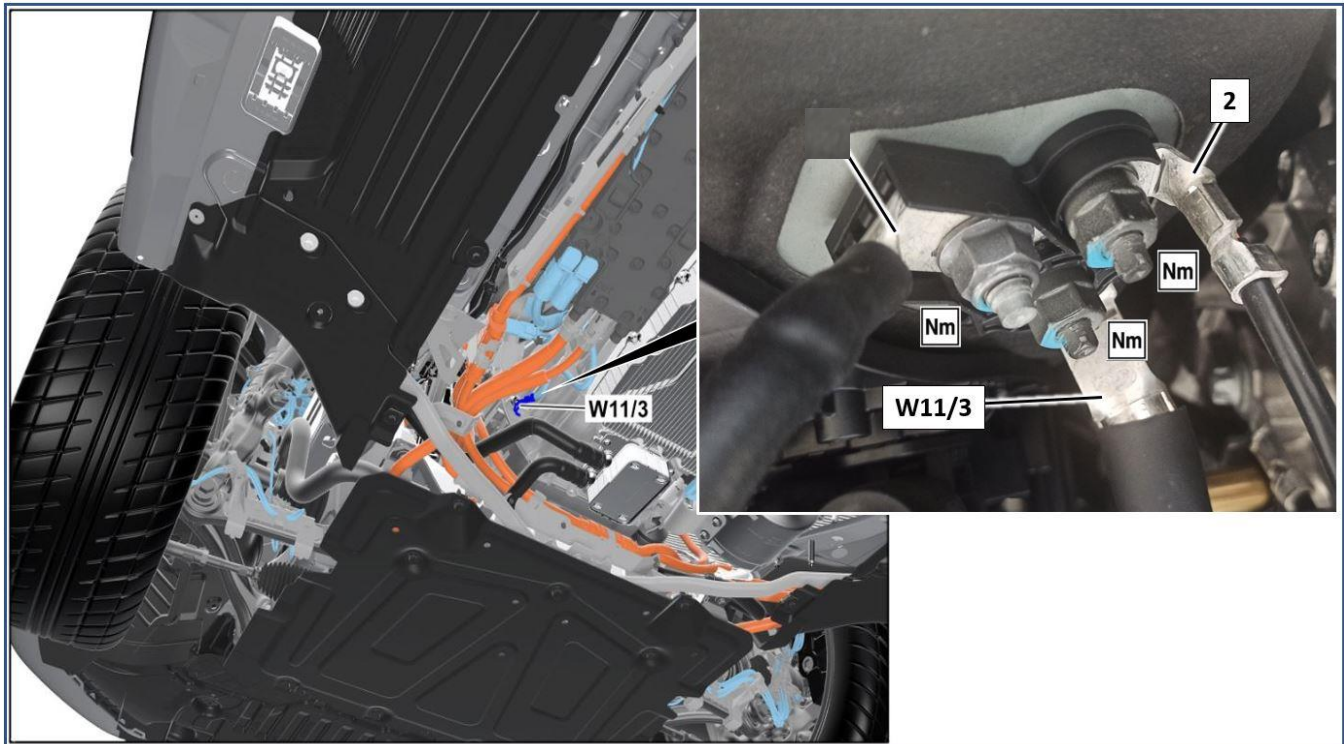
Figure 1

For basic information on model 214 see **AR61.20-P-1105WT**.
- Unscrew nuts on ground points (**Figure 1, W11/3 & 2**).

The number of ground points can vary depending on the engine involved.
 - Ground point for combustion engine, left (**Figure 1, W11/3**)
 - Ground point for circuit 31, with code B01 (48 V technology) (**Figure 1, 2**)

3. Perform a visual check on all detached electrical lines, the associated contact surfaces and the weld stud on the ground point:
 - a. If electrical lines, contact surfaces and/or weld studs **are damaged (such as signs of arching, welding, etc.):** Take descriptive pictures and clarify further repair procedure by opening a TIPS case and referencing code **25P5491321**.
 - b. If electrical lines, contact surfaces and weld studs are **not damaged: Continue with Work Procedure Step 4.**
4. **Replace** nuts on ground points (**Figure 1, W11/3 or 2**) and tighten to specified torque.
 - Left combustion engine ground point (**Figure 1, W11/3**): **20 Nm**
 - Ground point for circuit 31, with code B01 (48 V technology) (**Figure 1, 2**): **20 Nm**
5. Assemble in reverse order.
