## Safety Recall Launch Notification

Campaign #	NHTSA ID	Description	<b>Check Driver Seat Belt Tensioner Cover</b>
2025040012	25V253	25P9192004

# Recall Campaign Bulletin

CAMPAIGN NO.	2025040012
CAMPAIGN DESC.	25P9192004
NHTSA ID	25V253
SUBJECT	Check Seat Belt Tensioner Cover
MODEL(S)	C-Class (206 platform)
MODEL YEAR(S)	2022 – 2025
CAMPAIGN POPULATION	46

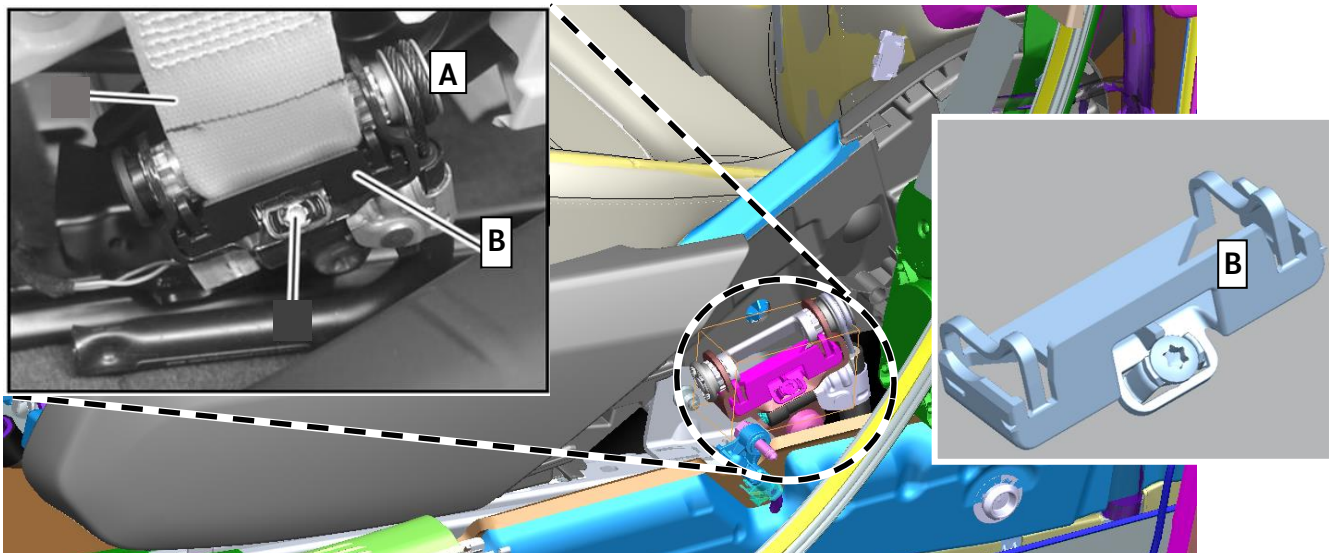
**Figure 2**

2. Check seat belt end-fitting (**Figure 2, A**) for correct installation.

**i** It is essential that the seat belt tensioner cover (**Figure 2, B**) is installed.

**i** The seat belt tensioner cover (**Figure 2, B**) could be missing from the vehicle.

- a. If the seat belt is not connected to the seat belt end-fitting tensioner (**Figure 2, A**) and/or the seat belt tensioner cover (**Figure 2, B**) is **not** installed: Carry out **Work Procedure**.
- b. If the seat belt end-fitting is installed correctly: **End measure**.

1. Correctly install seat belt end-fitting (**Figure 2, A**) and retrofit seat belt tensioner cover (**Figure 2, B**), if necessary.  
i For basic data, see **AR91.40-P-1030-02LWE**.
  2. Assemble in reverse order
-
