F1020 A

Creation Date: June 2025
Revised Date: July 2025
NHTSA # 25V-326
Transport Canada # 2025-269

Subject: Positive Junction Post

Models Affected					
Make	Model	Model Yr. Start	Model Yr. End	Prod. Start Date	Prod. End Date
Western Star	47X	2021	2026	July 8, 2020	May 14, 2025
Western Star	49X	2020	2026	March 19, 2019	May 14, 2025

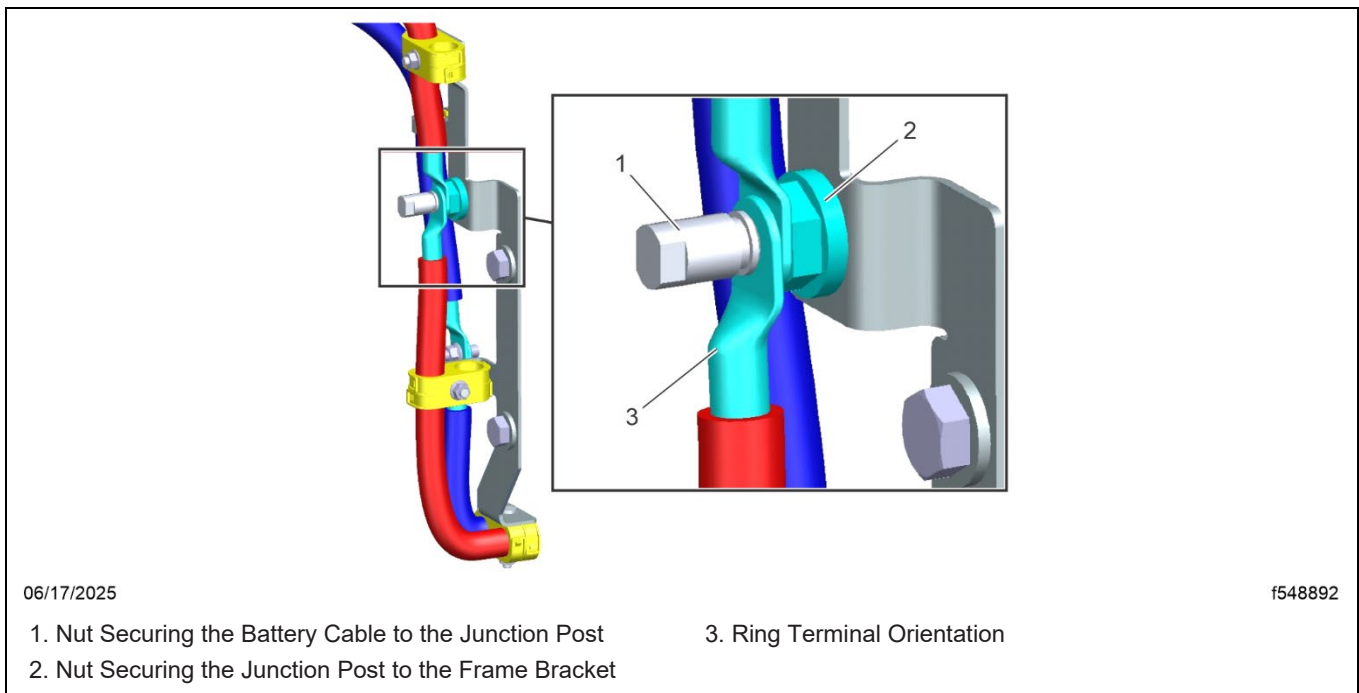
Fig. 1, Battery Cable Junction Post Connection (example)

8. Inspect the cable ends for corrosion and evidence of chafing. See **Fig. 1**.
 - If the corrosion is significant enough to cause pitting in the ring terminal, or if there is chafing on the insulation due to the incorrect installation of the cables, replace the affected cables.
 - If there is only minor corrosion and no evidence of chafing, clean the cable ends with a brass brush and wipe with solvent.
9. Clean any old dielectric paint from the overlap area of the post, nut, and cable ends.
10. Remove the plastic nut that secures the junction post to the frame bracket. See **Fig. 1**.

11. Inspect the junction post for damage to the plastic housing from overtightening.
 - If there is damage → Follow substeps 11.1 through 11.4 to replace the post.
 - If there is no damage → Clean any residual corrosion and go to step 12.
- 11.1. Remove any routing clamps or ties holding the cables to the bracket.
- 11.2. Remove the fasteners that secure the cable routing bracket to the frame.
- 11.3. Install the new junction post in the bracket and thread the plastic nut on to hold it in place.
- 11.4. Install the bracket on the frame rail and tighten the fasteners 148 lbf·ft (200 N·m).

Overtightening the plastic nut on the junction post can cause the post to separate from the plastic base.

7. Disassemble the junction post connection(s).
 - 7.1. Remove the nut that secures the battery cables to the junction post. See **Fig. 1**.
 - 7.2. Remove the cable clamping adjacent to the isolated post, as needed, to separate the cables from the post.
 - 7.3. Separate the cables from the post and note the orientation of the cable ends.

12. Tighten the plastic junction post nut 71 lbf·in (8 N·m). See [Fig. 1](#).
13. Assemble the cables on the post with the body of the ring terminals turned to give the most clearance to the mounting bracket. See [Fig. 1](#).
14. Install any remaining cable routing clamps or ties adjacent to the junction post terminal connection.

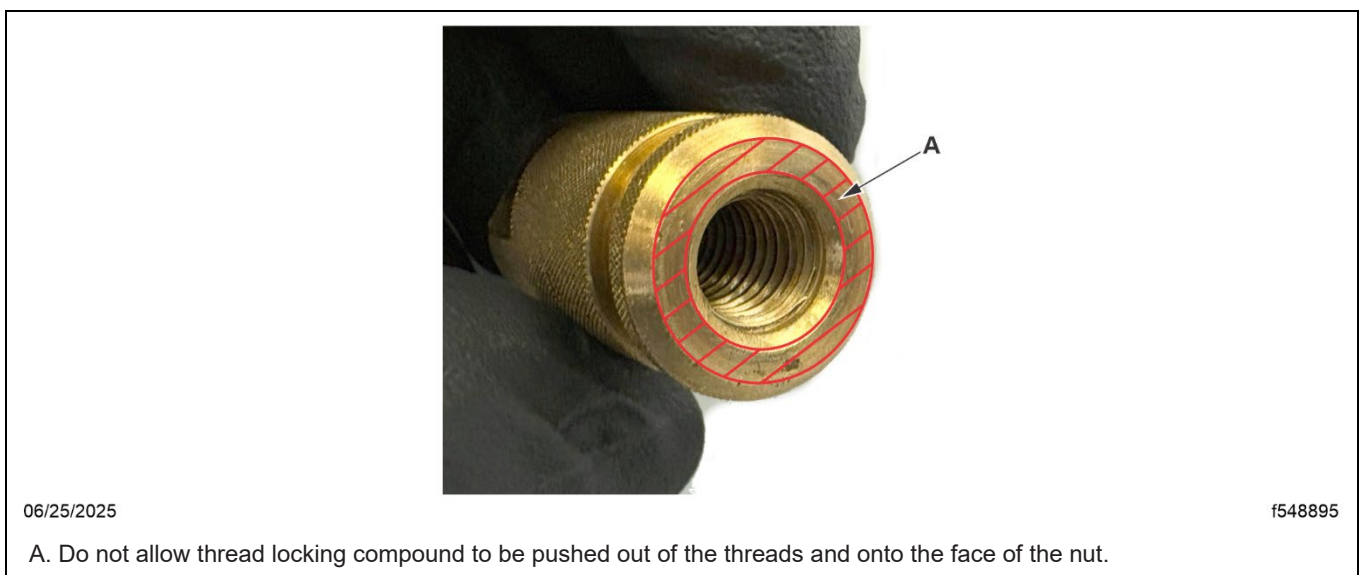
Fig. 3, Jumpstart Nut

A. Do not allow thread locking compound to be pushed out of the threads and onto the face of the nut.

16. If so equipped, ensure the jumpstart-nut does not get the thread-locking compound on the face that contacts the cable terminal. See [Fig. 3](#).
