Safety Recall Launch Notification

Campaign #	NHTSA ID	Description	Check Headlamp Adjustment Caps
2025060005	25V365	25P8291017

Recall Campaign Bulletin

CAMPAIGN NO.	2025060005
CAMPAIGN DESC.	25P8291017
NHTSA ID	25V365
SUBJECT	Check Headlamp Adjustment Screw Caps
MODEL(S)	GLC (254 platform)
MODEL YEAR(S)	2023
CAMPAIGN POPULATION	127

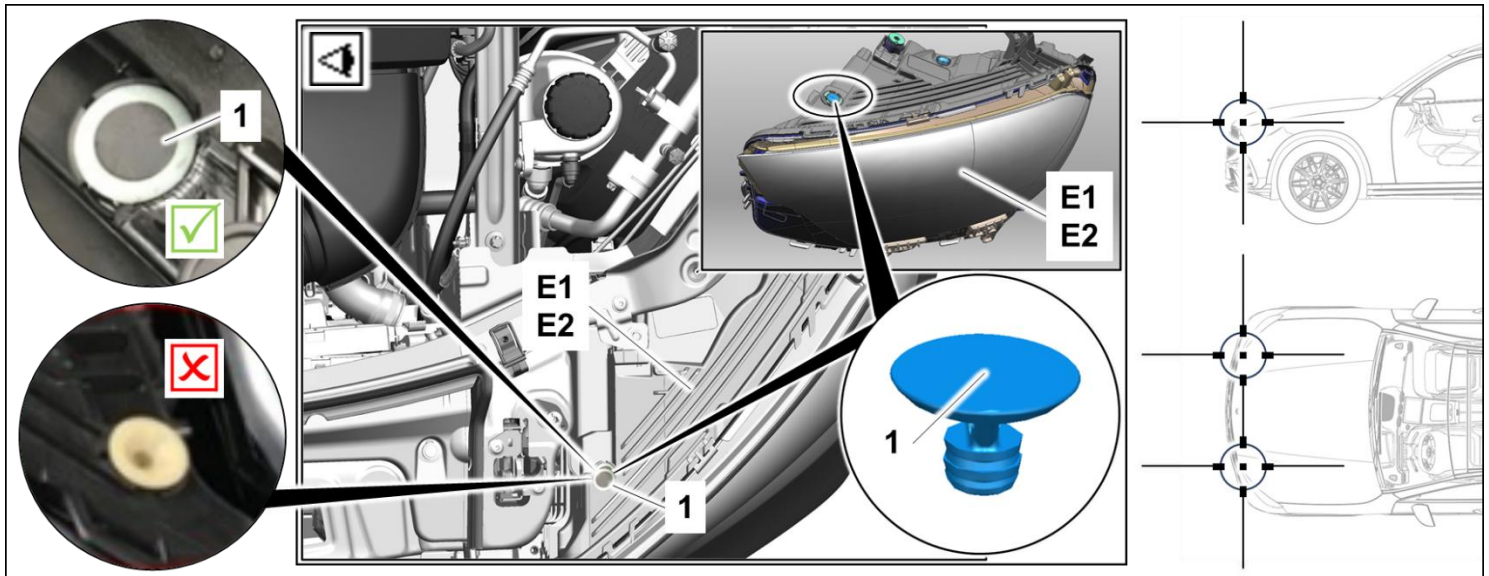
Figure 1 (Shown on driver side of vehicle)

Total Recall Population	127	Model(s)/ Platform(s)	GLC (254 platform)
Vehicles in Dealer Inventory	0		
Model Year(s)	2023		
Issue	Mercedes-Benz AG, the manufacturer of Mercedes-Benz vehicles, has decided that a non-compliance exists on certain subject vehicles. The cap covering the headlamp horizontal aiming screws might not have been installed during vehicle production. In this case, the headlamps are able to be adjusted horizontally, which is not intended. Subsequently, the regulatory requirements of FMVSS 108 might not be met. Horizontal adjustment might negatively impact intended roadway illumination and glare protection, which could increase the risk of a crash.		
What We're Doing	MBUSA will conduct a voluntary recall. An authorized Mercedes-Benz dealer will check the headlamps on the potentially affected vehicles and retrofit the retaining caps if necessary.		
Remedy	The remedy part is available and can be ordered at this time.

1. Check if cap (Figure 1, 1) is installed in the area shown on the front left & right headlamps (Figure 1, E1 & E2).

- a. Caps (Figure 1, 1) **are** installed: **End measure**.
- b. Caps (Figure 1, 1) **are not** installed: Perform **Work Procedure**.

1. Check adjustment setting of front left & right headlamp unit (Figure 1, E1 & E2), and correct if necessary.

i After adjusting the left and right headlamp settings (Figure 1, E1 & E2), the horizontal adjustment for the low beams must not be changed.

2. Install caps (Figure 1, 1) on the left & right headlamp (Figure 1, E1 & E2).
3. End measure.
