## Safety Recall Launch Notification

Campaign #	NHTSA ID	Description	<b>Rework Rear Headliner and C-Pillar Trim</b>
2025060004	25V379	25P6990005

# Recall Campaign Bulletin

CAMPAIGN NO.	2025060004
CAMPAIGN DESC.	25P6990005
NHTSA ID	25V379
SUBJECT	Rework Rear Headliner and C-Pillar Trim
MODEL(S)	GLC (254 platform)
MODEL YEAR(S)	2023 – 2025
CAMPAIGN POPULATION	92,851

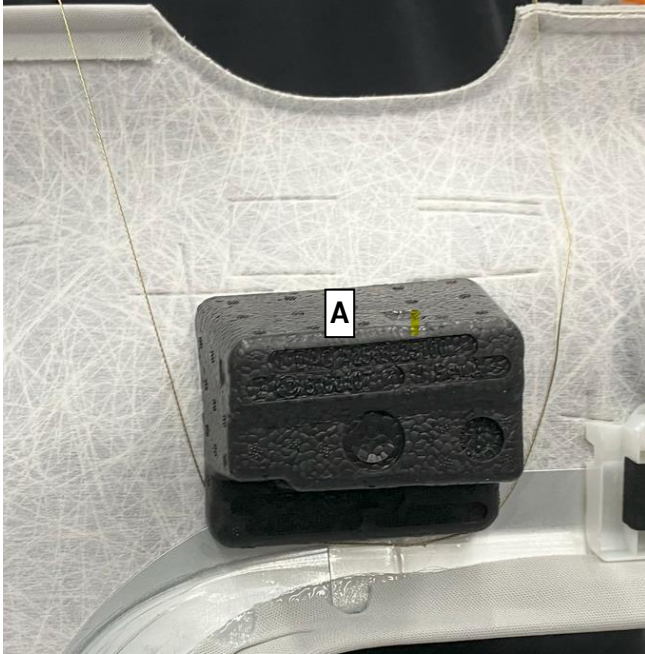
**Figure 1 (Left side, shown on removed headliner)**

**Work Procedure 1:** Remove foam blocks (Figure 1, A) from headliner in the area of the C-pillars.

1. Remove grab handles on rear of roof (AR68.30-P-4330WT).
2. Remove C-pillar trim on left and right side (AR68.30-P-4490WTC).
3. Detach headliner and frame of panoramic roof from the rear area up to the B-pillar.

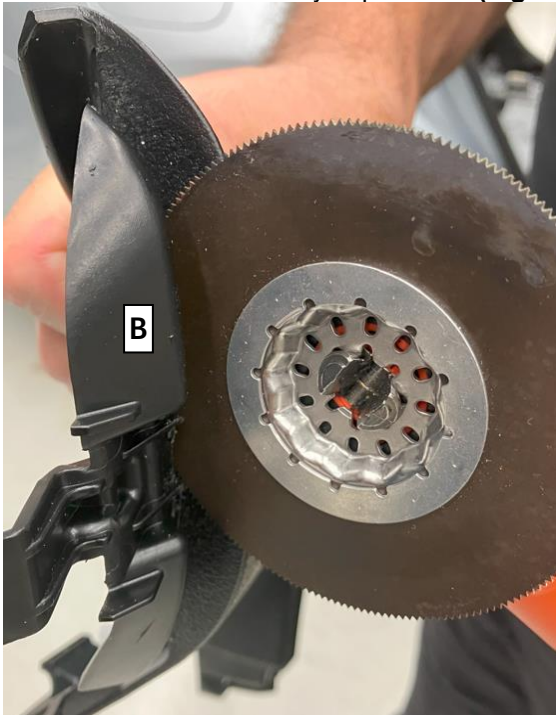
**Figure 2 (Shown on left C-pillar trim element)**

**Work Procedure 2:** Modify C-pillar trim (Figure 2, B) near the headliner contact area.
