# Safety Recall 25PACF: EMUX Exterior Lighting Not Compliant With FMVSS/CMVSS 108

25PACF / NHTSA # 25V436 / Transport Canada # 2025-357

PACCAR

7/25/2025

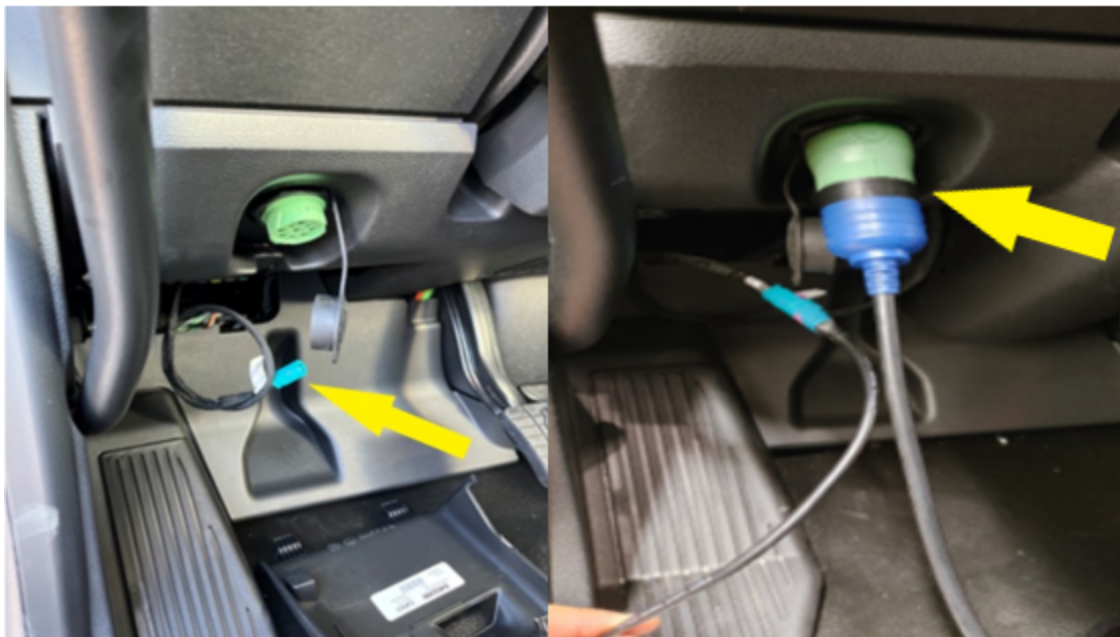
*Ethernet cable*

*9-pin diagnostics connector*

1. Process PACCAR Vehicle Pro (PVP) file.
  - In PACCAR.net open PACCAR Vehicle Pro (PVP).
  - Enter chassis number.
  - Select "Save and Continue."
  - Select "Submit".
2. Connect the 12V battery charger to the vehicle's 12V battery.
3. Connect DAVIE4 tool.
  - Connect Nexiq to the 9-pin diagnostics connector.
  - Connect the Ethernet cable. See TIB 98-016 for Ethernet cable details.

NOTE: Do not connect the DAVIE4 Ethernet cable directly to the Digital Display (DD2). Doing so bypasses the Central Security Gateway (CSG) and may cause a software update issue.
