Safety Recall Launch Notification

Campaign #	NHTSA ID	Description	Rework Steering Coupling Bolt Connection
2025080006	25V533	25P4691007

Recall Campaign Bulletin

CAMPAIGN NO.	2025080006
CAMPAIGN DESC.	25P4691007
NHTSA ID	25V533
SUBJECT	Check Steering Coupling Bolting
MODEL(S)	GLC and EQE (254 and 295 platform)
MODEL YEAR(S)	2023 – 2026
CAMPAIGN POPULATION	3,749

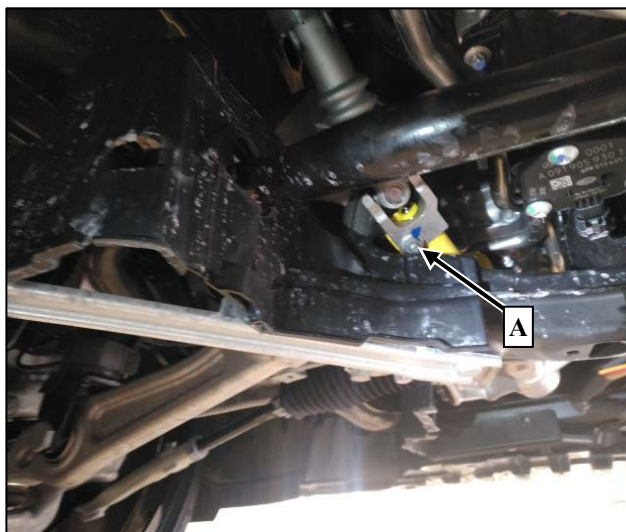
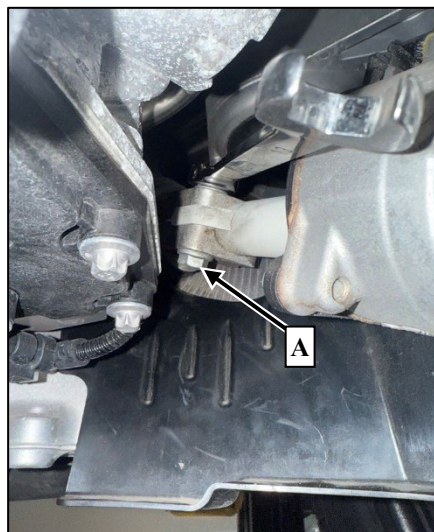
Figure 1 – looking towards front of vehicle

Total Recall Population	3,749	Model(s)/ Platform(s)	GLC, EQE (254, 295 platforms)
Vehicles in Dealer Inventory	217		
Model Year(s)	2023-2026		
Issue	Mercedes-Benz AG, the manufacturer of Mercedes-Benz vehicles, has determined that a defect exists on certain subject vehicles. The bolt securing the steering coupling might not be tightened to production specifications. As a result, the connection between the steering coupling and steering rack could loosen over time. This could lead to a loss of steering control and increase the risk of a crash.		
What We're Doing	MBUSA will conduct a voluntary recall. An authorized Mercedes-Benz dealer will rework the bolt connection of the steering coupling on the affected vehicles.		
Remedy	The remedy does not require ordering new parts; existing parts will be reworked to address the issue.		
Launch Date	Affected VINs will be flagged in VMI as "OPEN" on Friday, August 22, 2025. The campaign will be visible on the www.NHTSA.gov website and may generate questions from customers.

- Remove rear and center lower engine compartment lining.
 - i** For basic data on model 254, see AR61.20-P-1105WT.
 - i** For basic data on model 295, see AR61.20-P-1105EQS.
- Check torque of screw connection (**Figure 1, A**) from steering coupling to steering gear and retighten if necessary.
 - i** If damage is visible on the screw or nut, replace screw and nut.
 - Nm** Torque specification: **24Nm**
