## PRODUCT CAMPAIGN BULLETIN

**APPLICABILITY:** 2023-2025 MY Solterra

**NUMBER:** WRD-25

**SUBJECT:** Safety Recall and Stop Sale: Solterra HVAC  
 ECU Reprogramming

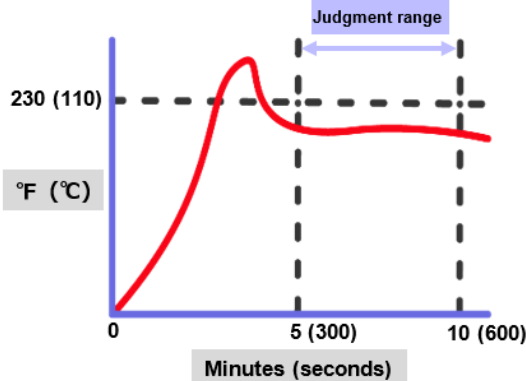
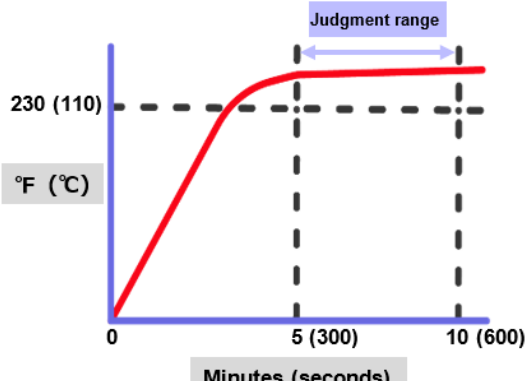
| JUDGMENT CRITERIA | | |
|---|---|---|
| <b>OK</b> | <b>After 5-10 minutes the temperature never reached 230°F (110°C).</b><br> | <b>Proceed to Step</b><br><b>17</b> |
| | <b>After 5-10 minutes the temperature was over 230°F (110°C).</b><br> | |

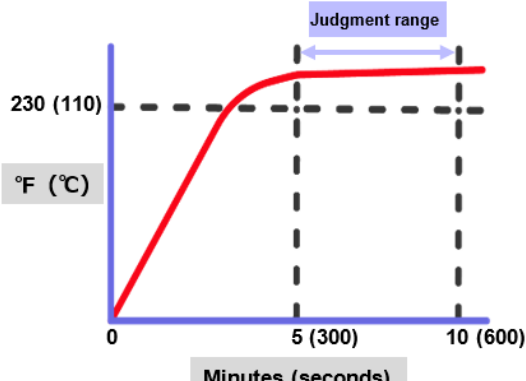
| JUDGMENT CRITERIA | | |
|---|---|---|
| <b>YES</b> | <b>After 5-10 minutes the temperature was over 230°F (110°C).</b><br> | <b>TBD</b><br><b>until part supply</b><br><b>becomes sufficient</b> |

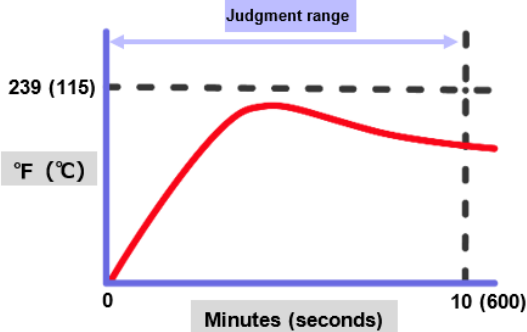
| JUDGMENT CRITERIA | |
|---|---|
| <div style="background-color: green; color: white; padding: 10px; text-align: center; font-size: 2em; font-weight: bold;">OK</div> <p>The temperature never reached 239° (115°C)F in 10 minutes.</p> <p>239 (115)<br/>°F (°C)</p> <p>0 10 (600)<br/>Minutes (seconds)</p> | <p><b>Proceed to Step</b></p> <p><b>17</b></p> |

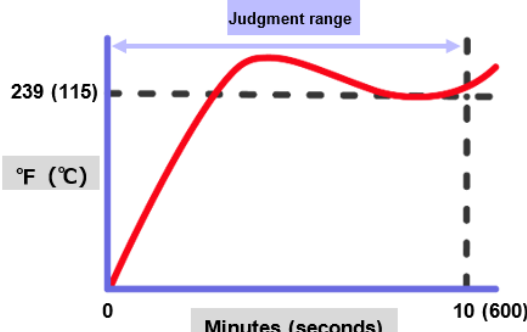
| JUDGMENT CRITERIA | |
|---|---|
| <div style="background-color: red; color: white; padding: 10px; text-align: center; font-size: 2em; font-weight: bold;">YES</div> <p>Within 10 minutes the temperature reached 239°F (115°C).</p> <p>239 (115)<br/>°F (°C)</p> <p>0 10 (600)<br/>Minutes (seconds)</p> | <p><b>TBD</b><br/>until part supply becomes sufficient</p> |
