Service Engineering Operations  
Customer Service Division

June 3, 2026

**SUBJECT: NEW VEHICLE DEMONSTRATION / DELIVERY HOLD**  
**Safety Recall 25S95 - Supplement #1**  
Certain 2023-2024 Model Year Transit Internal Combustion Engine (ICE) Vehicles  
Tire and Steering Shaft Bolt Replacement

# CERTAIN 2023-2024 MODEL YEAR TRANSIT INTERNAL COMBUSTION ENGINE (ICE) VEHICLES — TIRE AND STEERING SHAFT BOLT REPLACEMENT

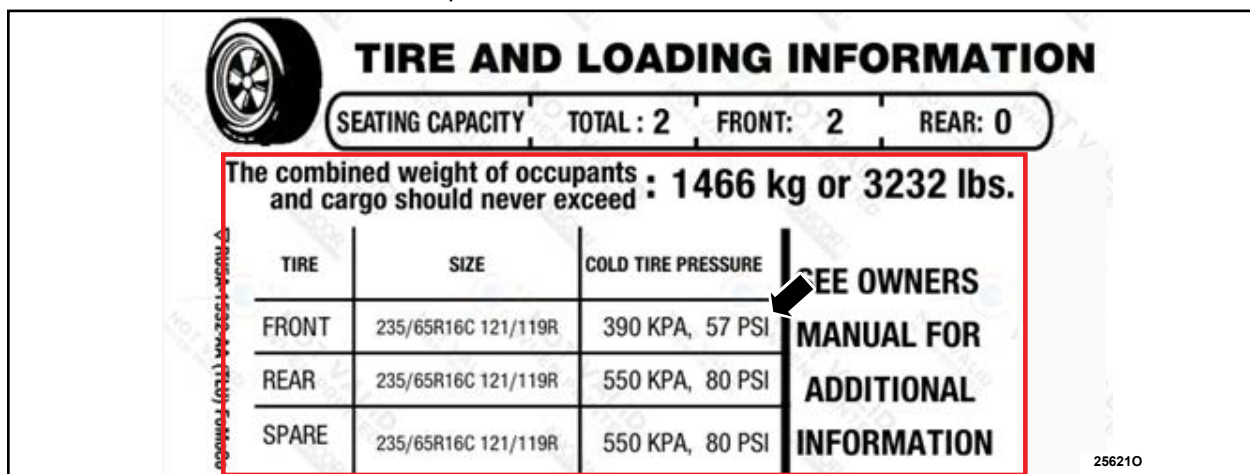
FIGURE 1

1. Inspect the TREAD Act label found on the driver-side door jamb. Does the TREAD label have the correct Vehicle Identification Number (VIN) and *front tire pressure of 57 PSI as shown in Figure 1?*
