Bentley Bulletin

26-008

To: Parts & Service, Sales & Marketing
Subject: USA RECALL CAMPAIGN – Bentley Bentayga Hybrid – Software Update
for HV Battery Management Controller (RE25/46, RD74)

Software Update For HV Battery Management Controller | Bentayga Hybrid |
23MY (RE25/46)

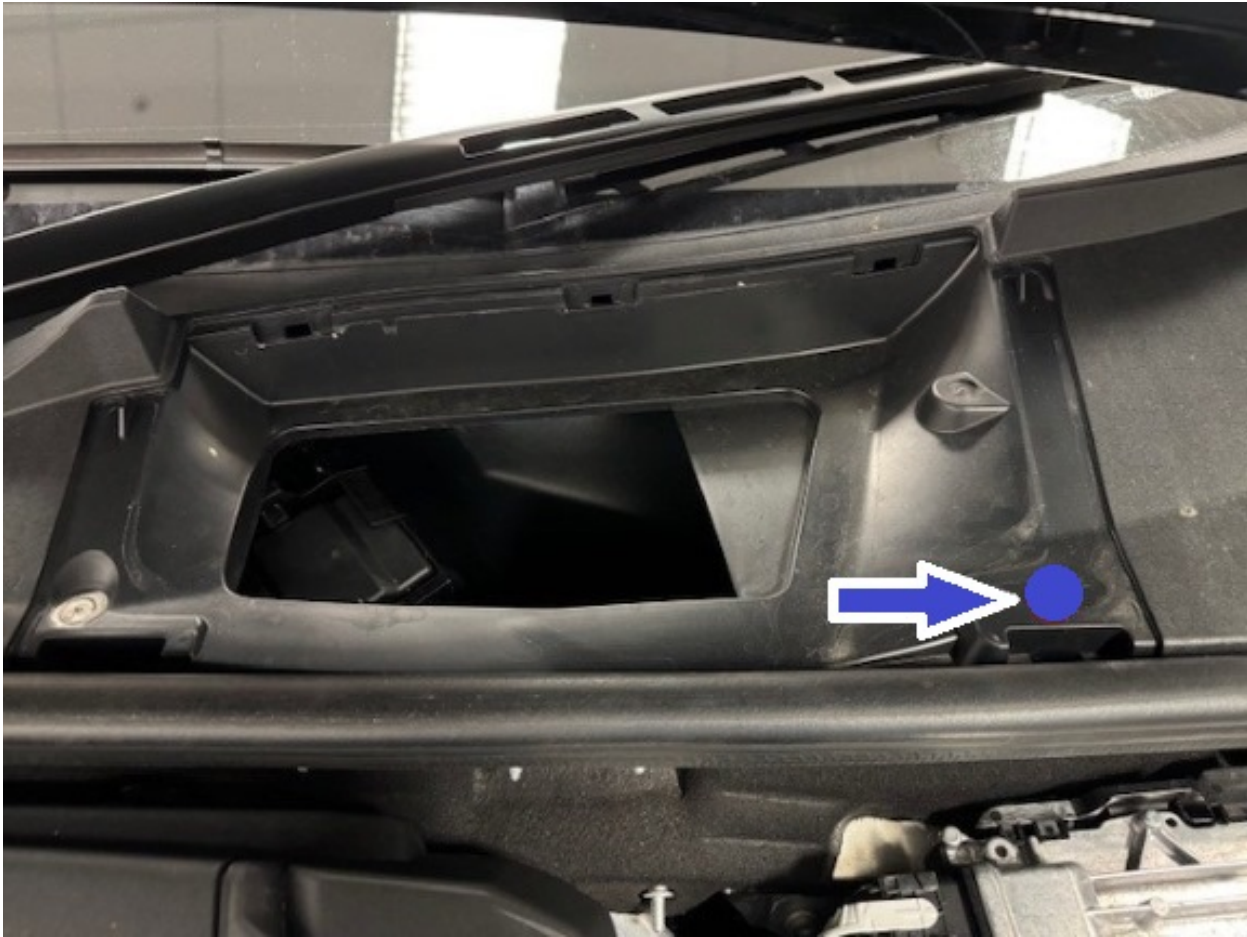
Identification

You must also the open bonnet and remove the air grille add a blue paint mark as shown below.
