Safety Recall Launch Notification

Campaign #	NHTSA ID / CA DMV #	Description
2026010001	25V865	25P5491322

Check and Rework Transmission Wiring Harness

CAMPAIGN NO.	2026010001
CAMPAIGN DESC.	25P5491322
NHTSA ID	25V865
SUBJECT	Check and Rework Transmission Wiring Harness
MODEL(S)	AMG E 53 Hybrid 4MATIC+ (214 platform)
MODEL YEAR(S)	2025
CAMPAIGN POPULATION	117

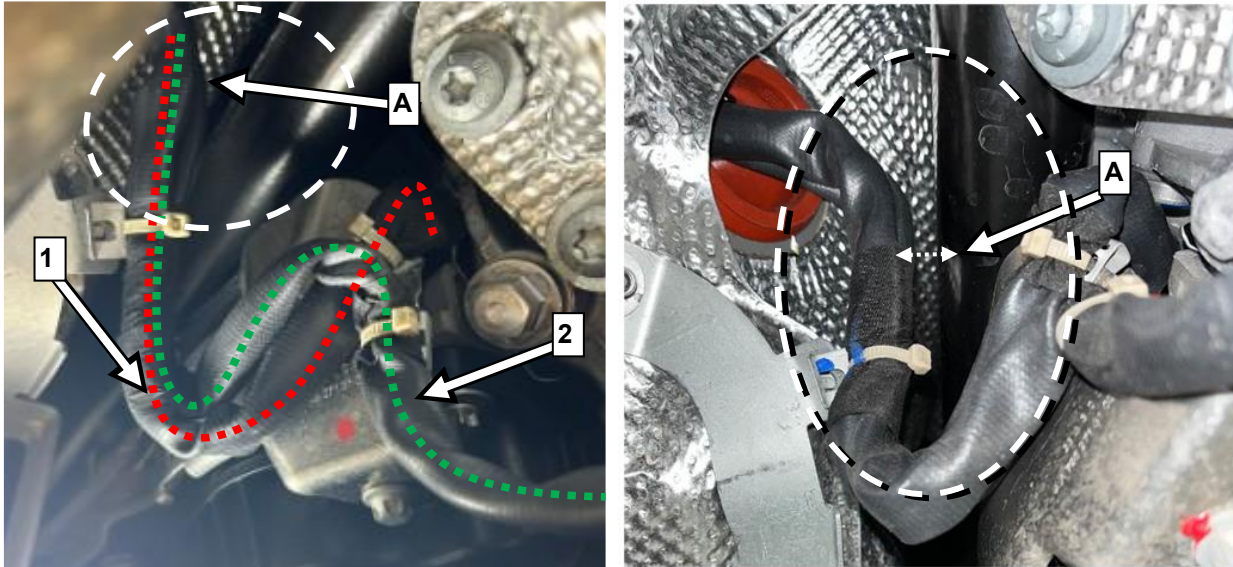
**Figure 1 – Red (1): Power supply line
Green (2): Signal wires**

1. Check routing (**Figure 1, 1 & 2**) and distance (**Figure 1, A**) of the electrical wiring harnesses between the transmission tunnel/drive shaft and transfer case to front axle differential [*indicated parts*].

The electrical wiring harnesses **must not** make contact with the indicated parts.

The distance from the electrical wiring harness to the drive shaft must be **at least 10 mm**.

- a. If electrical wiring harness is in contact with indicated parts or the distance (**Figure 1, A**) is less than 10 mm and wiring harness is **not damaged**: Perform **Work Procedure 1**.
- b. If electrical wiring harness is in contact with indicated parts and **it is damaged**: Perform **Work Procedure 1** and **Work Procedure 2**.
- c. If electrical **power supply line (Figure 1, 1) (line cross-section 10 mm²) is damaged**: Perform **Work Procedure 1** and **Work Procedure 3**.
- d. If electrical wiring harness is ***routed correctly***: **End measure**.

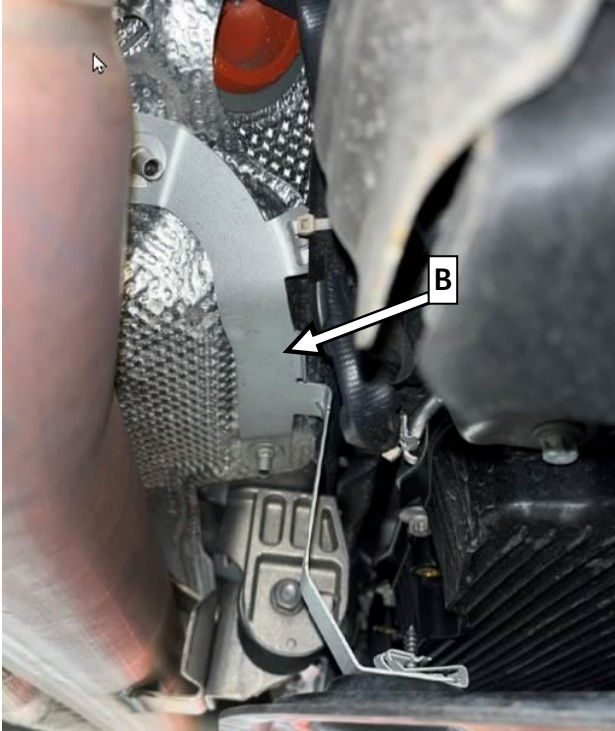
Figure 2

Electrical wiring harness is in contact with or less than 10 mm from the indicated parts, but *is not damaged*:

1. Remove holder (**Figure 2, B**) for attaching wiring harness and engine compartment lining.

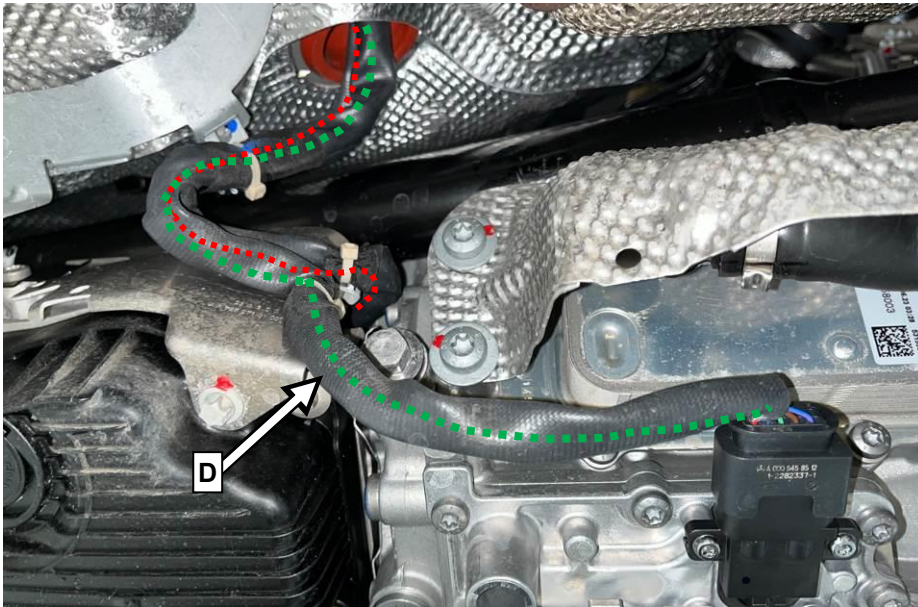
Figure 6

Electrical wiring harness is in contact with indicated parts and ***is damaged (chafed, melting, tears/scoring)***.
If only the protective sheathing is damaged, and the electrical wiring has no signs of damage:

i One or more of the electrical signal lines (**line cross section 0.35 mm² to 0.75 mm²**) in the electrical wiring harness (**Figure 6, D**) shows signs of damage.

1. Wrap affected area with fabric tape.
2. Route electrical wiring harness (**Figure 6, D**) correctly as shown.
 - i** The electrical wiring harness (**Figure 6, D**) must not be in contact with indicated parts ***in any location!***

1. Repair the affected electric signal line (**line cross-section 0.35 mm² to 0.75 mm²**) in the electrical wiring harness (**Figure 6, D**) using a line connector.
 - i** For basic information, see **AR00.19-P-0100A**.
 - i** To do this, cut the protective sheathing, repair the wiring harness using line connector(s), and reinstall protective sheathing using fabric tape to connect the cut sides.
2. Route electrical wiring harness (**Figure 6, D**) correctly, as shown.
 - i** The electrical wiring harness (**Figure 6, D**) must not make contact ***at any point!***
3. Assemble in reverse order.

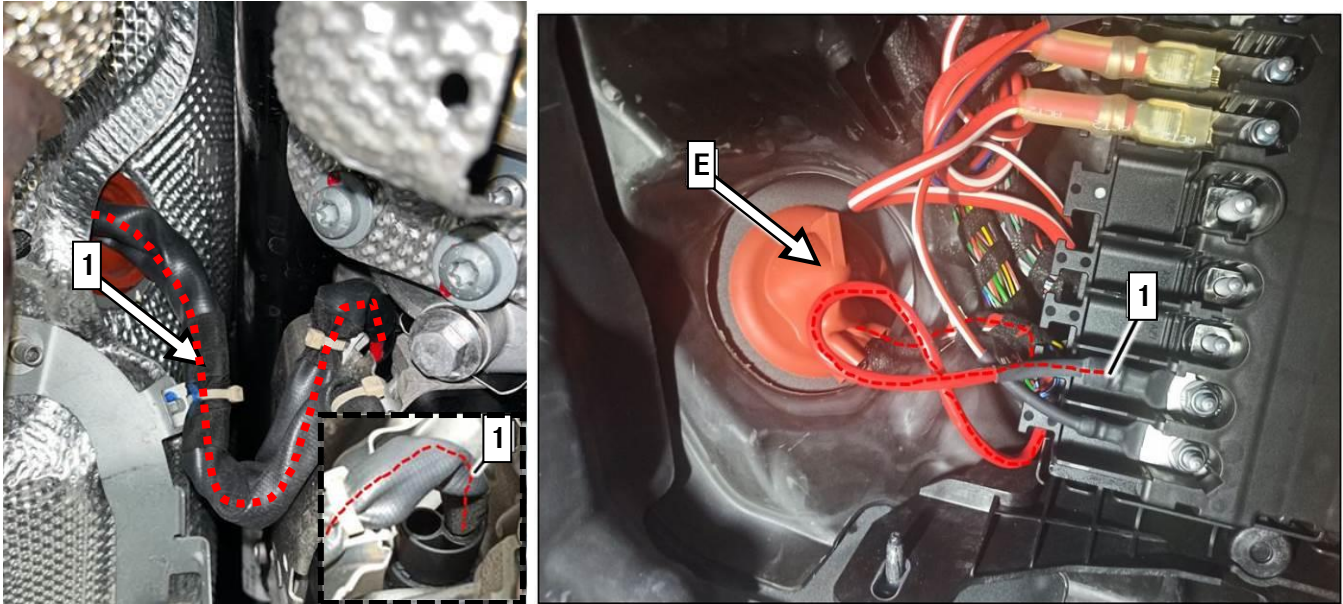
Figure 7

i If the electric power supply line (Figure 7, 1) (line cross-section 10 mm²) is damaged, replace electric power supply line (Figure 7, 1):

1. Disconnect ground line of 12 V electrical system battery.
i For basic information, see **AR54.10-P-0051WT**.
2. Remove rear section of underfloor paneling.
3. Remove protective metal sheet (Figure 8, F).
4. Detach electric power supply line (Figure 7, 1) from electrical connector on transmission.
5. Remove front floor covering on front passenger side.
i For basic information, see **AR68.80-P-0008WT**.
6. Remove electric power supply line (Figure 7, 1) with grommet (Figure 7, E).
7. Replace electric power supply line (Figure 7, 1).
i The electrical wiring harness **must not** be in contact with indicated parts at **any location**.
8. Assemble in reverse order.
